RE: Nine Mile Point Unit 1
Docket No. 50-220
DPR-63

Subject: *Generic Letter 94-03, "Intergranular Stress Corrosion Cracking of Core Shrouds in Boiling Water Reactors," Request for Approval Under the Provision of 10CFR50.55a(a)(3)(i) for Modification of the Four Stabilizer Assemblies (Tie Rods) for Nine Mile Point Unit 1 (NMP1)*

SUMMARY OF THE TIE ROD INSPECTION FINDINGS

MODIFICATION FIGURES AND DESIGN STRESS REPORT

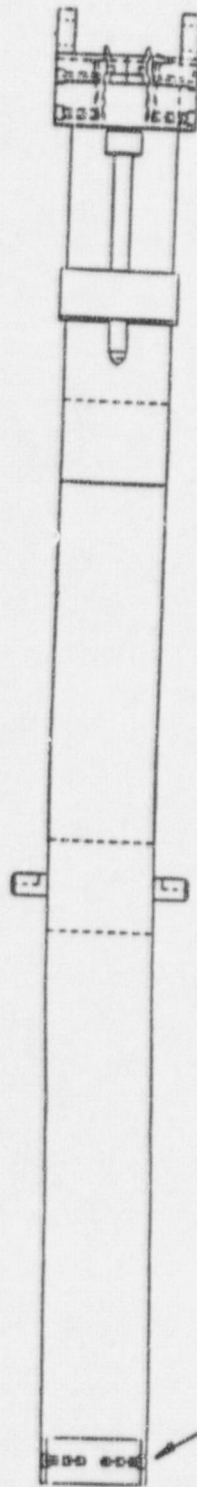
FIGURE 2 - UPPER SPRING

The degraded condition of the four tie rods was discovered during the tightness inspections. Specifically, the post-torquing visual inspection of the critical areas of the 166 degree tie rod revealed that a 3/8 inch cap screw made of alloy X-750 material had failed and the broken portion had dislodged from the upper spring assembly. The broken portion included the cap screw head and part of the threaded screw. Approximately 2 to 3 threads were included with the broken portion. The failed cap screw is one of the four cap screws that attaches the upper spring bracket to the upper spring.

During the 1999 outage, a cap screw was found to be broken during a visual inspection of the 166 degree tie rod assembly. An evaluation identified the root cause to be intergranular stress corrosion cracking (IGSCC) in the alloy X-750 cap screw material in conjunction with large, sustained differential thermal expansion stress due to fastening of dissimilar materials with the cap screw. A potential contributing cause was the sustained stresses that were attributed to the torquing of the cap screw associated with the original assembly of the tie rods. A second potential contributing cause is the stresses associated with friction between the vessel wall and the upper spring contact points.

SEE FIGURE 3
FOR REPAIR DESIGN

SEE FIGURE 4
FOR REPAIR DESIGN
