**CORROSION TEST OF STEAM GENERATOR  
TUBES WITH ALLOY 800  
MECHANICAL SLEEVES**

**REPORT NO. 98-FSW-021 REV. 00  
MARCH, 1999**

**ABB COMBUSTION ENGINEERING NUCLEAR POWER  
COMBUSTION ENGINEERING, INC.  
2000 DAY HILL ROAD  
WINDSOR, CONNECTICUT 06095**

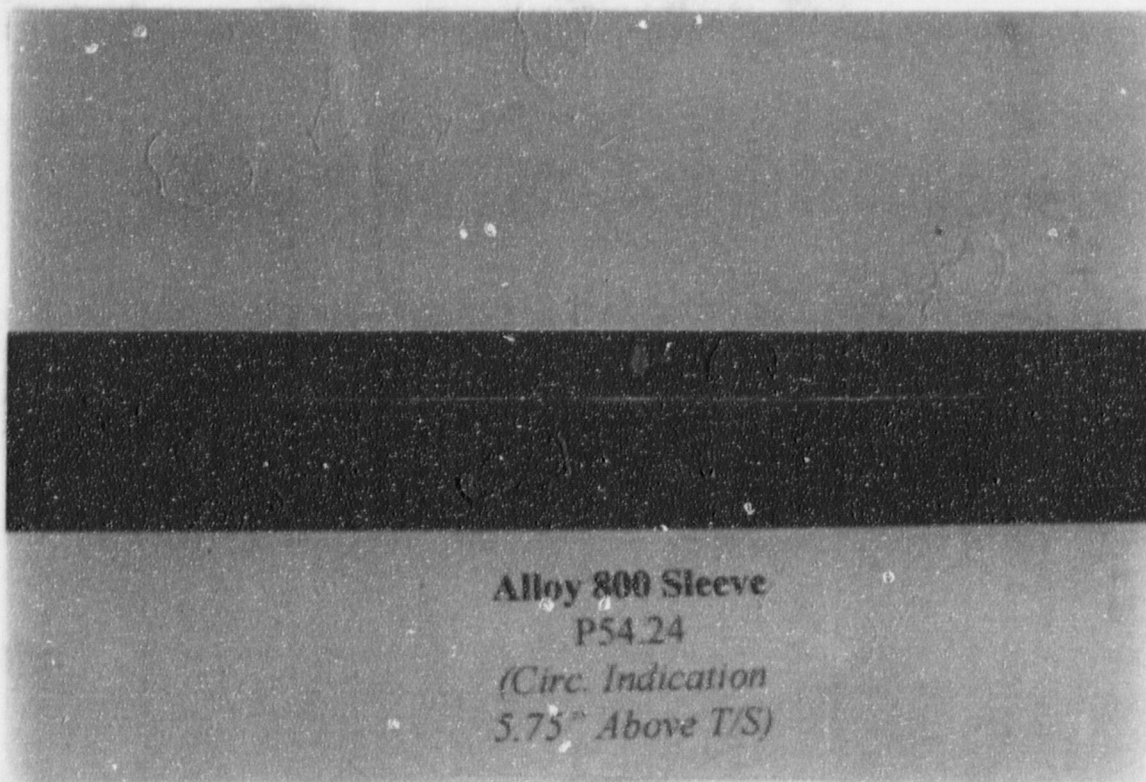
Figure 2. Cracks Visible in Primary Side Test Mock-up P54.24

There was a series of circumferential cracks visible on the OD of Section 3 that extended around the circumference. There was also possibly some minor OD initiated cracking elsewhere in this section. Examination of the ID of section 2 showed the circumferential cracks were near but below the bottom-most expansion. There were also numerous axial cracks in this section with some occurring between the circumferential cracks and expansion. The most severe were near the expansion but axial cracks were present along the length of the section.

Circumferential Crack 5-3/4 Inches Above Tubesheet

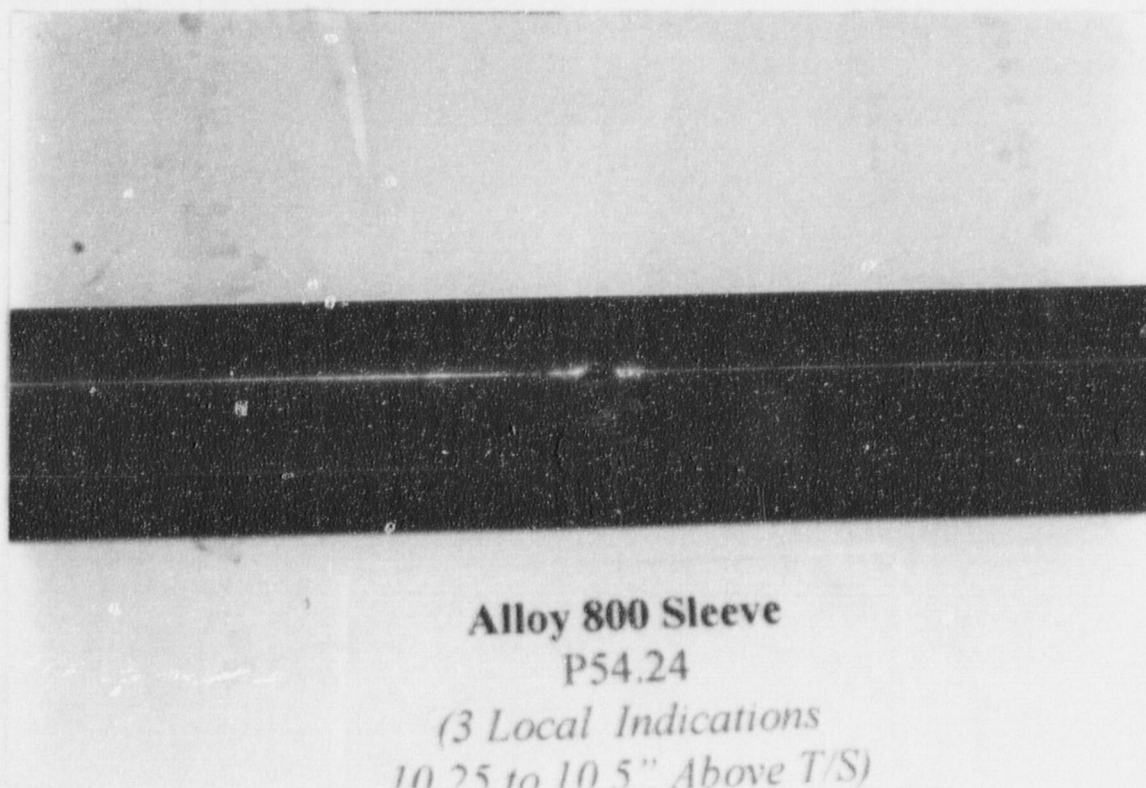
After sectioning, three axial cracks were visible on the OD of the Alloy 600 tube of section 1 of mock-up P54.24. This section had three expansions; the cracks were at approximately the location of the second expansion. The expansion locations were obvious on the ID but cracks were not visible on the ID at any magnification up to 49X. The three cracks were more pronounced when the section halves were flattened and had lengths on the OD surface of 1/4, 5/32 and 3/32 inch (approximate). There were no other cracks noted on the OD.

Three Axial Cracks 10-1/4 to 10-1/2 Inches Above Tubesheet

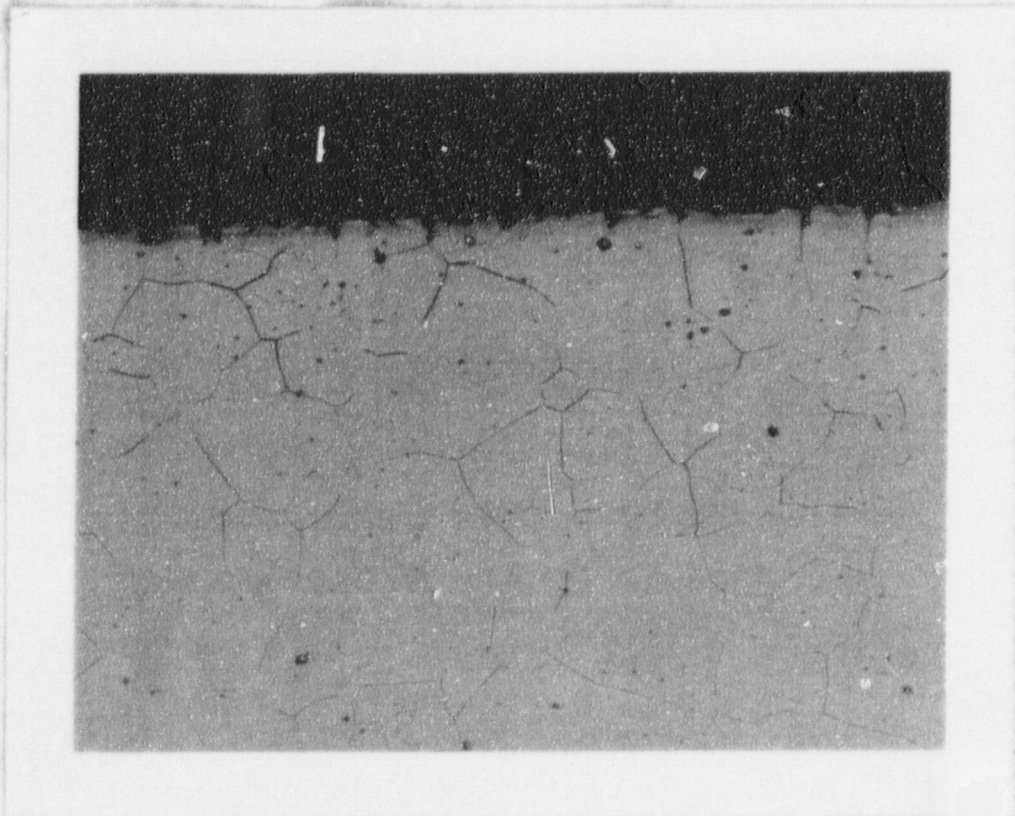
The Alloy 800 sleeves were examined in a similar manner with Sections 1 and 4 having no cracks visible and Section 2 and 3 possibly having several very shallow cracks, on the ID and OD generally associated with scratches and gouges. These appeared not to be significant in axial extent or depth, based on the stereomicroscope examination.

To determine if cracks were present, a transverse cut was made through some of these features in Sections 2 and 3 and the resulting sections were mounted for examination with the light microscope. They were ground and polished with typical metallographic techniques, etched with an electrolytic nital etch (reveals the grain boundary network) and examined by light microscope at magnifications up to 500X. This examination confirmed these features were shallow predominately intergranular penetrations with a depth of less than 1 grain. Figure 3 is typical of the areas examined.

Figure 3. Shallow Intergranular Penetrations in the Alloy 800 Sleeve from Mock-Up P54.24 (200X, Electrolytic Nital Etch)
