LICENSEE EVENT REPORT (LER)

FACILITY NAME (1) South Texas, Unit 1 DOCKET NUMBER (2) 0 5 | 0 0 | 0 4 | 9 | 8 | 1 OF 0 7

TITLE (4) Auxilliary Feedwater Pump Shaft Sleeve Failure Due To Stress Corrosion Cracking/
Hydrogen Embrittlement

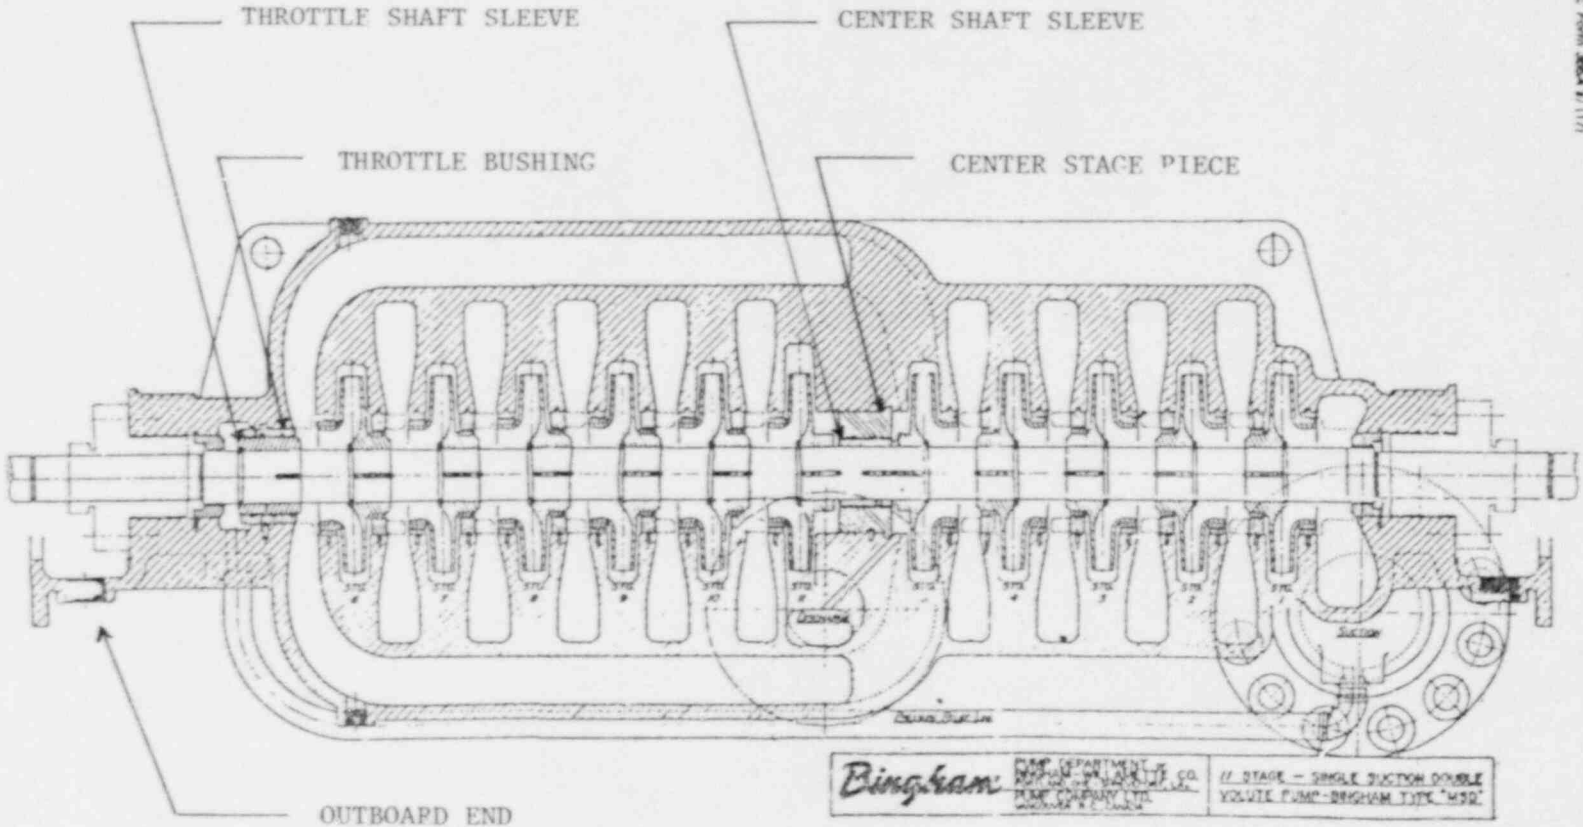
Figure 1

The pumps are Bingham model 4x6x9 C MSD eleven stage, single suction, double volute, with a horizontal split casing (see Figure 1). The configuration of the impellers is called an opposed impeller arrangement. The first five impellers face in one direction, and the remaining six impellers face in the opposite direction. In order to center the impellers and shaft, a center stage bushing and a throttle bushing assembly are utilized. Both assembly locations use a rotating sleeve and stationary bushing design. The sleeves are shrunk-fit and keyed to the shaft. The material used for the sleeve is AISI 420 stainless steel hardened to 450-525 HB.

Based on the above information, the immediate cause of the pump failure was determined to be friction and internal damage to the pump caused by splitting of the shaft sleeves. This splitting was induced by stress corrosion cracking/hydrogen embrittlement of the shaft sleeve material. The primary root cause was the use of a material that is susceptible to stress corrosion cracking/hydrogen embrittlement.

1. The sleeve and wear ring material on the pumps will be changed to Type 410 stainless steel hardened to 250-300 HB. This material has been used successfully in earlier models of this type of pump. For compatibility, the bushing material will be replaced with ASTM A436 Ni-resist Type 2. This change will eliminate susceptibility to stress corrosion cracking/hydrogen embrittlement as experienced with the harder material presently used, and thereby eliminate this problem.
