NRC Inspection Report: 50-128/88-03

Licensee: Texas A&M University (TAMU)
Nuclear Science Center
College Station, Texas 77843

Facility Name: Nuclear Science Center (NSC) - TRIGA Reactor (1 Megawatt)

Inspection Conducted: April 11-12, 1988

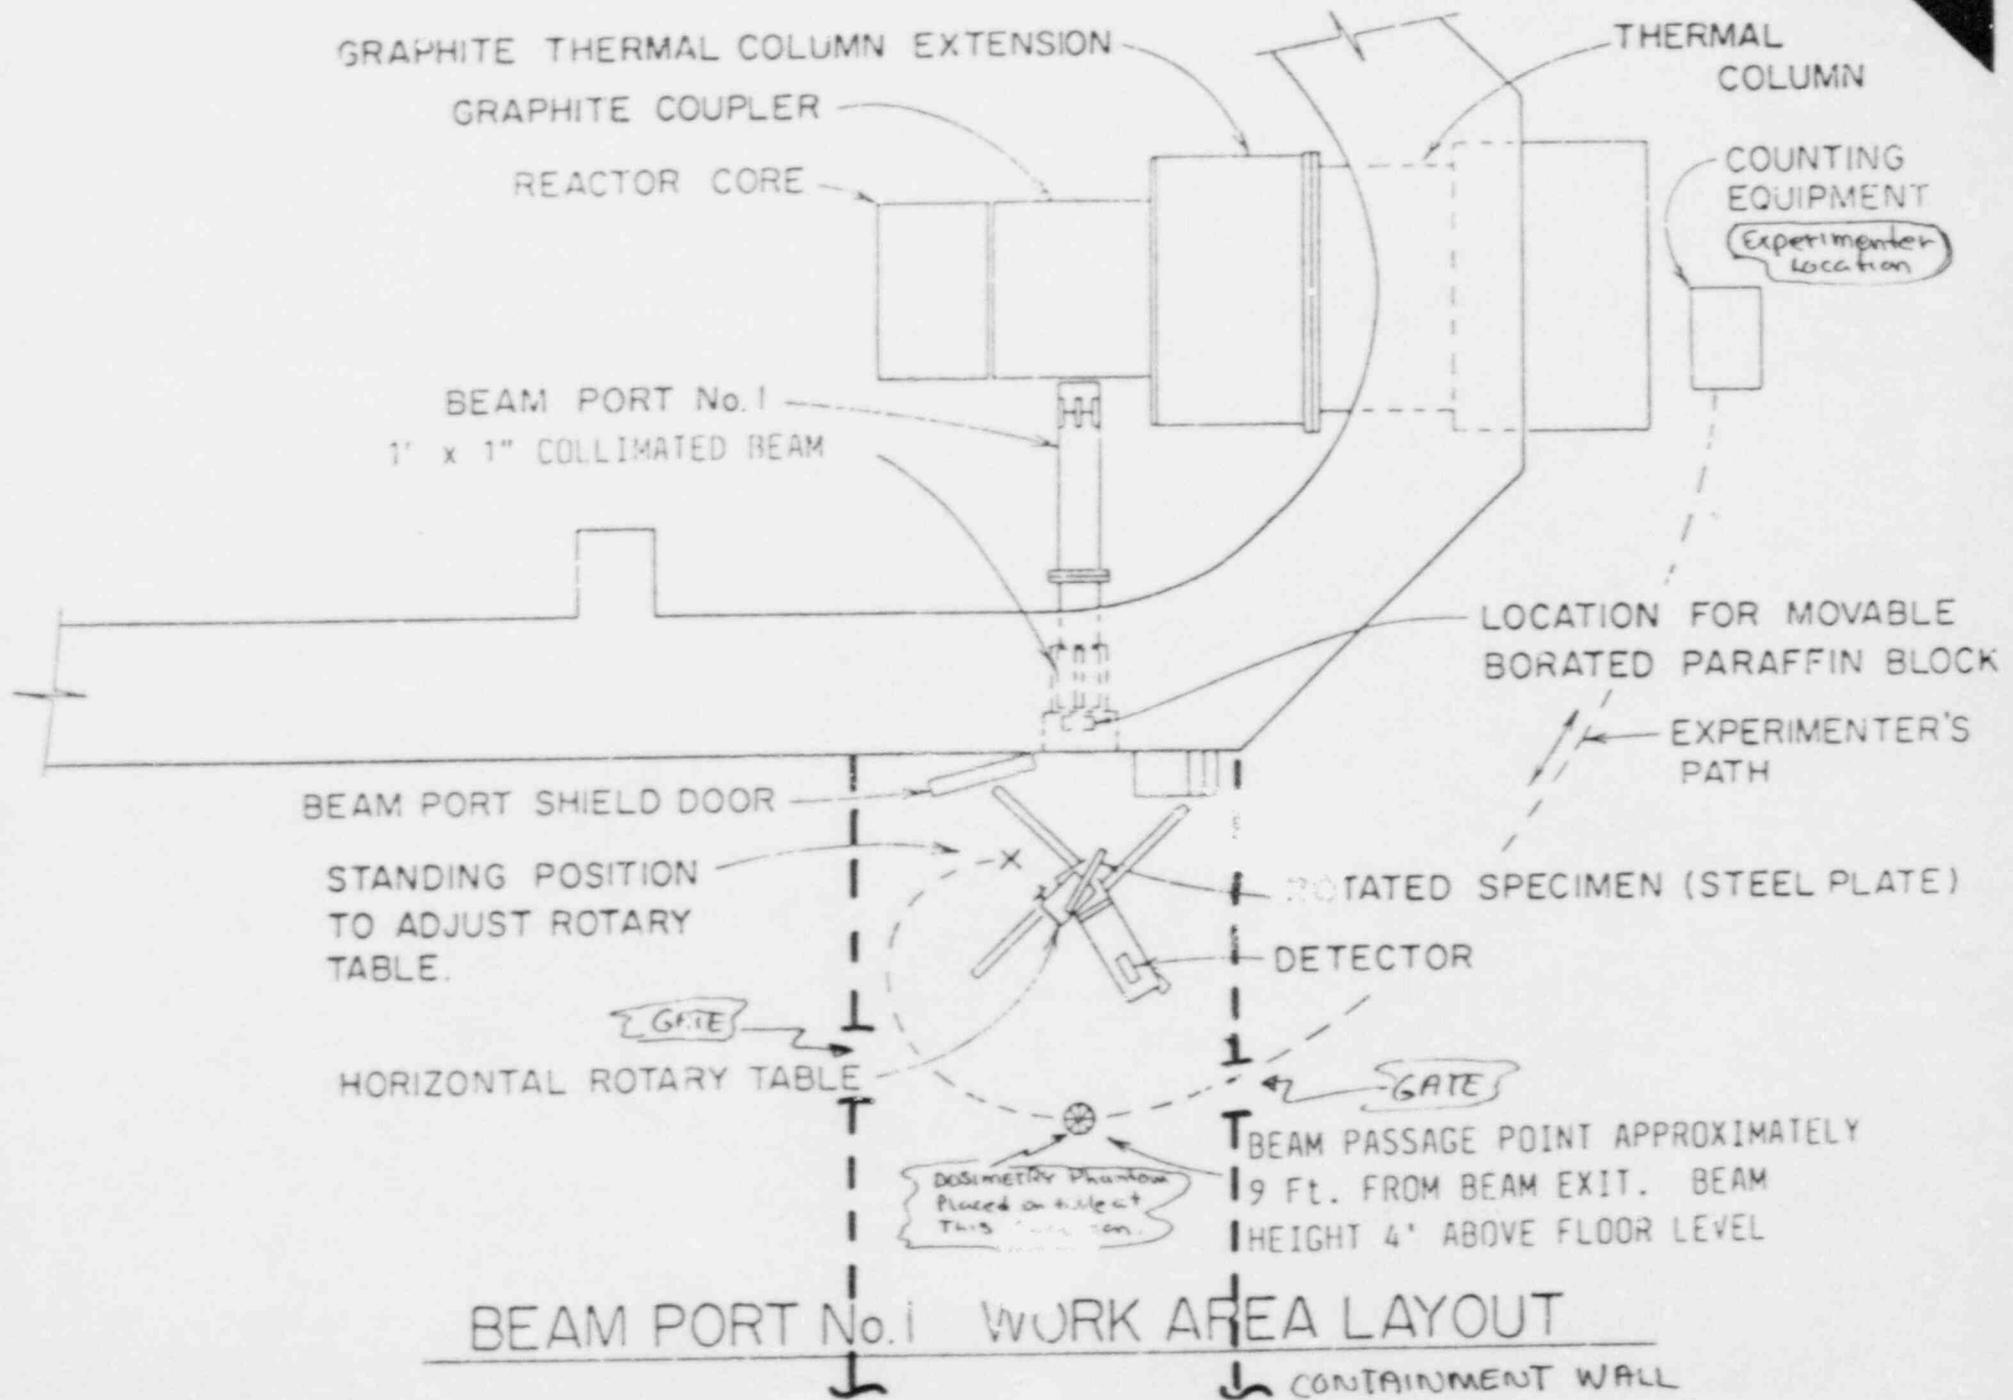
ATTACHMENT 1

periodically removed for annealing or hardening. As is shown in Attachment 1, the orientation of the equipment and the counting station required personnel to pass through the attenuated beam to get to and manipulate the equipment. The NSC senior health physicist (SHP) understood that the ND experiment was initially only supposed to take approximately 1 or 2 weeks to complete. Several different TAMU radiation safety office (RSO) health physicists (HPs) were involved at various times with the experimenters.
