*Entergy*

**Probabilistic Operational Assessment of ANO-2 Steam Generator  
Tubing for Cycle 14**

May 28th, 1999

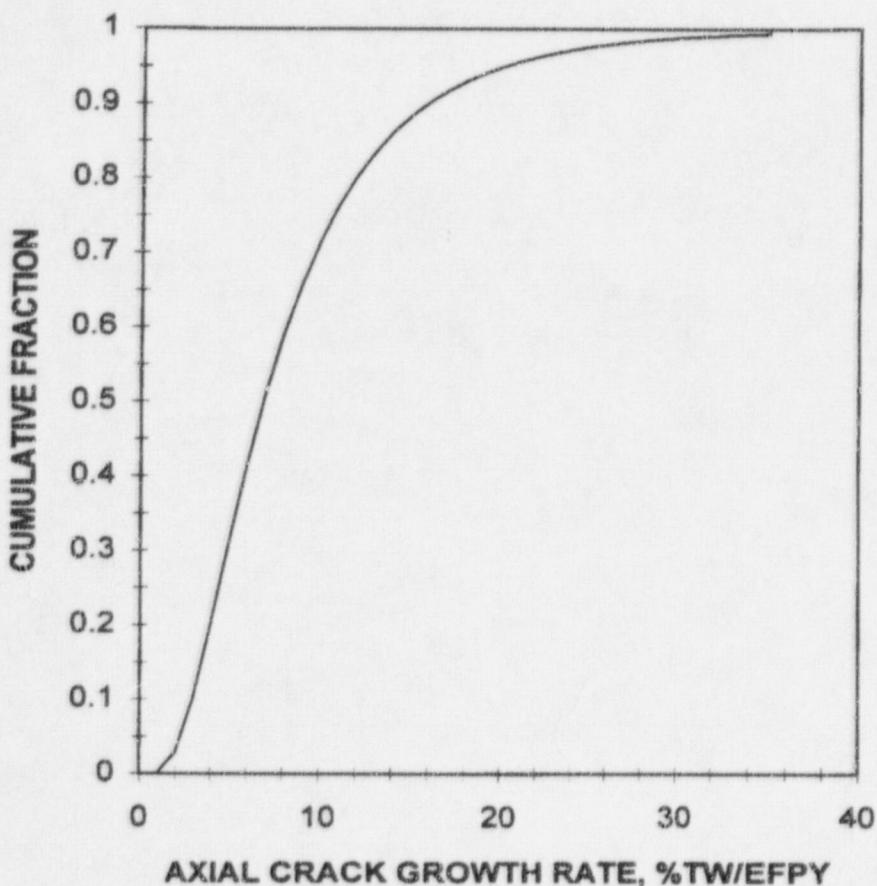
**Figure 4.3**  
**Distribution of Axial Crack Growth Rates**

The end result of the growth study is that a reasonable upper bound growth rate distribution is given by a log normal distribution with a standard deviation of 0.70 and a mean growth rate of 6.89%TW/EFPY. This growth rate distribution bounds the results of several growth rate studies for plants of similar design. Based on the ANO growth rate data and data from other plants, the maximum growth rate was limited to 40%TW/EFPY. A realistic growth distribution would have an average crack growth rate of about 4%TW/EFPY. Note that the growth rates are based on average depth as compared to maximum depth. The average depth growth rate is used in the model. For any particular crack, maximum depths are calculated based on known distributions of ratios of maximum depths to structural (average) depth. Listed below in Figure 4.3 is the distribution curve for the growth rates used in the model.

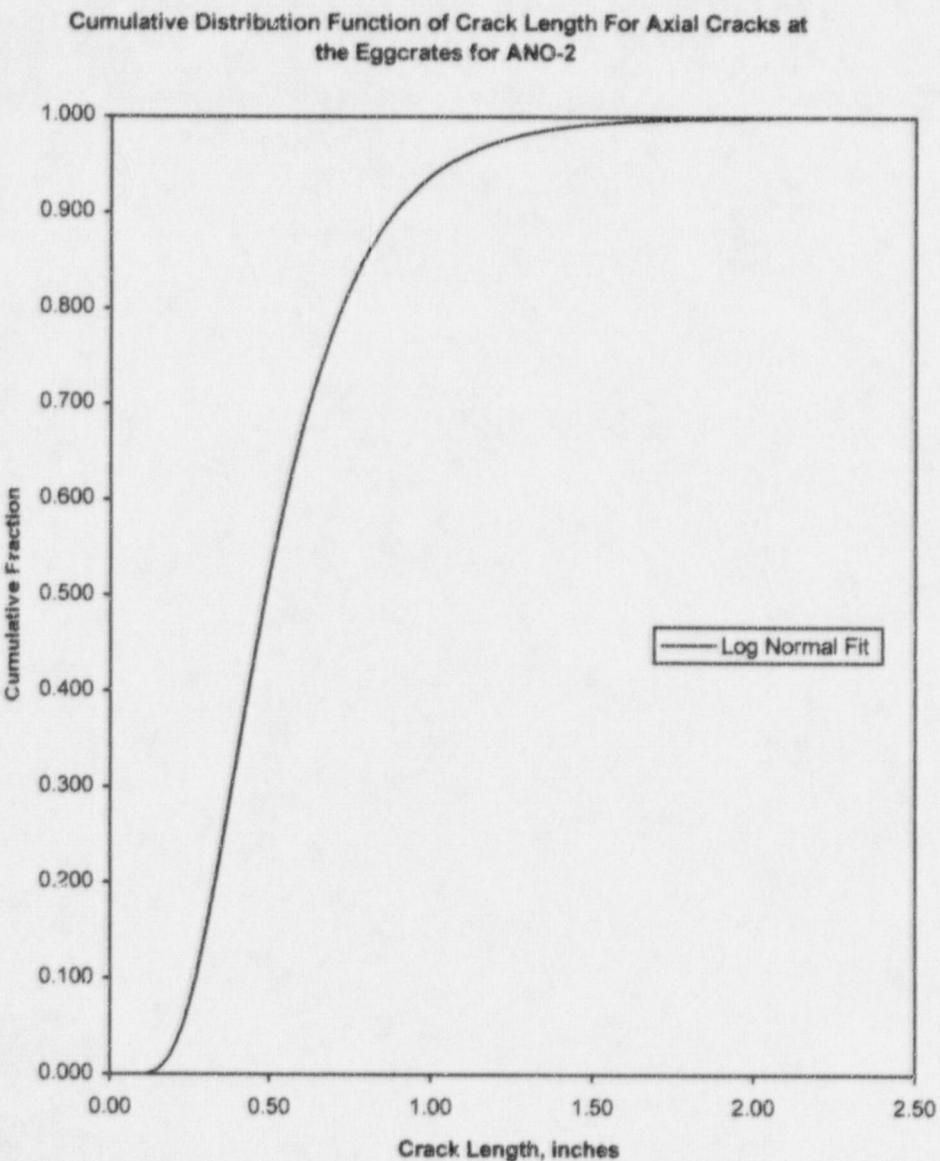
**Figure 4.4**  
**Distribution of Eggcrate Axial Crack Lengths used in Probabilistic Model**

As with POD, the length of the flaws is a critical input. The use of MRPC to determine the axial extent and then establishing a distribution to sample allows this input to be obtained. By MRPC sizing the axial flaws during the 2R13 outage, it is believed that an accurate distribution is obtained. Once the distributions are obtained they are sampled during the model simulation. Figure 4.4 shows the function obtained from the MRPC measured eggcrate axial length distributions.

The length values were obtained directly from the raw MRPC data. This is a conservative method of determining extent due to the eddy current field look ahead and fall behind, which is defined as the influence of the flaw seen prior to the coil reaching

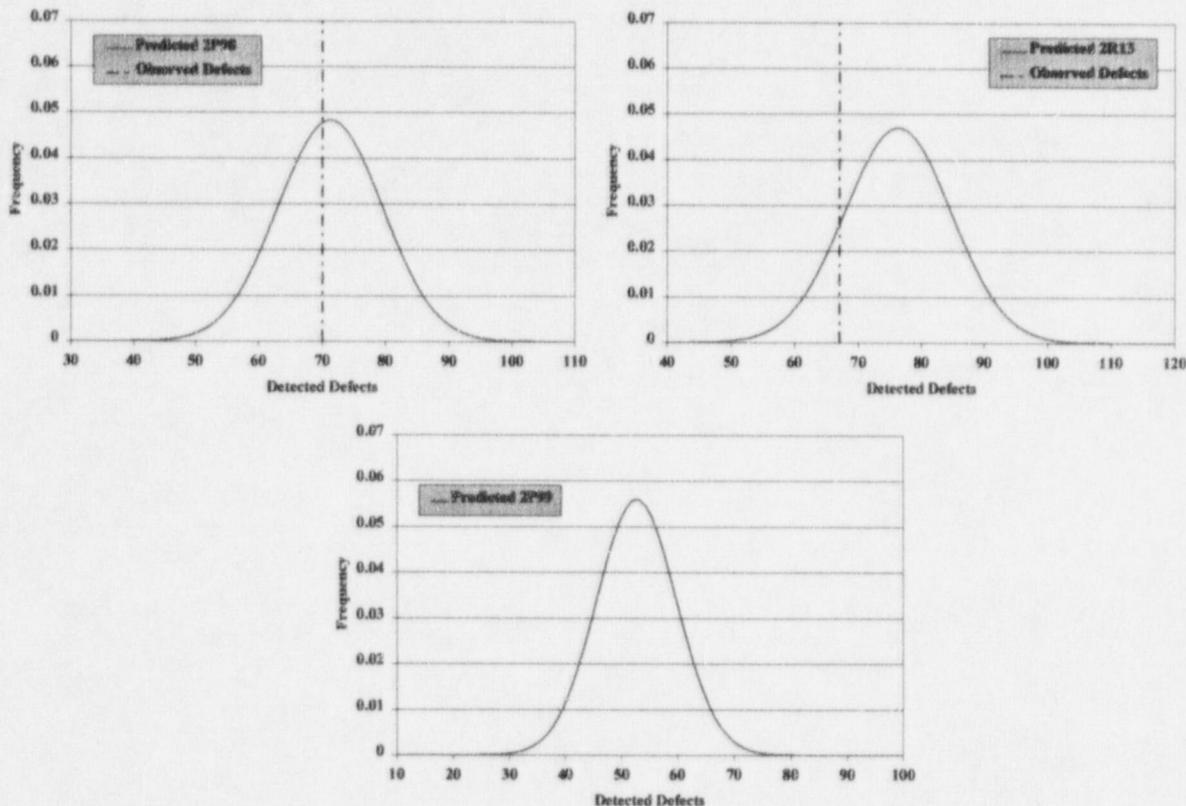
**Figure 4.7**  
**Predicted Axial Cracks vs. Observed Axial Cracks**  
**Hot Leg Eggerates**

The predictions of the degradation numbers generated by the Monte Carlo simulation agrees well with past observations of corrosion degradation at ANO-2. Benchmarking of several parameters were conducted to verify this. The actual observations match well with the numbers predicted by the model as illustrated in Figure 4.7 for the axial eggcrate hot leg defects.

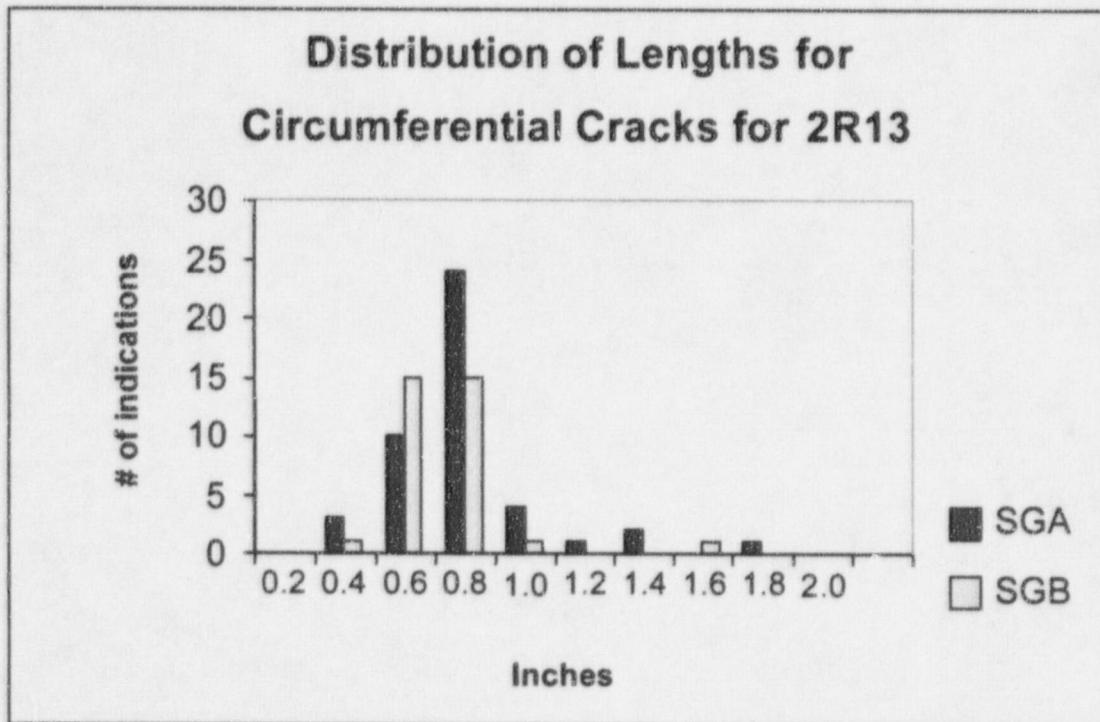
Figure 4.9

validate the PDA distribution utilized in the Monte Carlo simulation. The arc length distribution for 2R13 is provided in Figure 4.9. The figure shows that the majority of the flaws are small and thus are of no structural concern. The growth rate data used in the Monte Carlo simulation was obtained from the most recent ANO Circumferential Crack Growth Rate Evaluation<sup>7</sup>.

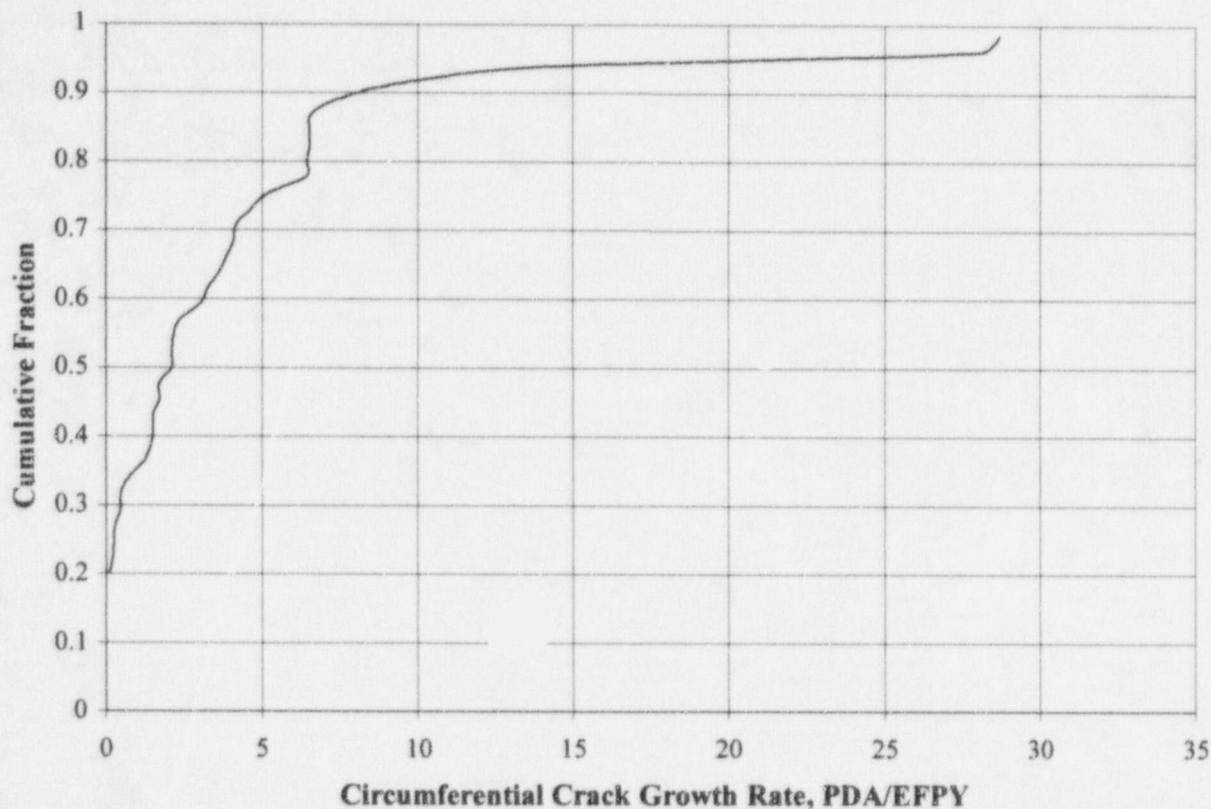
**Figure 4.10**  
**Distribution of Circumferential Crack Growth Rates**

The size distributions are obtained from the MRPC measured values and from the ANO2 Circumferential Crack Growth Rate Study<sup>7</sup>. In this case growth rates are expressed as changes in PDA verses maximum depth. A detailed crack growth rate study was conducted with the most recent outage data. Negative growth rates were set to zero and the resulting cumulative distribution of circumferential crack growth rates is shown in Figure 4.10. This growth rate distribution is conservative in the sense that no attempt was made to account for PDA measurement errors. Measurement errors increase the dispersion of observed growth rates compared to actual growth rates. Historically, flaws that had significant length circumferentially were detected which resulted in larger PDA values. Currently, the flaws being identified are shorter in length but have a larger maximum depth. For this reason the model was altered to reflect a distribution more typical of what was observed.

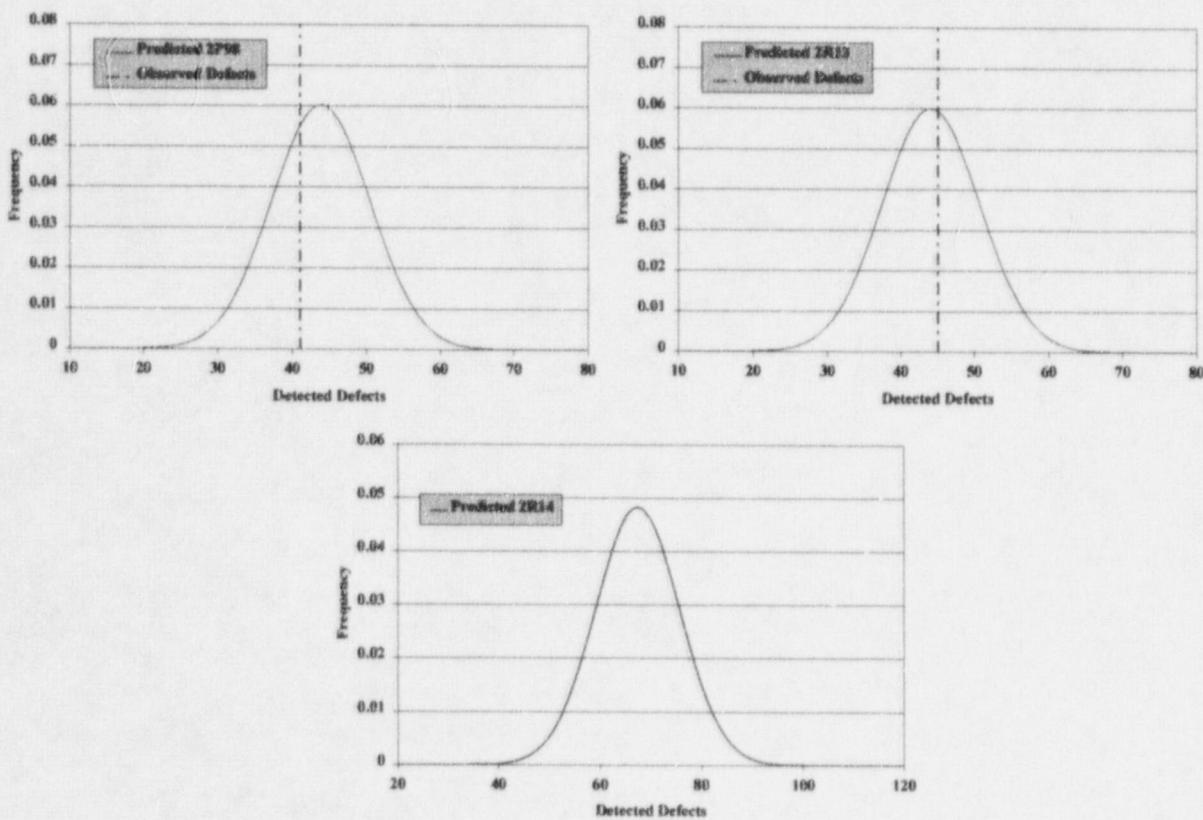
**Figure 4.11**  
**Predicted Circumferential Cracks vs. Observed Circumferential Cracks**  
**Expansion Transition**

The predictions of the degradation numbers generated by the Monte Carlo simulation agrees well with past observations of corrosion degradation at ANO-2. Benchmarking of several parameters were conducted to verify this. The numbers from actual observations match well with the numbers predicted by the model as illustrated in Figure 4.11

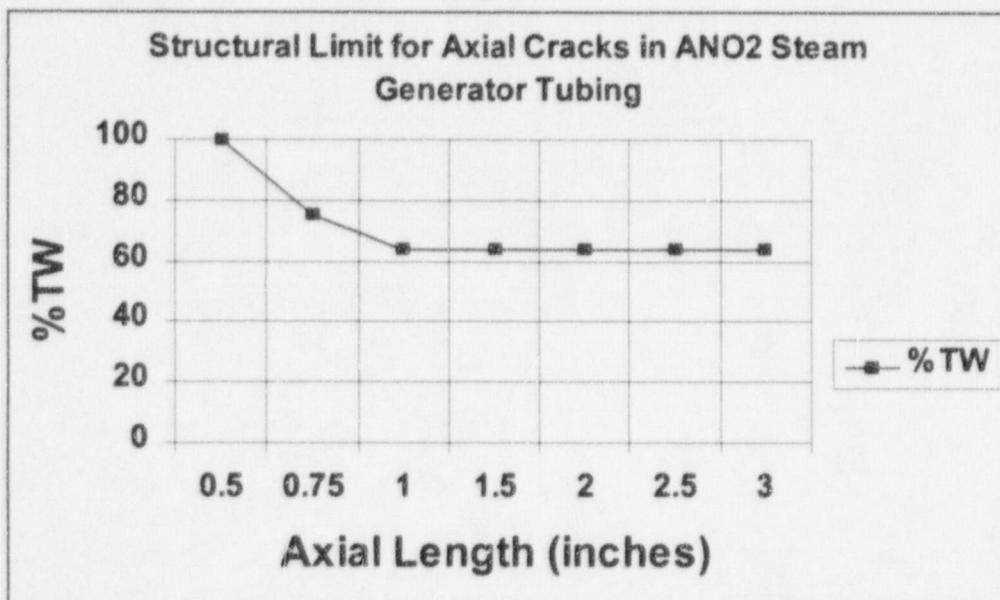
Figure 4.12

As noted in the graph, the structural limit in the range of length specified is 100% TW. The largest of the two flaws (R50L114) was 0.33 inches in length and had a maximum depth of 75% TW. Since this was the first time that this mechanism was examined one can assume that it is possible that a flaw could have been left in service if it is at the detection level of the test. Using the plus point coil, the minimum detectable depth would be approximately 20% based on the EPRI qualification. To be conservative, a 40% TW value was used. Applying a maximum growth rate based on the eggcrate axial data, 40% TW would be added for a total of 80% TW. Based on the length and calculated depth, the largest postulated flaw would pose no threat from a structural or leakage standpoint. Based on the above results, it is acceptable to operate full cycle due to potential axial cracks in a dented eggcrate.
