U.S. NUCLEAR REGULATORY COMMISSION
REGION I

Report No. 50-219/88-80

Facility Name: Oyster Creek Nuclear Generating Station

Inspection Summary: An Augmented Inspection Team (AIT) was dispatched to review the circumstances surrounding a steaming phenomenon on both Isolation Condensers in late August and September 1988 and an electrical fault associated with the No. 2 Diesel Generator on October 2, 1988. The team's charter was to provide NPC management with a comprehensive review of these events to assess the safety significance and licensee response to the events.

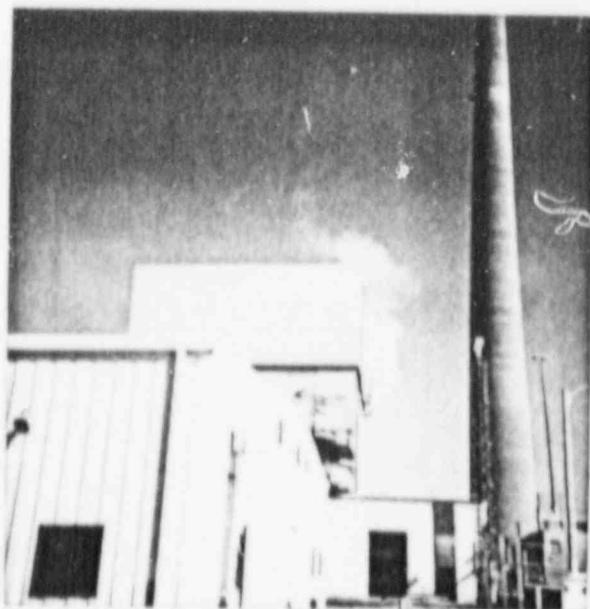
12

"B" ISOLATION CONDENSER
STEAMING, SEPTEMBER 11, 1988
