SUBJECT: Calvert Cliffs Nuclear Power Plant
Unit Nos. 1 & 2; Docket Nos. 50-317 & 50-318
Response to Request for Additional Information; Summary Report on the
Verification of Seismic Adequacy of Mechanical and Electrical Equipment in
Operating Reactors (TAC Nos. M69435 & M69436)

RESPONSE TO REQUEST FOR ADDITIONAL INFORMATION;
SUMMARY REPORT ON THE VERIFICATION OF SEISMIC ADEQUACY OF
MECHANICAL AND ELECTRICAL EQUIPMENT IN OPERATING REACTORS

Baltimore Gas and Electric Company
Calvert Cliffs Nuclear Power Plant
November 12, 1998

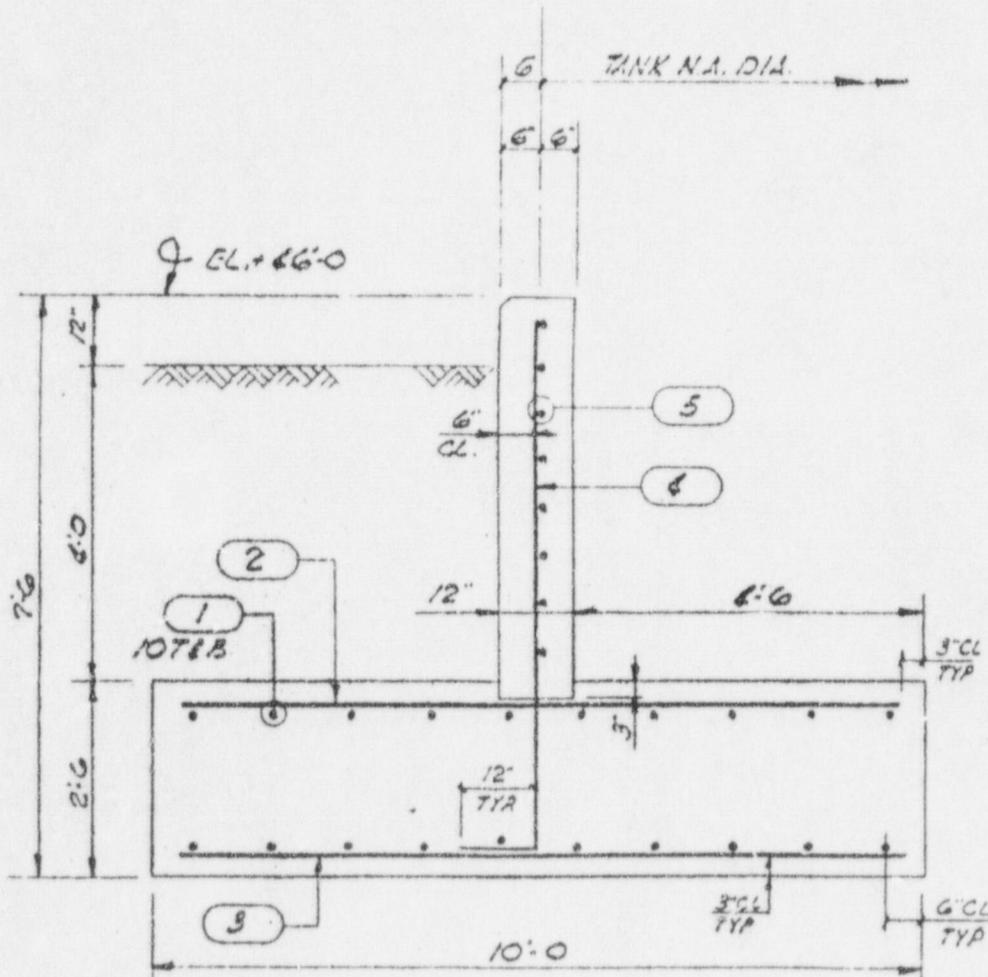
SECTION

Based on the presence of a significant amount of reinforcing steel in the ring foundation the analysts concluded that failure due to an unreinforced concrete shear cone was not credible. The reinforced concrete ring is not susceptible to collapsing on itself horizontally due to the additional strength provided by the buried slab to which it is attached and its soil embedment depth. Page 25-13 of Enclosure B of the March 23, 1998 letter goes into detail on determining the "monolithic" nature of the concrete ring/slab. A sketch is attached which provides additional details on the ring foundation. This sketch represents a "section" cut of the PWST ring foundation.

The failure mechanism was, therefore, concluded to be the failure of the bond stress between the cast-in-place anchor and the concrete. The use of an ultimate bond stress of 200 psi for plain steel rod is considered acceptable per EPRI Report NP-5228-SL, Rev. 1, Volume 1.
