LICENSEE EVENT REPORT (LER)

FACILITY NAME (1) RIVER BEND STATION	DOCKET NUMBER (2) 0 5 0 0 0 4 5 8 1	PAGE (3) 1 OF 0 6
---	--	----------------------

TITLE (4) Concrete Roof Plugs Forming Part Of Secondary Containment Boundary Missing Retention Hardware - Operation Prohibited By Technical Specifications

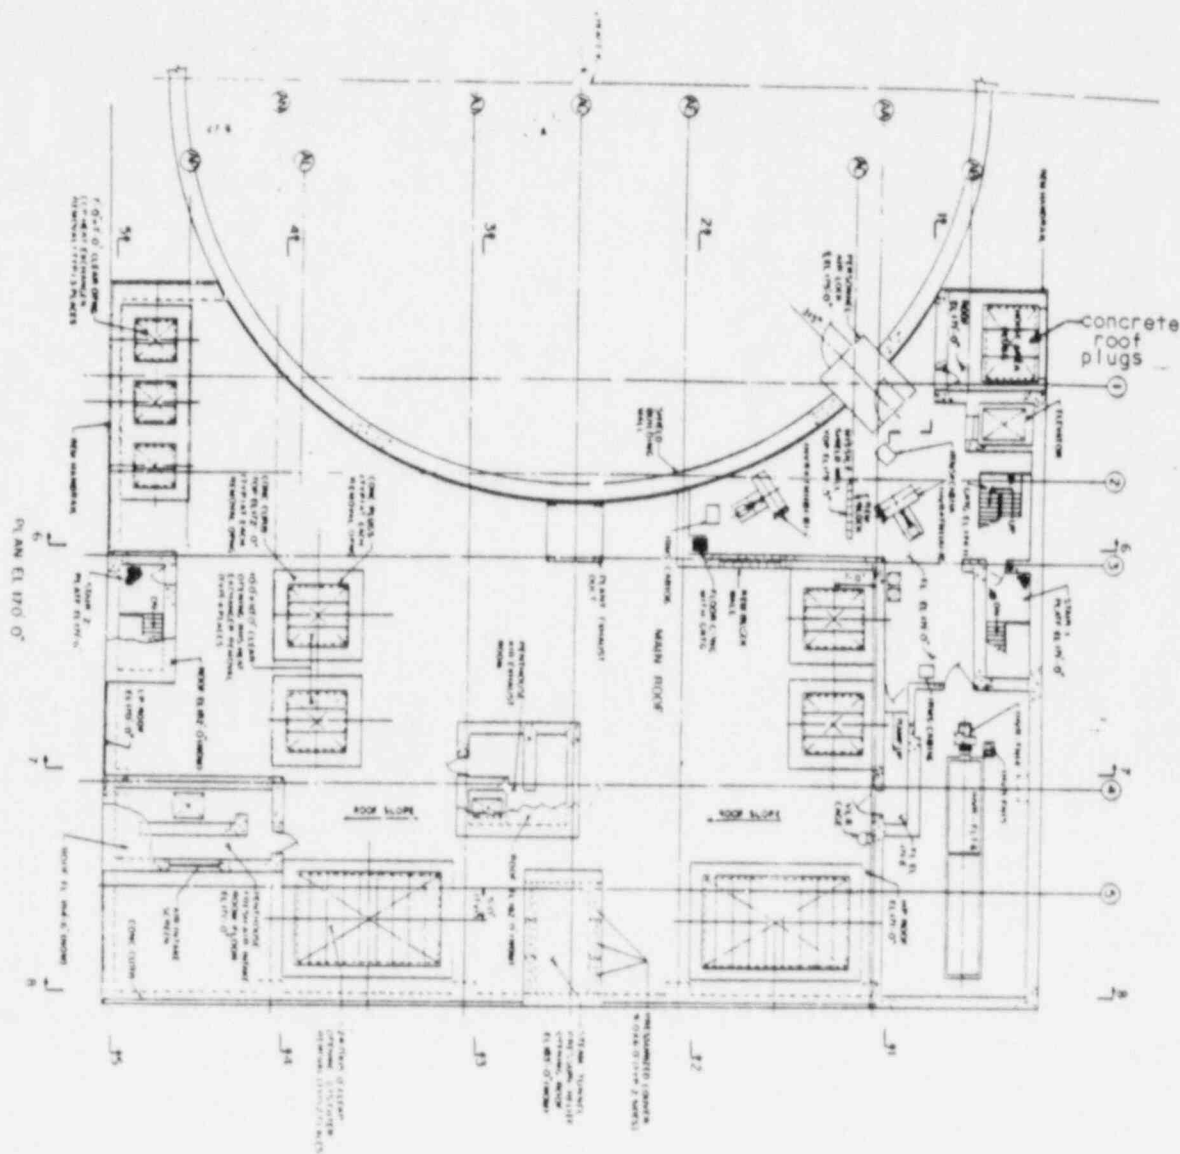
ATTACHMENT

The auxiliary building roof plugs (see attached drawing) provide part of the boundary for secondary containment integrity. Though not designed to be airtight, the plugs provide a barrier for large masses of air flow, thereby allowing the building to be placed under a slight negative pressure utilizing the standby gas treatment system (3H*). The plugs with their retention bolts and nuts are required by design to be installed during operational conditions 1, 2, and 3 as specified in Technical Specification Section 3.6.5.1.

Each of the individual subject plugs are restrained from upward movement by 4 retention bolts with nuts, 2 on each end. The primary purpose of this arrangement is to prevent the plugs from being

dislodged if subjected to tornadic loadings. The tornadic loads are described in the RBS USAR Seciton 3.3.2.2.2 and have been postulated to create a differential pressure of 3 pounds per square inch (psi) between the outside and the inside of the building. This differential pressure would be sufficient to overcome the gravitational loading (2 psi) of the concrete plugs and potentially dislodge them from the roof. In the unlikely event of a tornado passing over the subject plugs, the capability of the building to maintain SECONDARY CONTAINMENT INTEGRITY-OPERATING under tornadic loading might not have been maintained.

The initial design of the retaining bolts and nuts was performed as a generic design detail. The worst case loadings and the largest concrete plugs in the auxiliary building roof were utilized in the initial design analysis. Four retaining bolts in each of the roof plugs were conservatively designed to prevent uplift as a result of the tornadic loadings. GSU determined for the identified plugs, that as a minimum, only 2 retention bolts with nuts positioned diagonally were required per plug. Maintenance installed the nuts and washers on the retention bolts that were previously in place. The one exception was the bolt that was originally identified as missing. However, this bolt could not be installed immediately due to interferences in the bolt hole. Since three other bolts and nuts were installed in this plug, the requirements were satisfied.

At the time that the identified condition was determined to potentially affect SECONDARY CONTAINMENT INTEGRITY-OPERATING, an LCO was initiated while the identified roof plugs were secured via installing 11 nuts on the arrangement of 3 roof plugs on the auxiliary building roof. Two of the three plugs were secured with all four nuts and one plug with only three since a new retention bolt could not be threaded into the existing hole due to interferences in the hole resulting from foreign deposits. Per a review of calculations performed by engineering, the one remaining retention bolt and nut are not required to ensure the plug would withstand tornadic loadings.
