Subject: Augmented Inspection Team Report No. 50-219/87-29

Report No. 50-219/87-29

Facility Name: Oyster Creek Nuclear Station

Technical issues associated with the reported violation of Safety Limit 2.1.E on September 11, 1987 wherein a condition requiring at least two sets of suction and associated discharge valves in the five reactor recirculation loops to be in the full open position was not met.

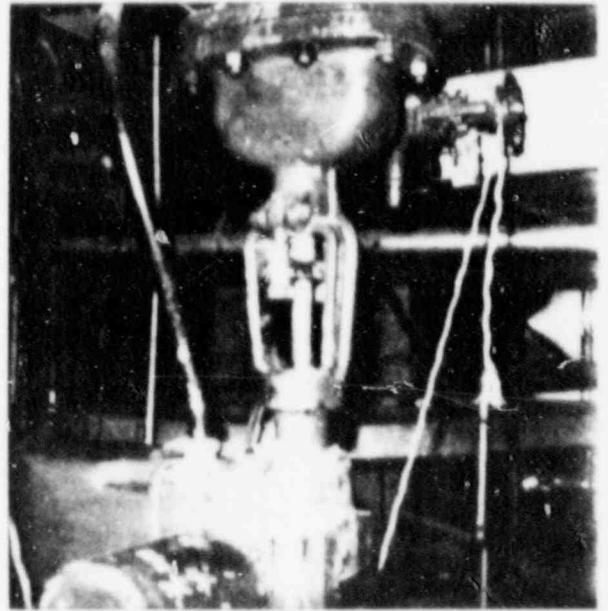
VALVE V-5-167

V-5-167 failed to meet its required valve stroke time during a surveillance test conducted on July 31, 1987. An investigation determined that a corrosion inhibitor (Boron Nitrate) used in the RBCCW system had leaked from the packing down the valve stem (valve is mounted upside down). This packing leakage allowed boron crystals to form in the limiter operator stem nut, increasing valve stem friction to the point that the limiter motor cut off on high torque. The licensee cleaned up the stem nut and applied a nuclear grade lubricant on the valve stem while stroking the valve. This action enabled the valve to meet its required stroke time demonstrated during MOVATs testing conducted on August 3, 1987. However, the MOVATs testing also determined that the motor operator was still experiencing higher than desired motor current during valve operation. As the long term corrective action, the licensee initiated a work order on August 6, 1987 to repack the valve with Chesterton live loaded packing. This packing usually prevents or minimizes packing leaks and would prevent recurrence of the previous problem. Until the valve could be repacked, the licensee implemented additional action to ensure valve operability. This action included partially closing the valve monthly using the manual operator and fully closing the valve quarterly using the electric motor operator.

BONNET AND STEM AREA

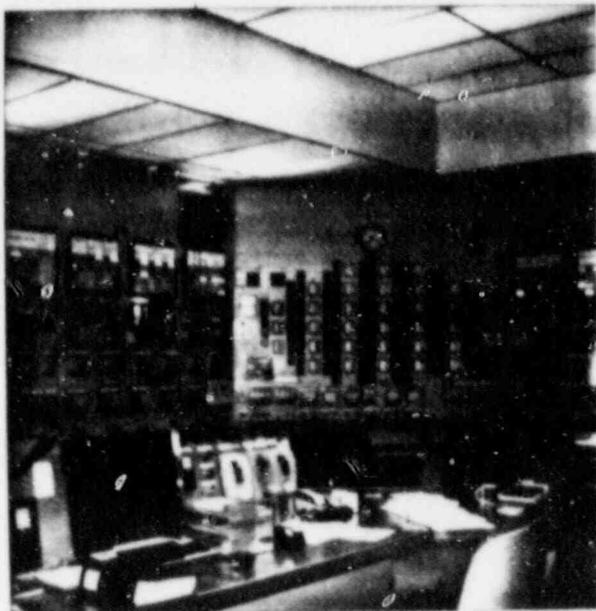
View of 3F and 4F panels from behind control room desk.

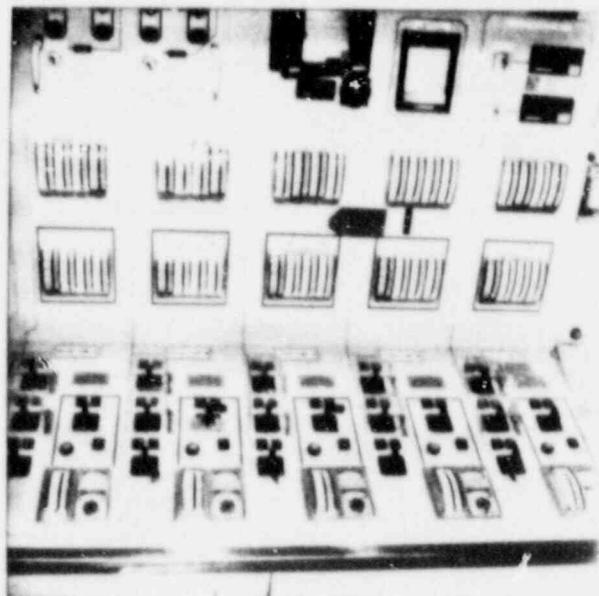
View of 3F panel. Five individual recirc pump speed controllers on bottom. Second and third row of switches are for recirc suction and discharge valve operation.

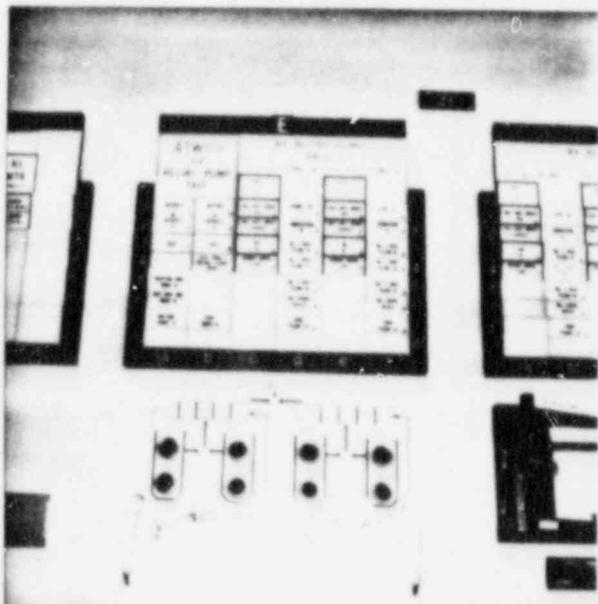
Alarm display E on 3F panel. Alarm 4-b reads "LESS THAN 2 RECIRC LOOPS OPEN."

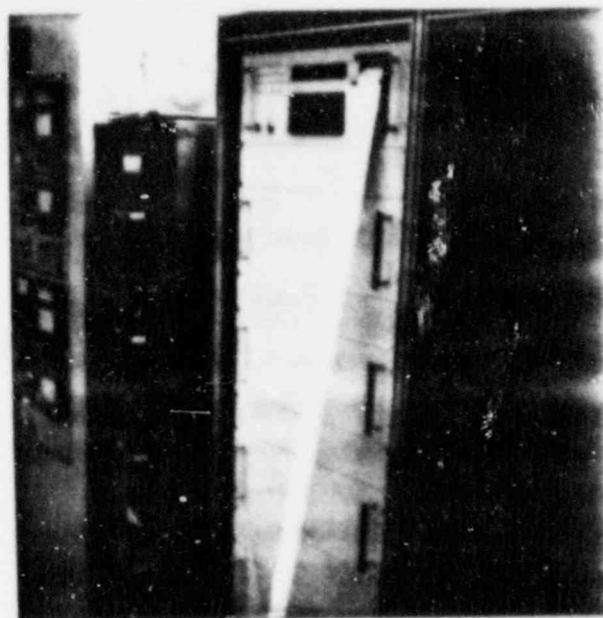
Late on the morning of September 11, 1987, the licensee reported to NRC that a portion of the Sequence of Alarms Recorder printout was missing. Later in the day, an operator disclosed that he tore off the tape, discarded some in wastebaskets and threw some in a toilet. The circumstances surrounding this missing record are subjects of investigation by the licensee and by NRC. The inspection team examined a sample of similar records to ascertain patterns.

Sequence of Alarms Recorder (SAR) with tape coming out.
