Subject	Westinghouse Circuit Breakers Type DS/DSL: Welds on Breaker's Pole Shaft		Number	NSID-TB-87-11
System(s)	All Plant Systems		Date	December 1, 1987
Affected Plants	All Plants with DS/DSL Circuit Breakers		S.O.(s)	309, 386, BOP
References	See Below	Affects Safety Related Equipment	Yes <input checked="" type="checkbox"/> No <input type="checkbox"/>	Sheet 1 of 17

This technical bulletin supercedes and replaces the 9/87 letter, and it is to be regarded as the controlling document for inspection of the breaker's pole shaft and alignment, and corrective action if required.

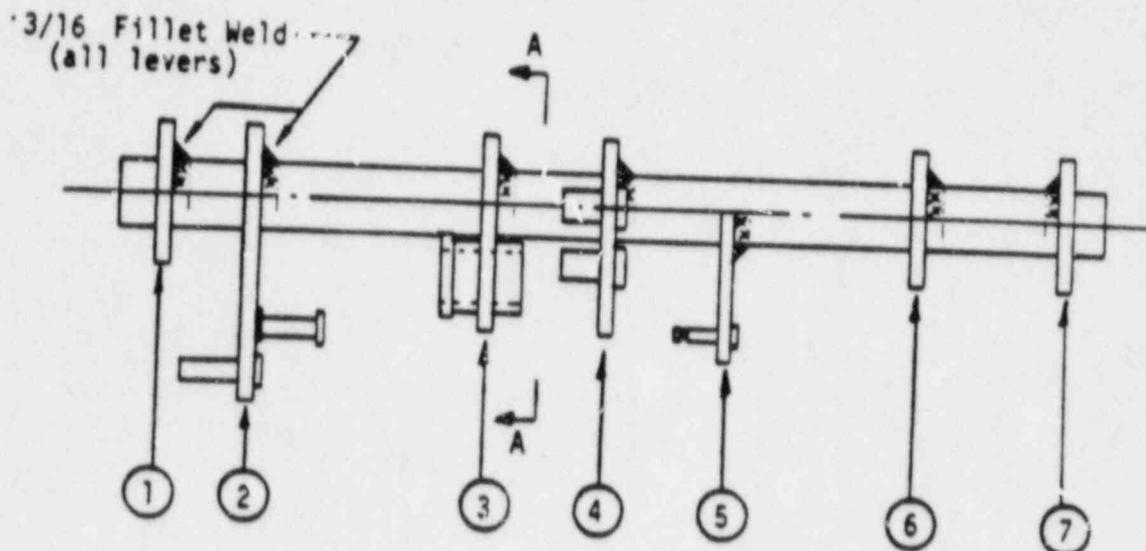
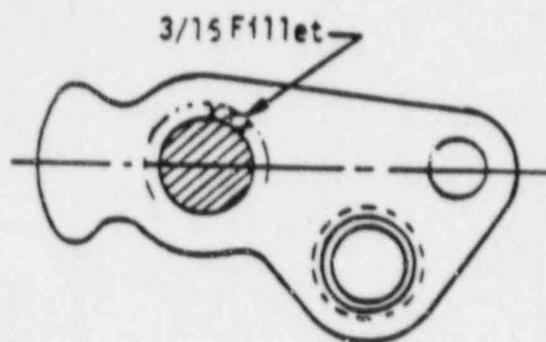
FIGURE 1

This section lists the criteria to be applied to the welds for the three pole levers on the pole shaft. See Figure 1, items 2, 3, and 6. The remaining welds are discussed in Section 7.0.

- 6.1.1 A pole shaft, for which the 3 noted welds meet or exceed all of the criteria listed below, is to be considered acceptable for continued service up to the limit defined in Section 6.2.1.
 - a) weld size - 3/16 inch fillet
 - b) length - 180° continuous around the pole shaft
 - c) fusion - fused to lever and shaft for the above length
 - d) cracks - no cracks are allowed
- 6.1.2 If the criteria listed in 6.1.1 are not satisfied, the pole shaft can still be retained in service, but for a limited time as defined in 6.2.2, provided it meets or exceeds the criteria given below.

- a) weld size and length - 3/16 inch fillet for 90° continuously around the pole shaft, or 1/8 inch fillet for 120° continuously around the pole shaft
- b) fusion - fused to lever and shaft for the above length
- c) cracks - no cracks are allowed

This section lists the criteria for acceptance of the 4 welds on the pole shaft, which were not addressed in short-term inspection described in Section 6.0. See Figure 1, items 1, 4, 5 and 7.

- a) size and length - at least 3/16 inch fillet for a minimum of 90° continuously around the shaft, or at least 1/8 inch fillet for a minimum of 120° continuously around the shaft.
- b) fusion - good fusion along both legs of weld.
- c) cracks - no cracks are allowed.

Exception - The lever for the Auxiliary Switch Drive Link spans about 90° around the shaft, and carries an extremely light load. This lever should be checked for a well fused joint only.

- 6.2.3 A pole shaft which does not meet the criteria in 6.1.2 must be removed from service immediately, and a replacement pole shaft installed in the breaker before returning it to service. (See exception, Section 6.2.4.) The replacement pole shaft shall meet the criteria in 6.1.1.

If the above criteria are not met, replace the pole shaft prior to returning the breaker for service.

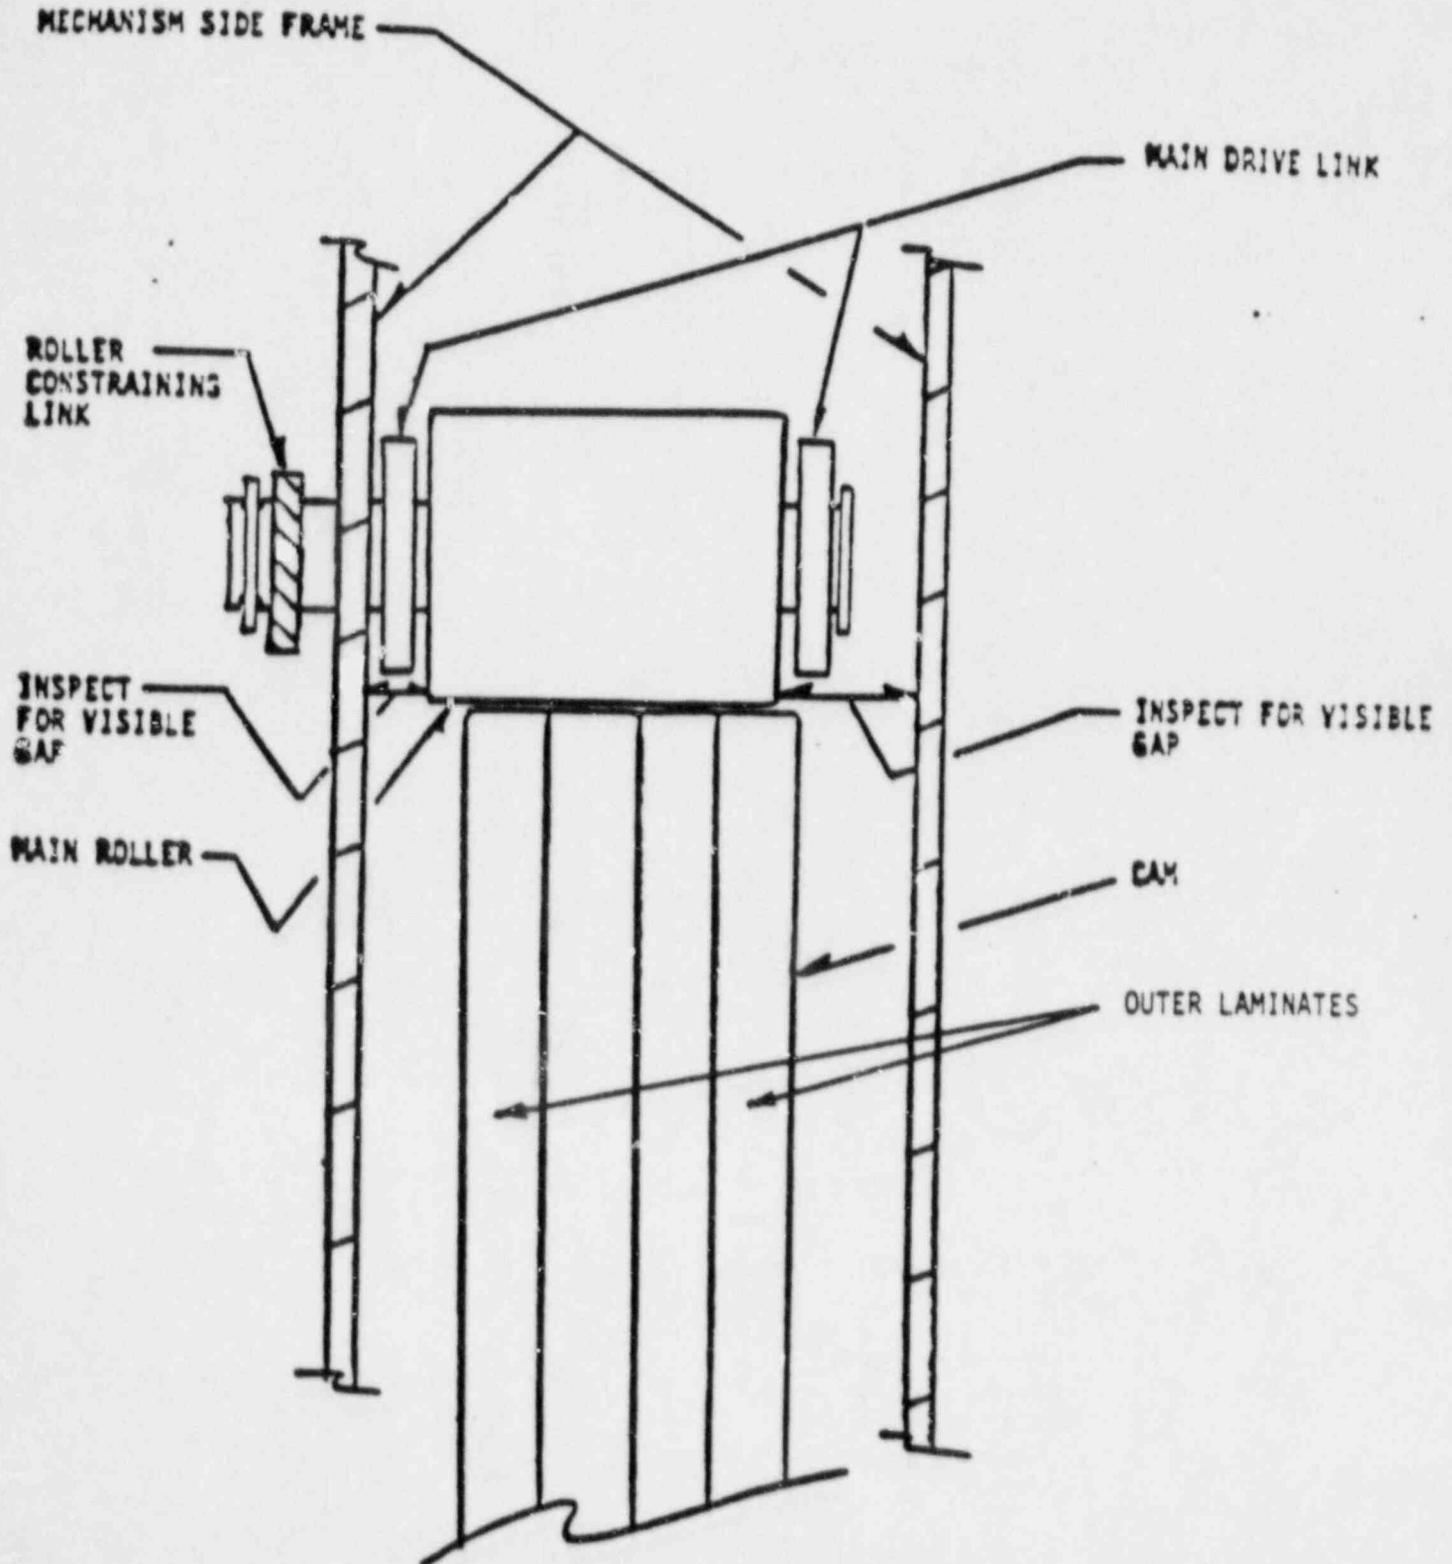
FIGURE 2

- 7) Through the front of the breaker, sight the close cam, the roller and the side frames. Using a flashlight, verify -
 - a) Roller is on top of both of the two outer laminates of the close cam. It is not required to be centrally placed with respect to the cam assembly. See Figure 2.
 - b) There is a visible gap between the side frame and the roller side at each end of the mechanism.

If either of the two checks are not satisfactory, contact Westinghouse with details of the observations.

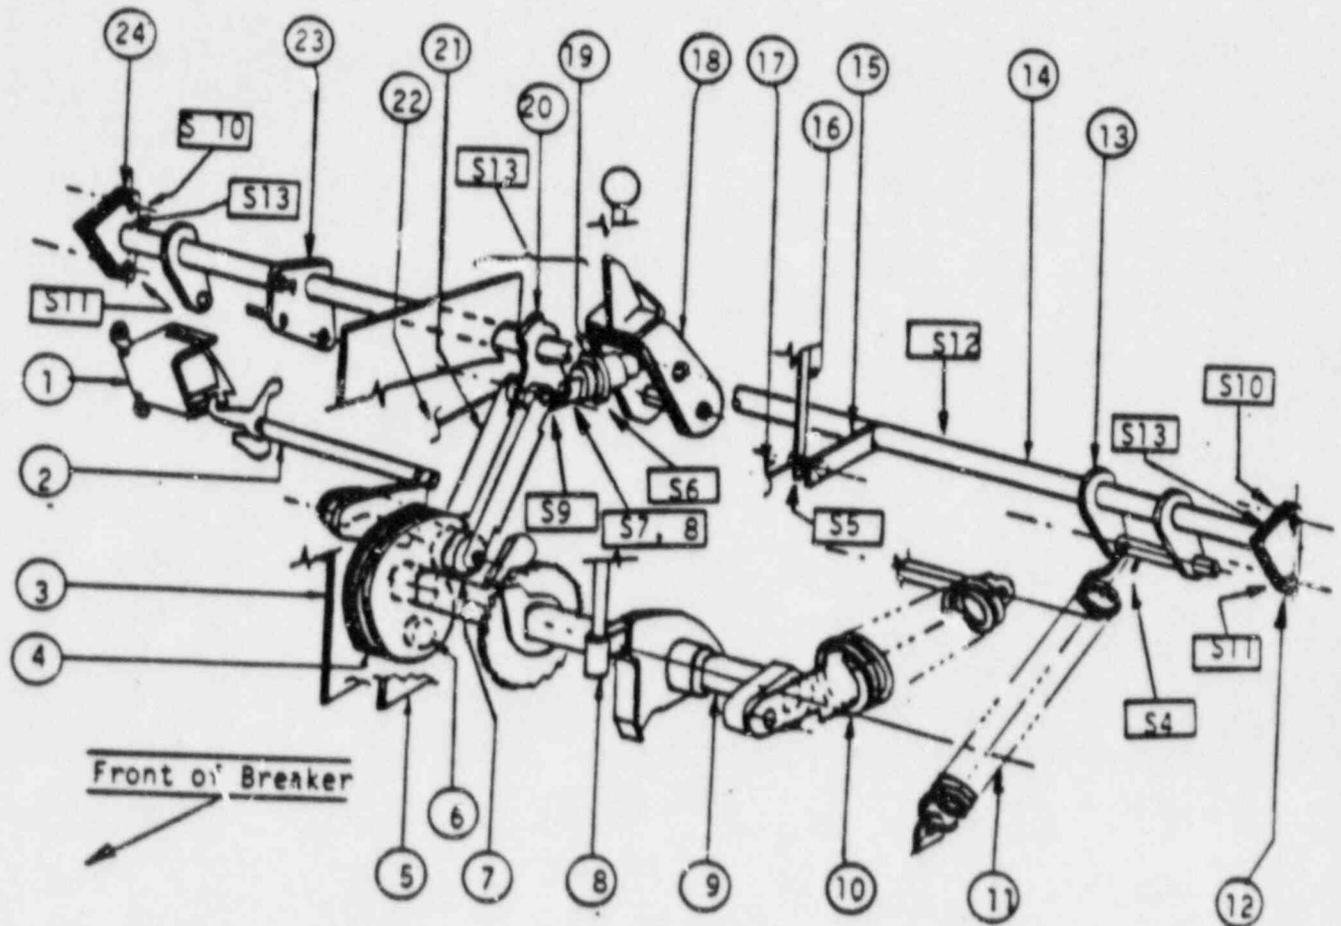
FIGURE 3

It is recommended that personnel assigned to do this task review Figure 3 before beginning the tasks. It shows the components involved in this procedure.
