LICENSEE EVENT REPORT (LER)

FACILITY NAME (1) Waterford Steam Electric Station Unit 3	DOCKET NUMBER (2) 0 5 0 0 0 3 8 2 1	PAGE (3) OF 0 9
--	--	--------------------

TITLE (4)
Reactor Trip Due to a Failed Solenoid Valve During Main Steam Isolation Valve Testing

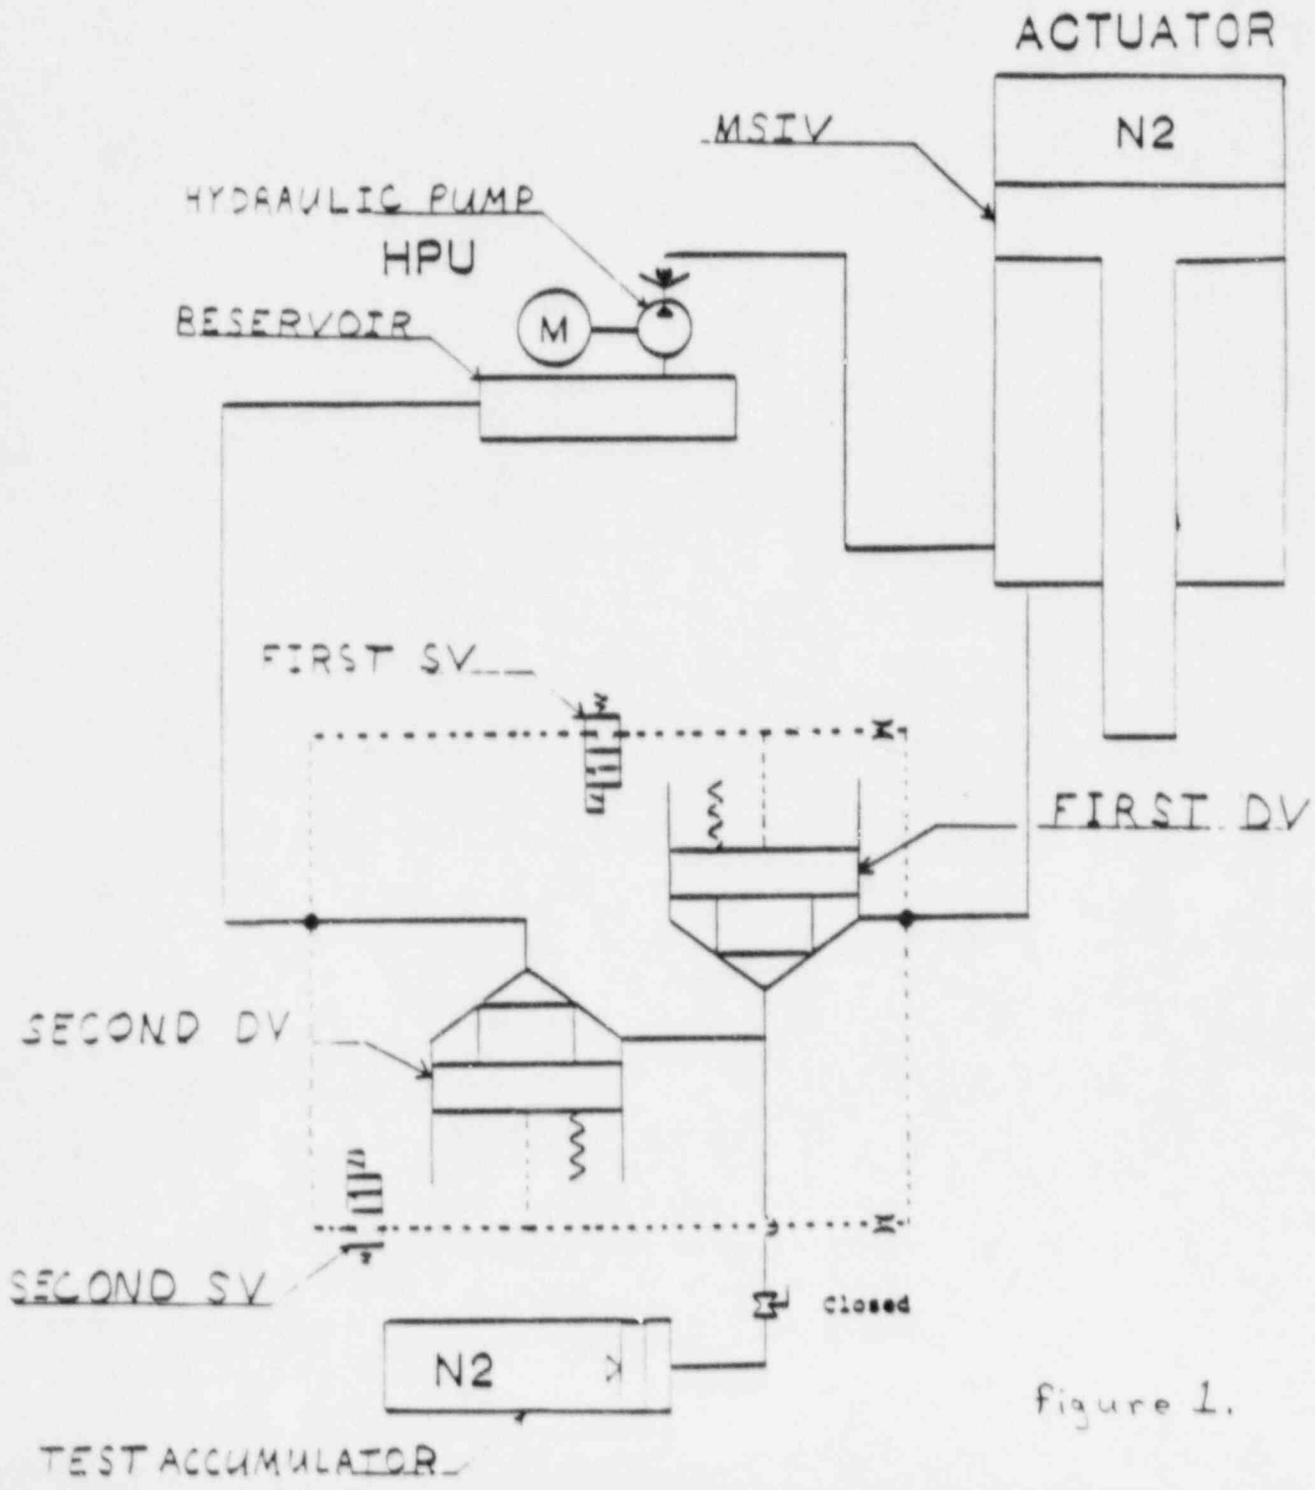
Figure 1.

After the plant was placed in a normal hot standby condition, troubleshooting was performed on #2 MSIV. It was determined that a solenoid valve (EIS Identifier SB-FSV) manufactured by Fluid Control Inc. Model No. 7WXP4774-600K865 had stuck open. Refer to figure 1 during the following explanation. The first solenoid valve (SV) energizes open and bleeds hydraulic fluid (HF) off of a dump valve (DV), causing the DV to open. The open DV allows HF to flow from the MSIV to a small test accumulator. The accumulator is sized so that when it is filled the MSIV is approximately 10% from the fully open position. The HF pressure then builds up and reopens the MSIV. When the MSIV is at the 10% shut position a limit switch operates to deenergize and shut the SV to allow HF pressure to build up on the DV and shut it. After a time delay to allow the MSIV to reopen, a second SV is energized open to bleed HF from a second DV. When this second DV opens the HF in the accumulator is drained to a reservoir. The problem occurred because the first SV stayed open when it was deenergized, allowing the first DV to remain open. When the MSIV reopened and the second DV opened, both DV's were open, allowing HF from the MSIV actuator to drain directly to the reservoir. This caused the MSIV to move rapidly in the closed direction. The same limit switch which deenergized the first SV also deenergizes the second SV if the MSIV goes 10% shut. When the MSIV went 10% shut again, the limit switch operated to shut the second SV which shut the second DV. This prevented all the HF from draining from the actuator, thus preventing the valve from shutting all the way. When the second DV went shut HF pressure built up, reopening the MSIV.

The root cause of this event was determined to be a stuck open SV. Immediately after the MSIV problem the hydraulic pumps which maintain HF pressure in the system were cycling on and off very rapidly, indicating a system leak. As there was no visible system leak it was concluded a valve must be leaking by internally. All of the signal circuitry tested properly during troubleshooting, so the MSIV was test stroked using closure train A. The first test failed in the same manner as the test which tripped the plant. The MSIV was then tested successfully twice. The hydraulic pumps returned to their normal cycling after the first successful MSIV test. Since the leak went away after a successful test, and a closure stroke of the MSIV requires both DV's to be open simultaneously, it was concluded that the first SV stuck open. The SV being open would cause an internal hydraulic leak and it would also cause the first DV to be open when the second DV opened. The reason for the SV sticking open is suspected to be mechanical malfunctioning or debris caught in the SV's hydraulic orifices. To prevent a possible reoccurrence of the event, the SV was replaced and the replacement was tested successfully per procedure ME-4-809 "Low Voltage (600 Volts and Less) Power and Control Cable/Conductor Terminations and Splices". Procedure OP-903-032 for MSIV #2 was completed successfully at 1636 hours on December 12, 1987. At 1738 hours on December 12, 1987 a reactor startup was commenced. The SV and a HF sample have been sent to the vendor, Paul-Munroe, for failure analysis and possible system upgrade recommendations. If any system changes are to be made as a result of the manufacturers evaluation, results of this evaluation will be included in an LER revision.
