U.S. NUCLEAR REGULATORY COMMISSION
REGION IV

Report No. 40-8989/98-02

Licensee: Envirocare of Utah, Inc.

Facility: South Clive Facility

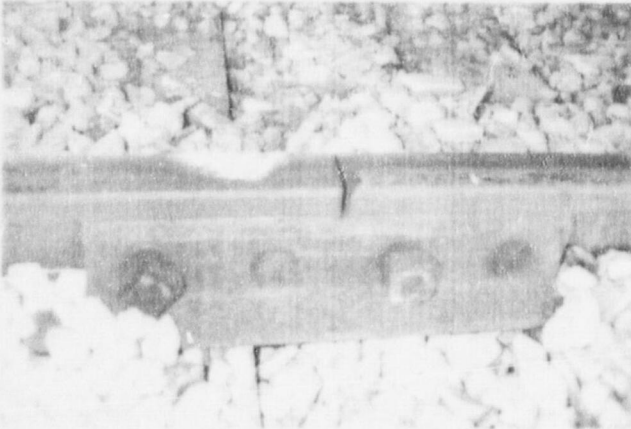
During a review of the operational controls for these 32 rail cars, the NRC inspectors noted that neither the license, license application, or site procedures discussed the use of track 4, or any rail track. For example, there were no surveillance requirements for these railcars and no routine surveillances had been conducted. If the railcars had been located inside of the restricted area, the license application specifies that monthly container integrity inspections would be required. During the site tours, the NRC noted material on the tracks beneath 2 railcars on track 4 which indicated that leakage had occurred. This material had not been analyzed by the licensee for contamination and, consequently, represented a potential source of contamination of track 4. This finding indicated that the licensee was not effectively monitoring or controlling wastes at this location. Situations such as this create the potential for long-term problems with future decommissioning and the requirement to maintain records of spills of radioactive

During the inspection, the licensee obtained samples of the railcar leakage to ascertain whether the leakage was radioactive waste material. The sample results revealed that the specimens contained radioactive material at background levels. In this particular instance, the railcar leakage apparently was not radioactive waste material.

Figure 1 Residue Beneath a Rail Car on Track No. Four

The licensee stated during the final exit briefing that they initially thought that the material on track 4 was still in transit. Since the licensee assumed that the material was in transit, operational control of the railcars did not have to be included in the site procedures. However, the NRC inspectors noted that the material could not be considered in transit if the material was under the control of the licensee, and the inspectors concluded that the railcars located on track 4 were under the control of the licensee. To resolve this procedure deficiency, the licensee committed to revise existing site procedures by the end of January 1999 to include written guidance for track 4 operations.

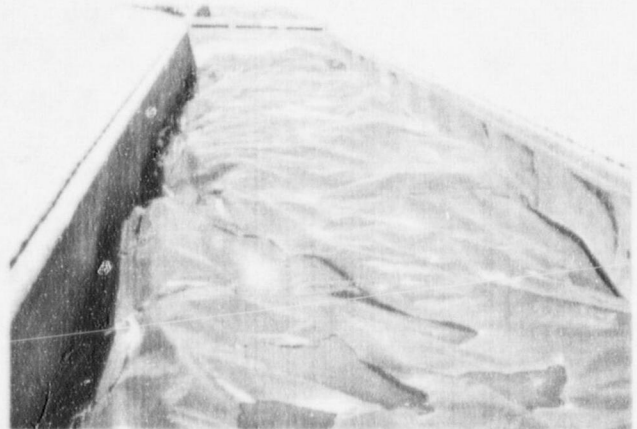
Figure 2 "Burrito Bag" Liner in Rail Cars

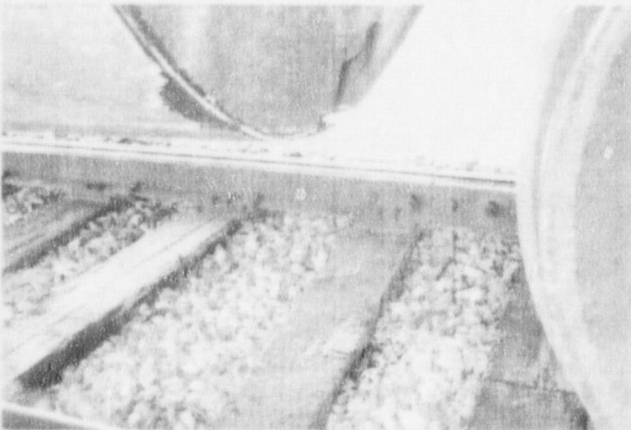
An investigation was conducted by the generator who concluded that the container lids were not properly sealed. The unsealed lids allowed rain and snow to enter the railcars during shipment to the Envirocare site. Proposed corrective actions included modification of the railcar lids. By letter dated June 10, 1998, the licensee reaffirmed the generator's corrective actions which included repairing, modifying, and sealing the railcar lids to prevent future reoccurrences.

were apparently ineffective because the modification of the rail car lids was not the solution to the root causes of the free standing liquid problem.

Figure 3 Leaking Rail Car from Vendor

The licensee issued the generator a stop shipment order on October 7, 1998, in accordance with Envirocare's Waste Characterization Plan. By letter dated October 9, 1998, the generator submitted a revised corrective action plan to the licensee. The generator suspected that the material contained more sand than material previously shipped and that absorbent material would be added to the wastes to reduce the moisture content of this sandy waste material. Also, the generator suspected that the method used to add material in the cars (in two piles) may have created low spots that promoted leaching and pooling of moisture. Immediately after the conclusion of the onsite inspection, the licensee lifted the stop shipment order based on the generator's commitments to add absorbent material to the wastes.

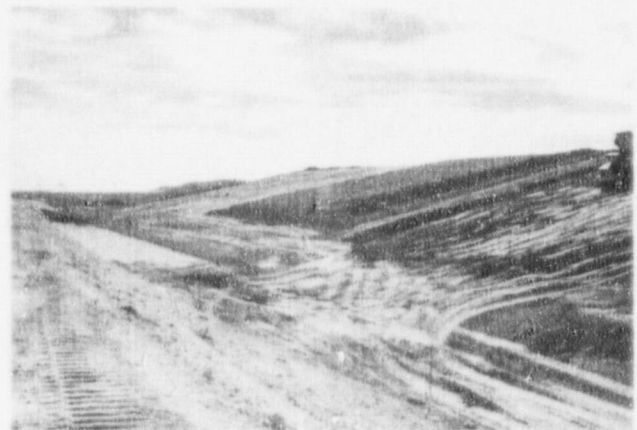
Figure 4 11e(2) Cell Construction

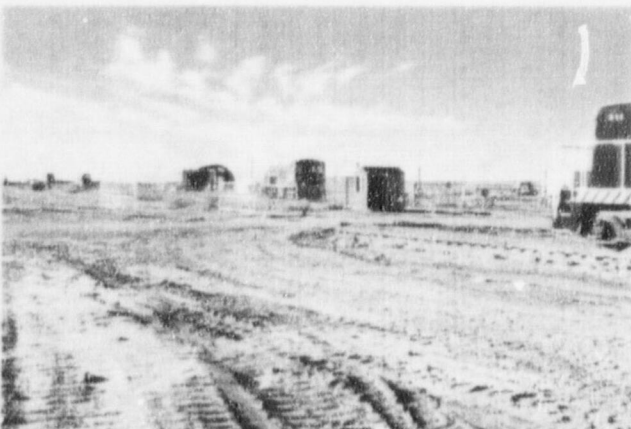
During this inspection, the NRC noted that 32 rail cars containing 11e.(2) wastes were situated on this track. These wastes had been in short-term storage at this location for up to 10 weeks. The area was fenced, but the gates were open and unsecured. Further review by the NRC inspectors revealed that the material on track 4 had been received by the licensee but had not been accepted or rejected for disposal. The material was being stored at this location by the licensee following receipt for eventual transfer into the site restricted area.

License Condition 9.6(a) states that the licensee shall establish and implement standard operating procedures for all operational activities involving the handling, storage, or disposing of radioactive materials. Contrary to this requirement, the licensee was noted to be handling and storing radioactive materials on track 4, although the licensee did not have procedures for performing such activities. The licensee's failure to have developed procedures or related guidance for the handling and storing of radioactive wastes on track 4 was identified as a violation of License Condition 9.6(a) (VIO 40-8989/9802-02).

Figure 6 Rail Systems Showing Track No. Four Exiting to the Left

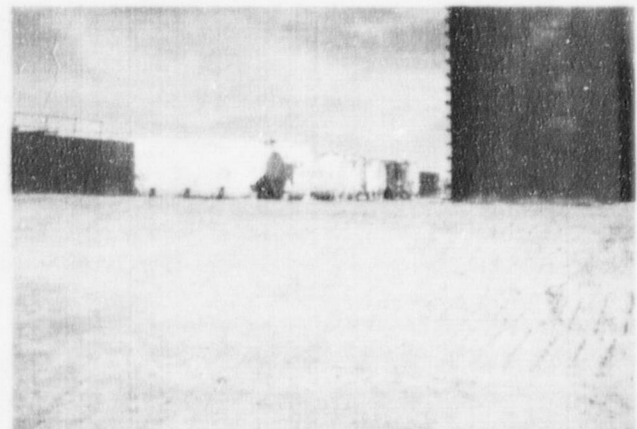
Figure 5 "Frac Tanks" Used for Temporary Water Storage On-Site
