U.S. NUCLEAR REGULATORY COMMISSION APPROVED OMB NO 3150-0104 EXPIRES B/31 MA LICENSEE EVENT REPORT (LER) DOCKET NUMBER (2) FACILITY NAME (1) Prairie Island Unit 1 0 15 10 10 10 1 2 1 8 1 2 1 OF 014 TITLE (4) Auto Start of 12 Component Cooling Water Pump OTHER FACILITIES INVOLVED (8) EARCH! DATE (7) EVENT DATE (8) LER NUMBER IS DOCKET NUMBERIS FACILITY NAMES SEQUENTIAL MONTH DAY MONTH DAY YEAR YEAR 0 15 10 10 10 1 40 119 81 7 2 0 0 01 8 0 15 10 10 10 1 THIS REPORT IS SUBMITTED PURSUANT TO THE NECESIFIREMENTS OF 10 CFR \$ (Check one or more of the following) (11) SPERATING 73.71(b) 20 A05(e) 50 73(a)(2)(iv) 73.71(e) 50 38(a)(1) 50.73(a)(2)(v) 30 408(a)(1)(i) OTHER (Specify in Abstract below and in Text, NAC Fo. 366A) 50.73(a)(2)(vii) 50 36(a)(2) 11 01 0 20.406(4)(1)(9) 50 73(a) (2) (viii) (A) 20 408(+)(1)(4) 50.73(4)(2)(1) 50.73(a)(2)(viii)(8) 50.73(a)(2)(k) 50.73(a)(2)(x) 20.408(a)(:/(v) 50 T Jan 12 1760 LICENSEE CONTACT FOR THIS LER (12) ELEPHONE NUMBER NAME Arne Hunstad, Staff Engineer 8 8 2 Prairie Island Nuclear Conerating Plant COMPLETE ONE LINE FOR EACH COMPONENT FAILURE DESCRIBED IN THIS REPORT (13) EPORTABLE TO NPROS MANUFAC REI JATABLE MANUFAC CAUSE SYSTEM COMPONENT SYSTEM

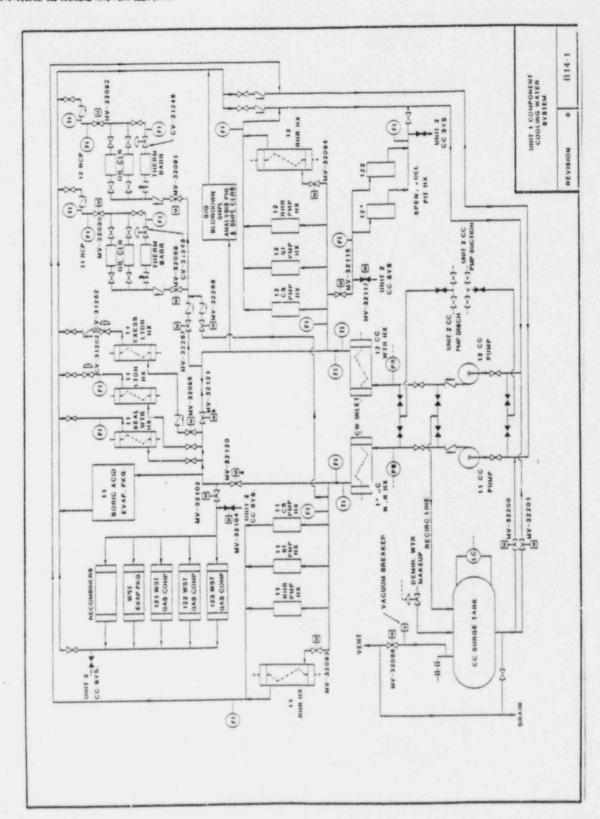
Refer to the attached system flow diagram.

The cause of the event was a procedural inadequacy which allowed the No. 12 CC pump discharge header to be isolated from the No. 11 CC pump discharge header without first starting No. 12 CC pump.

Valve MV-32121 was immediately reopened following the automatic start of No. 12 CC pump. No. 12 CC pump was then stopped when adequate pressure and flow from the No. 11 CC pump to the No. 12 CC pump discharge header was assured. The prework test procedure for the subject work request was modified to require the manual starting of No. 12 CC pump prior to the cycling of MV-32121. In addition the procedures for testing the other three component cooling heat exchanger outlet valves were modified to require the respective CC pump to be running prior to cycling the valve. Subsequent testing of component cooling heat exchanger outlet valves was performed with both CC pumps for the associated unit in operation.
