LICENSEE EVENT REPORT (LER)

FACILITY NAME (1) Peach Bottom Atomic Power Station Unit 2	DOCKET NUMBER (2) 0500 277	PAGE (3) 1 of 5
--	--------------------------------------	---------------------------

TITLE (4)
This LER reports multiple unplanned Engineered Safety Feature (ESF) actuations during a planned electrical bus restoration following maintenance activities.

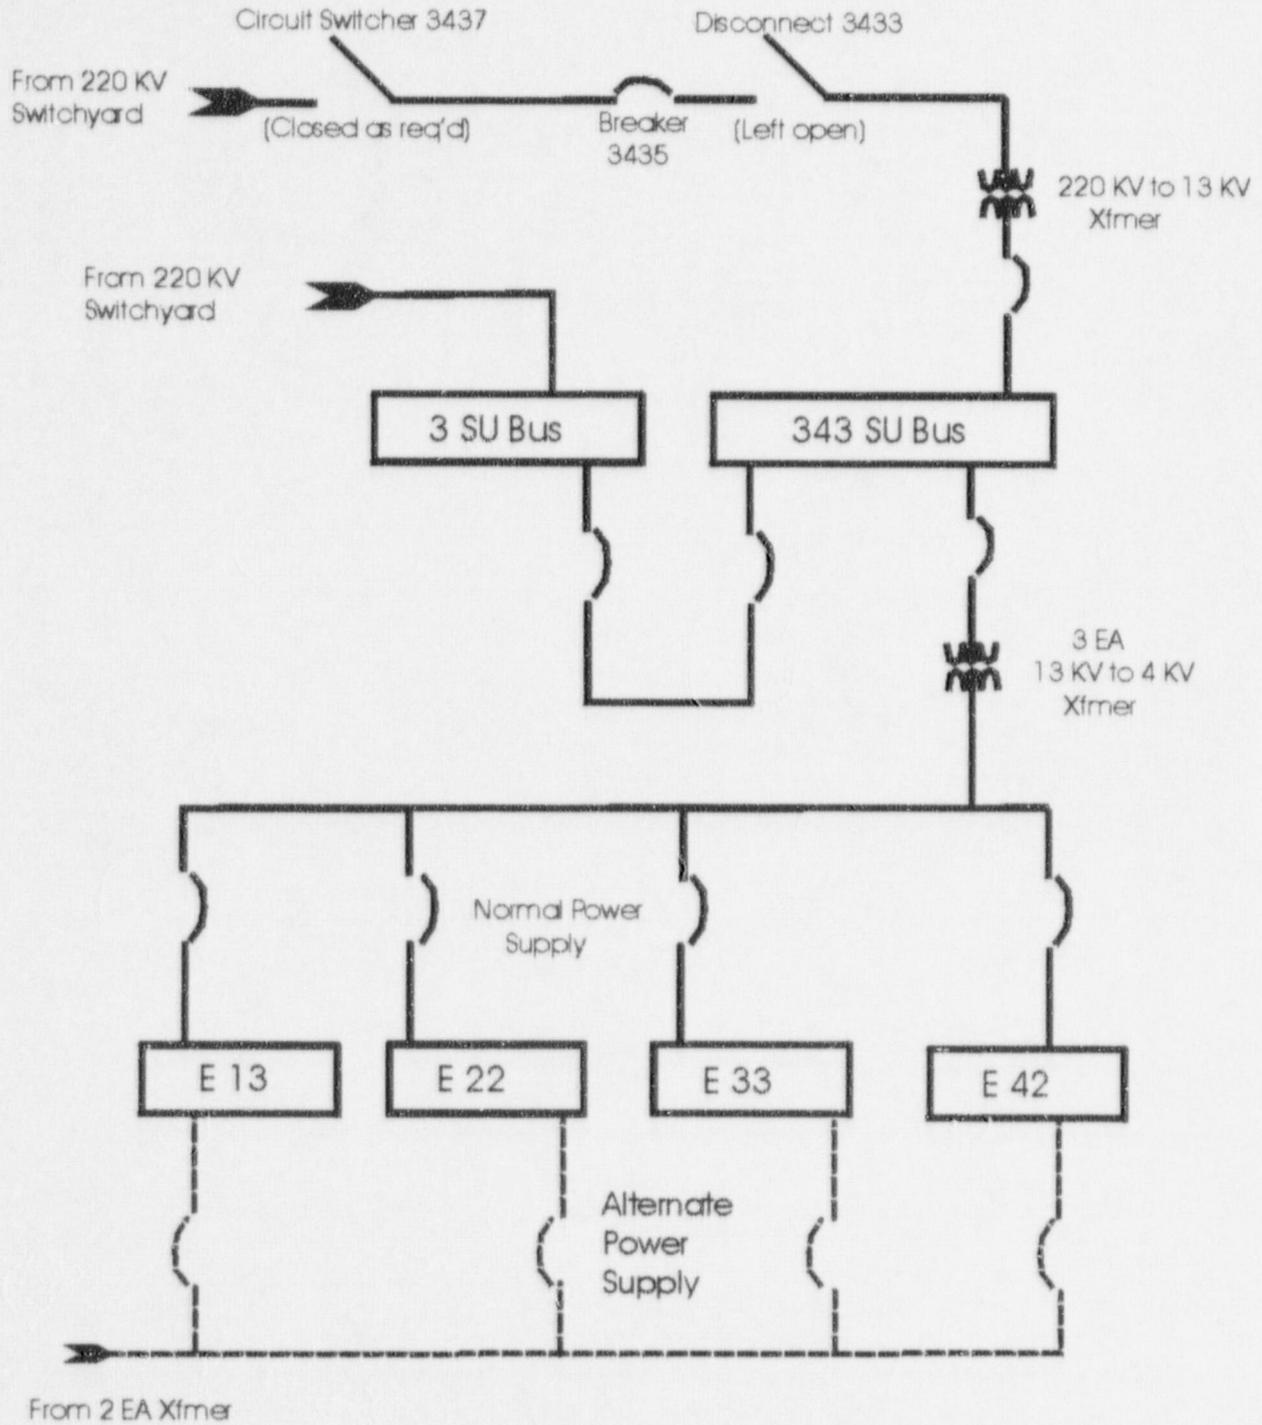
Attachment 1: Simplified System Drawing

Due to weaknesses in the administrative controls (disconnect 3433 being excluded from the clearance), the crew did not recognize that disconnect 3433 was out of its normal position.

At 2220, the PRO closed the 3435 breaker. When he released the control switch, the 343SU-1 breaker, which was supplying power to the 3EA transformer from 3SU, opened as expected. At this point the 3EA transformer became deenergized because disconnect 3433 was still open. This caused a momentary deenergization and fast transfer of the E-13, E-22, E-33, and E-42 4 KV electrical buses.
