LICENSEE EVENT REPORT (LER)

FACILITY NAME (1) Point Beach Nuclear Plant	DOCKET NUMBER (2) 0 5 0 0 0 2 6 6	PAGE (3) 1 OF 0 5
--	--------------------------------------	----------------------

TITLE (4)
Single failure potential in 4160 volt safeguards switchgear

DOCKET 50-266
LICENSEE EVENT REPORT 88-001-00
SINGLE FAILURE POTENTIAL IN 4160 VOLT SAFEGUARDS SWITCHGEAR
POINT BEACH NUCLEAR PLANT UNIT 1

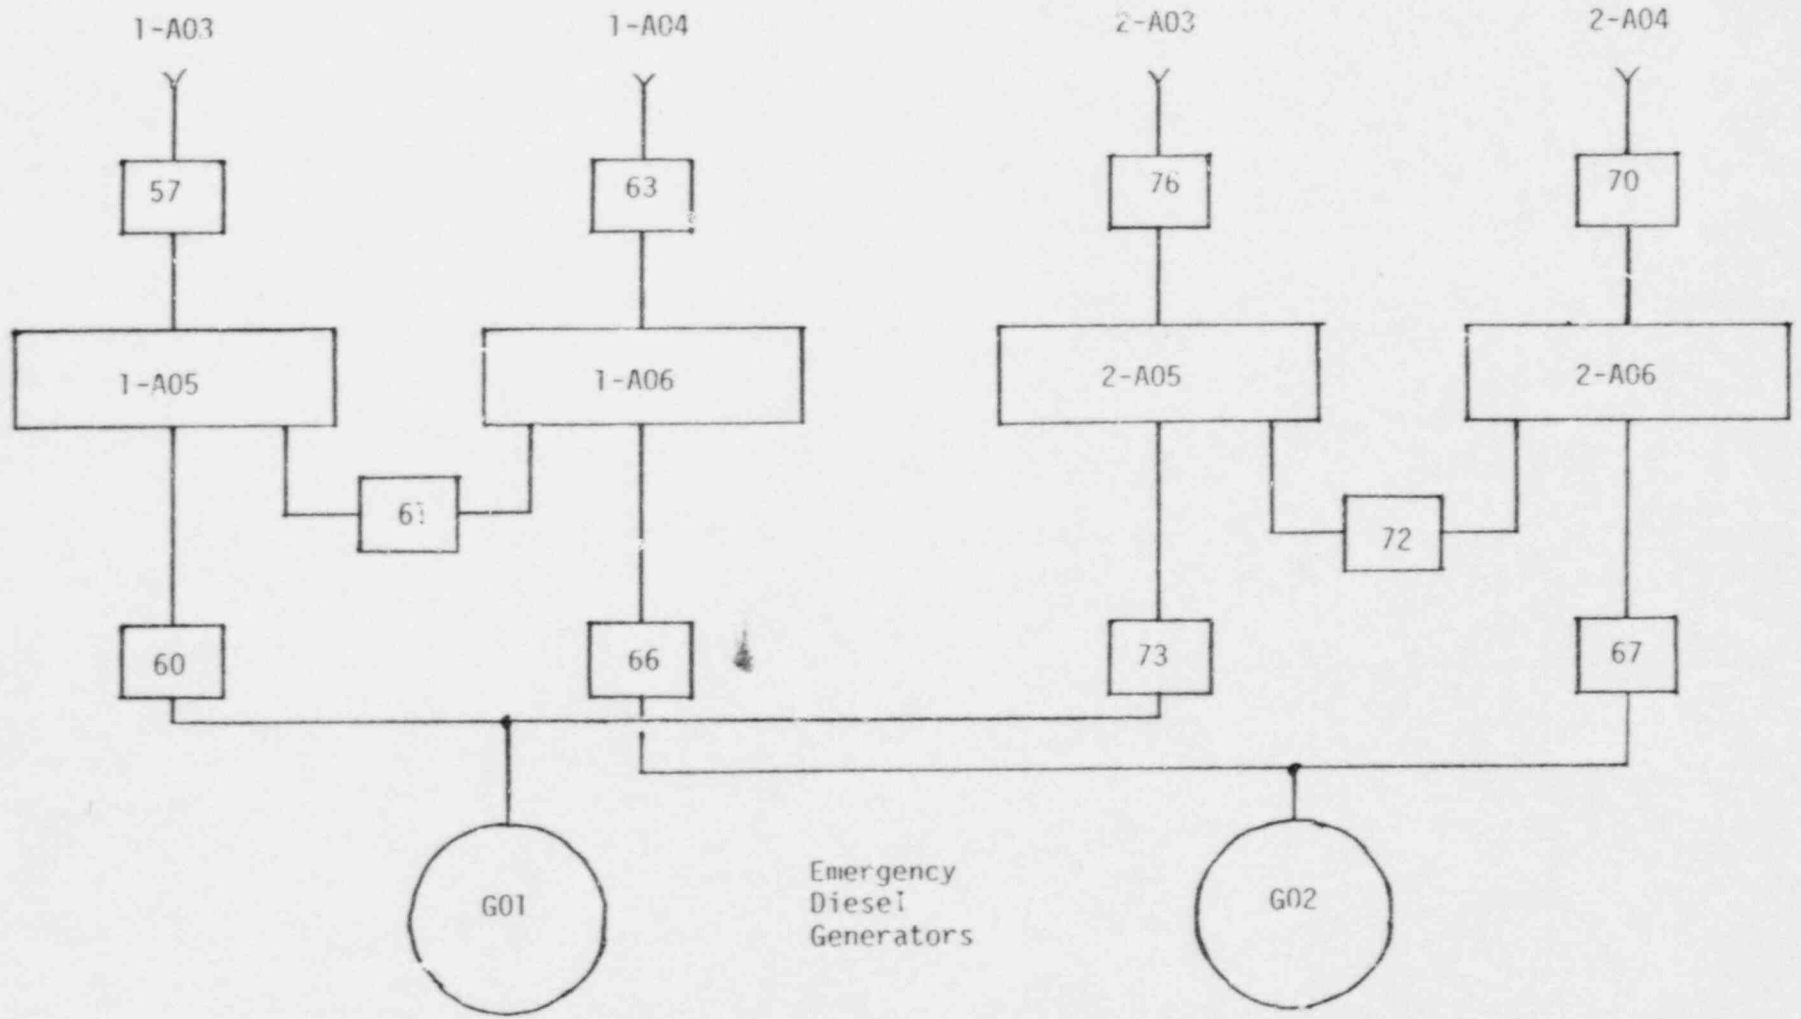
SIMPLIFIED SCHEMATIC OF BUS SECTIONS
A05 AND A06 NORMAL AND EMERGENCY
POWER SUPPLIES

A diagram of the busses and breakers involved is attached. The following is a system description and discussion of the design deficiency for the Unit 1 breaker arrangement. It is equally applicable for Unit 2.

Tie breaker 61 provides a means to tie together safeguards busses 1-A05 and 1-A06. These busses supply the 4160 volt power to Train A and Train B safeguards loads. The tie breaker is provided for use during a unit shutdown to facilitate maintenance on the normal bus supply breakers, 57 or 63. A cell switch associated with tie breaker 61 provides an interlock in the automatic closing circuits for both breakers 60 and 66, preventing automatic closure of those breakers when breaker 61 is closed. The purpose of this interlock is to prevent the automatic paralleling of both emergency diesel generators following a fast start without synchronization.

It is postulated that a single failure in this cell switch could, in the event of a loss of offsite power, prevent the automatic closure of breakers 60 and 66 and thereby temporarily disable emergency power to both trains of 4160 volt safeguards equipment. This cell switch failure would not, however, prevent the 60 and 66 supply breakers from being closed manually by the control room operator from the unit's control board. The Point Beach Emergency Operating Procedures direct the operators to manually energize the 1-A05 and 1-A06 busses should automatic breaker closure not occur.

The cell switch contacts indicate the actual position of the tie breaker in the diesel generator output breaker closing logic. This logic allows the diesel output breaker to close if the tie breaker is open and prevents it from closing if the tie breaker is closed.

When the single failure problem was discovered, the position of the cell switch contacts was verified by electrical continuity testing and breaker position was administratively controlled to ensure the switch was not operated without subsequent continuity testing. Additionally, a temporary modification was installed on January 21, 1988, which defeats the cell switch interlock, thus preventing a single failure of the cell switch from affecting automatic closure of the diesel generator output breakers. The temporary modification may be removed only under administrative control when the tie breakers are closed during a maintenance or emergency evolution. Since these tie breakers are intended only for use during maintenance done during refueling shutdown conditions, when the normal supplies to the safeguards busses are unavailable, the administrative controls are adequate for the short term and not a hardship on the normal operations of the plant.

A permanent modification is being designed which will provide the original automatic function but does not allow a single failure of a cell switch to affect the automatic closure of the diesel generator output breaker safeguards bus supply breakers. This modification is scheduled for completion during the Unit 1 spring
