U. S. NUCLEAR REGULATORY COMMISSION

Report No. 50-341/87049(DRP)

Facility Name: Fermi 2

Areas Inspected: Special safety inspection of the events that led to the loss of essential bus 72 CF on September 8, 1987, the evaluation by the licensee of the event, and the design basis for bus 72 CF.

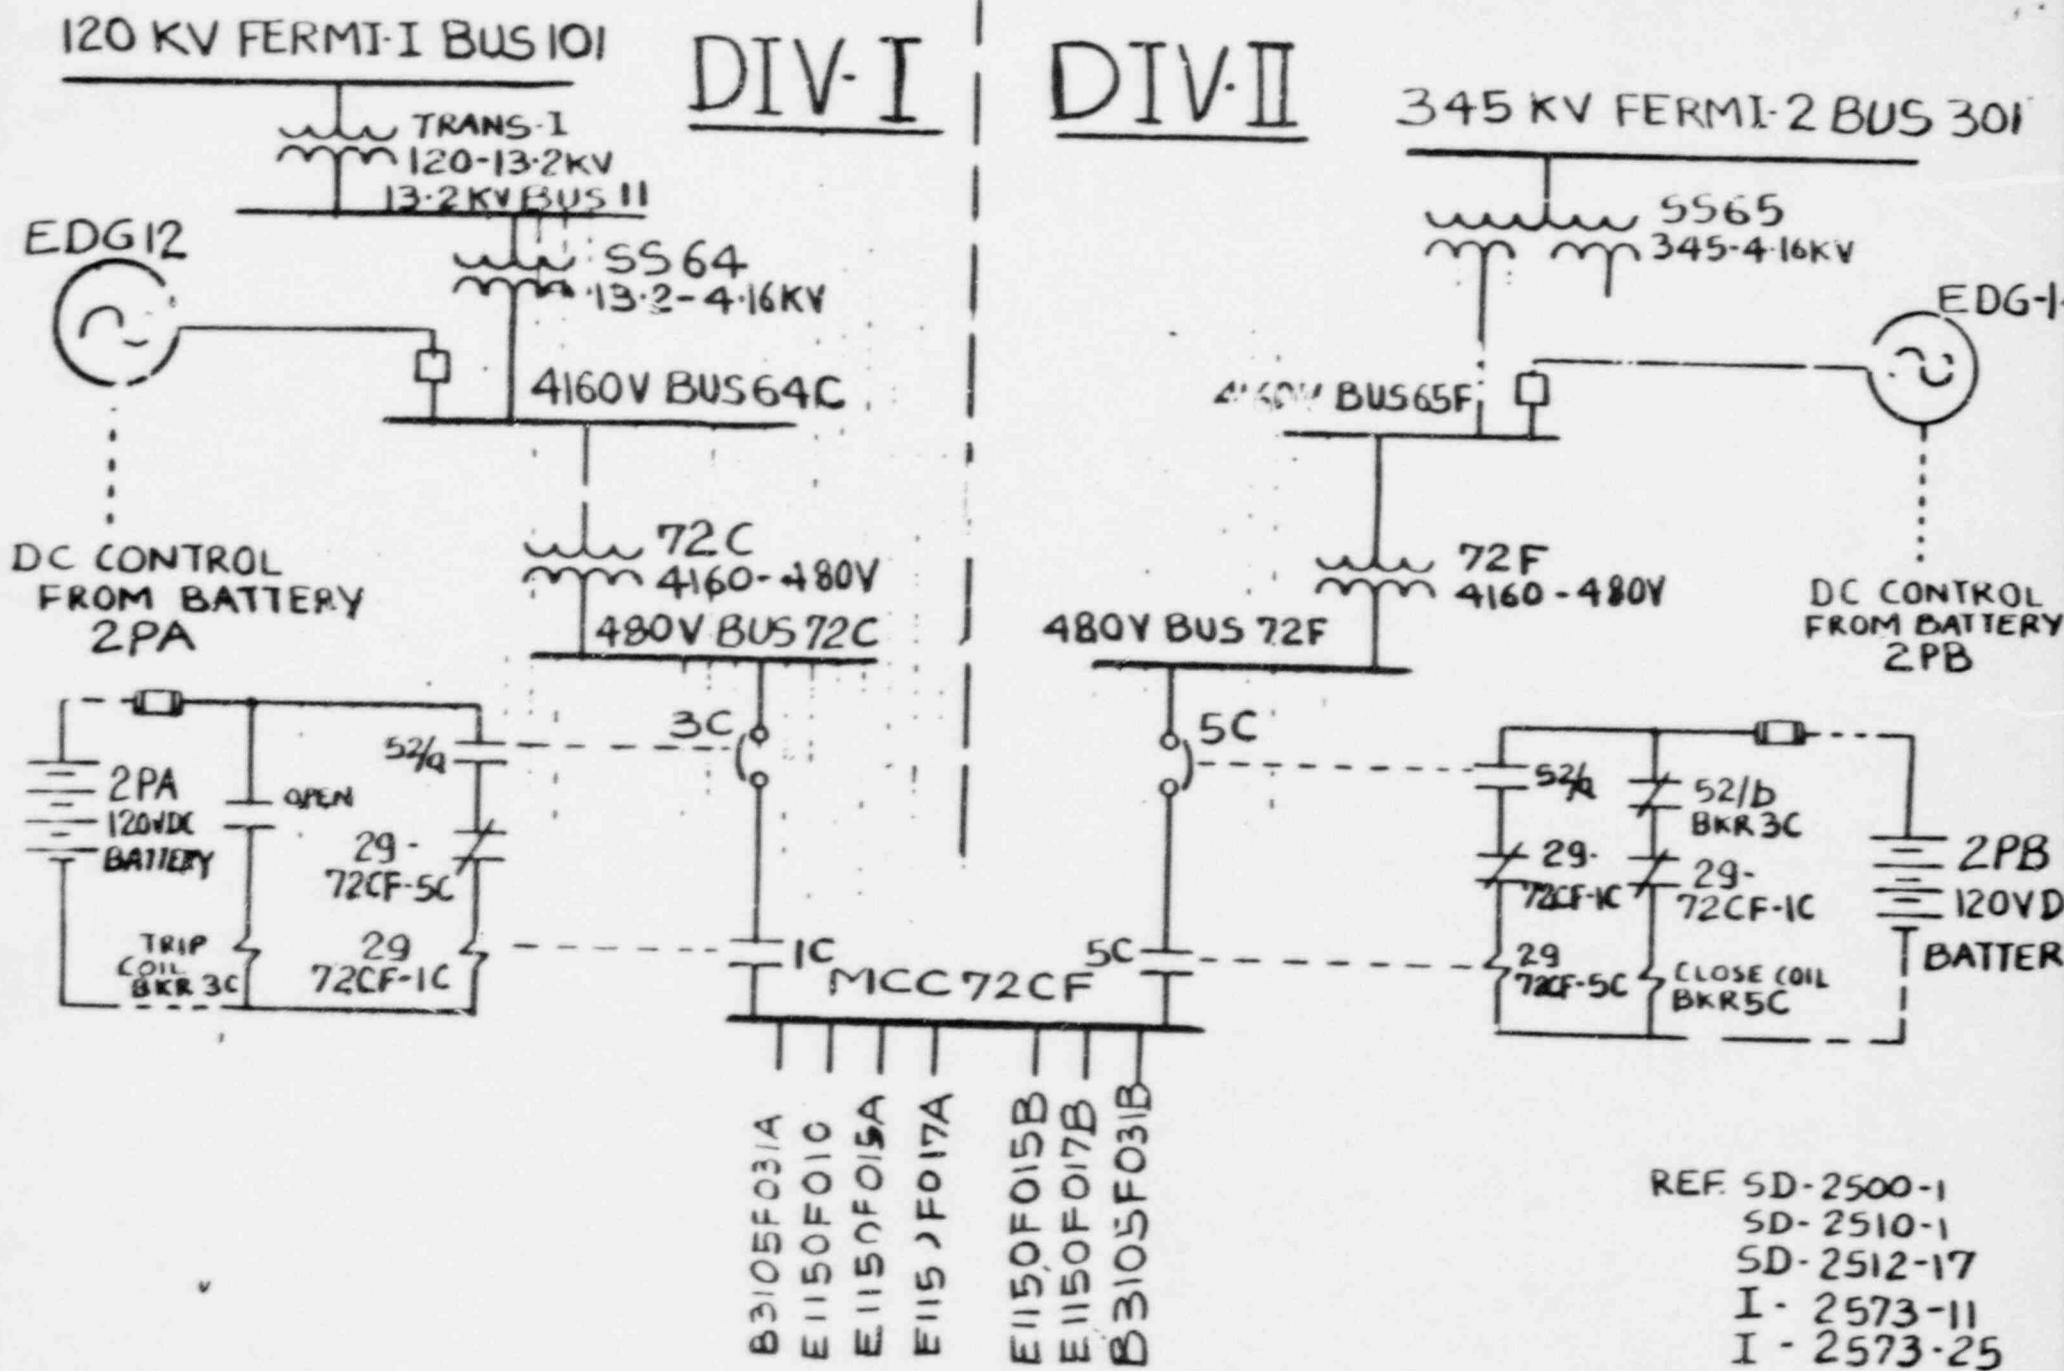
Fig. 1

Normally, the swing bus was powered from Division 1 and upon loss of power the electrical feed to Division 2 would close providing power to the swing bus. The manner in which this power throw over logic was constructed is shown in Figure 1. For the Division 1 power feed, there was a breaker, 3C, and a contact, 1C, which must be closed. For the Division 2 power feed there was a breaker, 5C, and a contact, 5C, which must be closed. When breaker 3C opened and contact 1C opened, the closing coil for breaker 5C was energized, closing breaker 5C. Once breaker 5C was closed, the relay to contact 5C was energized, closing contact 5C. With the 5C breaker and contact closed, bus 72CF would be powered from Division 2. Power for the trip coil, for breaker 3C, and for contact 1C's relay was provided from Division 1 battery 2PA via 2PA2-14 position 2. Power for the trip coil, for breaker 5C, and for contact 5C's relay was provided from Division 2 battery 2PB.

When the switch at 2PA2-14 position 2 was opened, the Division 1 power to swing bus 72CF was lost and the automatic power feed transfer to the Division 2 power source did not occur. Opening 2PA2-14 position 2 caused a loss of power to the 1C relay deenergizing and opening the 1C contact. With the 1C contact open, the Division 1 electrical feed to bus 72CF was interrupted. Also, when 2PA2-14 position 2 was opened, power to breaker 3C's trip coil was lost. Without a powered trip coil, breaker 3C did not open. The 72CF automatic transfer to Division 2 only occurs when breaker 3C and contact 1C are open. Therefore, the automatic transfer did not occur and bus 72CF deenergized.

Engineering personnel redesigned the swing bus electrical circuitry to conform to the appropriate regulatory requirements. An NRC Region III inspector and two representatives from the Electrical Systems Branch of NRR reviewed the new design and determined it to be acceptable. The new design was implemented under engineering design package 7906 prior to the licensee starting up from the maintenance outage which they had been in when the design deficiency was discovered. The NRC technical implementation review will be performed as indicated in Inspection Report No. 50-341/87042 by an electrical inspector during a future inspection. The resident inspectors attended operator training on the new swing bus design and considered the training acceptable.
