**Commonwealth Edison**

Subject: Zion Nuclear Power Station Units 1 and 2  
Response to Allegation (RIII-A-88-0086)  
License Nos. DPR-39 and DPR-48  
NRC Docket Nos. 50-295 and 50-304

ATTACHMENT  
RESPONSE TO ALLEGATION RIII-88-A-0086

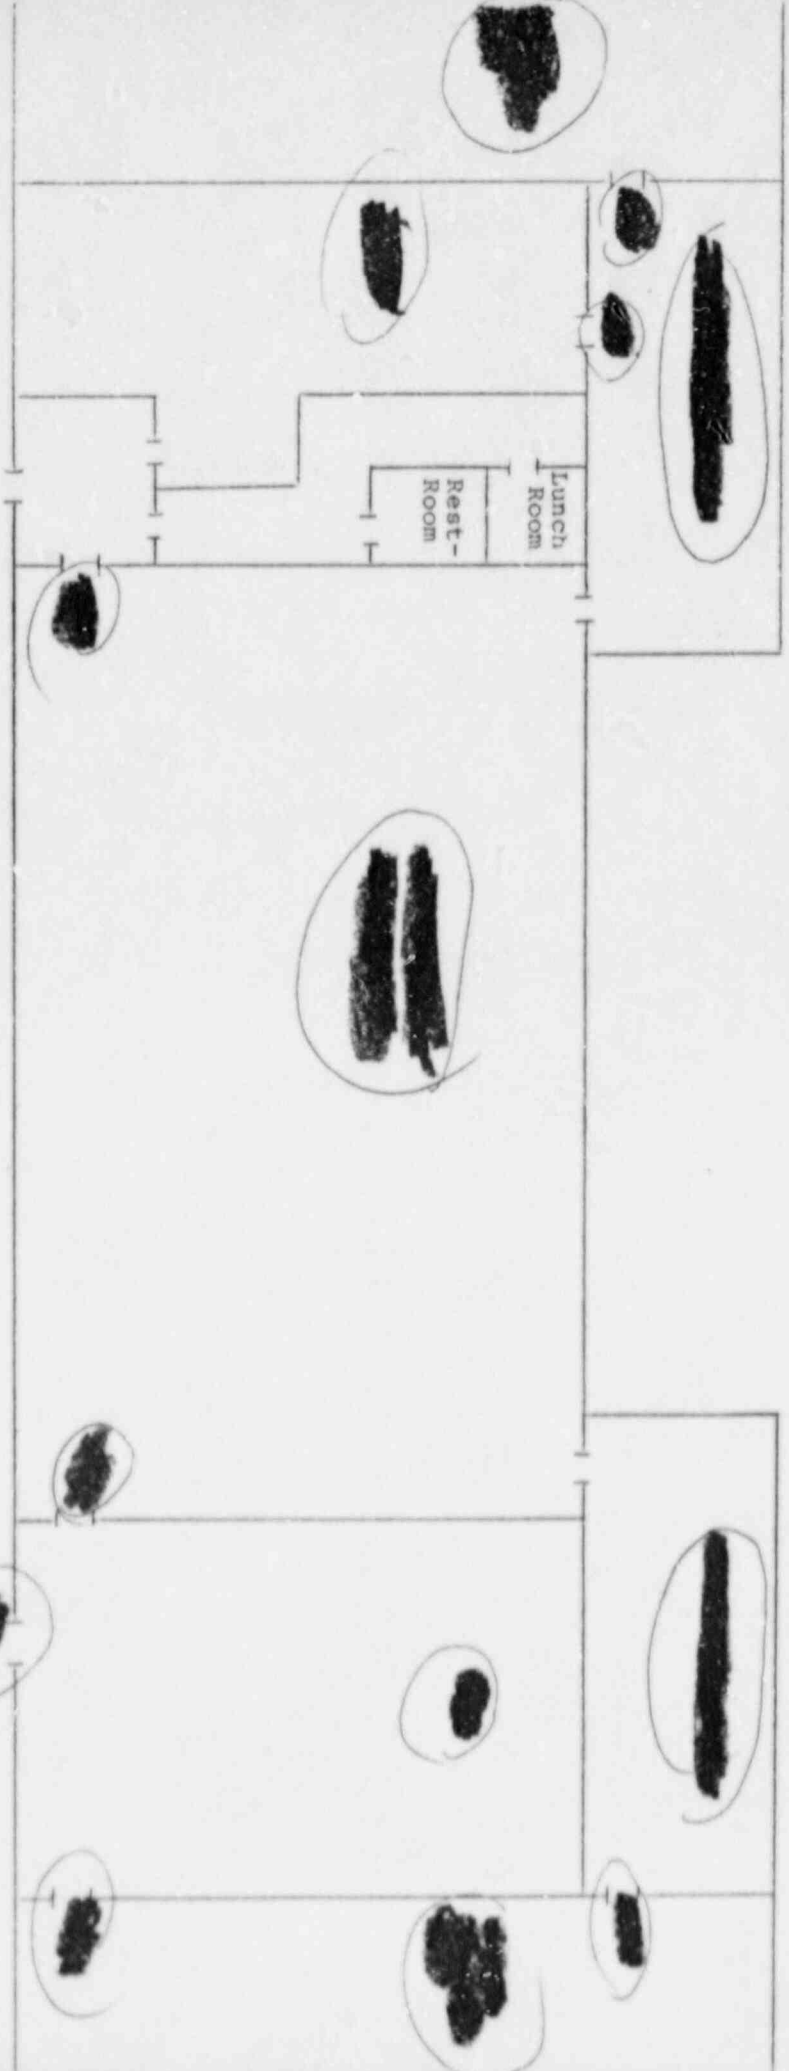
ATTACHMENT 'A'

Vital Area Door [redacted] (actually noted as Door [redacted] in the allegation summary) is the South Door of the Zion Station [redacted]. This door leads from the [redacted] to a small vestibule. Three other doors open into this vestibule which provides access to the [redacted] (see attachment 'A').

All doors leading into this vestibule provide passage to locations within the vital area of the plant and are not protected area to vital area portals. Of the four doors leading into this vestibule, only Door [redacted] is equipped with a [redacted]. The other doors are normally closed and unlocked.
