U. S. NUCLEAR REGULATORY COMMISSION

Report Nos. 030-00001/88-002(DRSS); 030-12559/88-001(DRSS)

Licensee: Mallinckrodt Incorporated
2703 Wagner Place
Maryland Heights, MO 63043

Inspection Conducted: May 16 through June 3, 1988

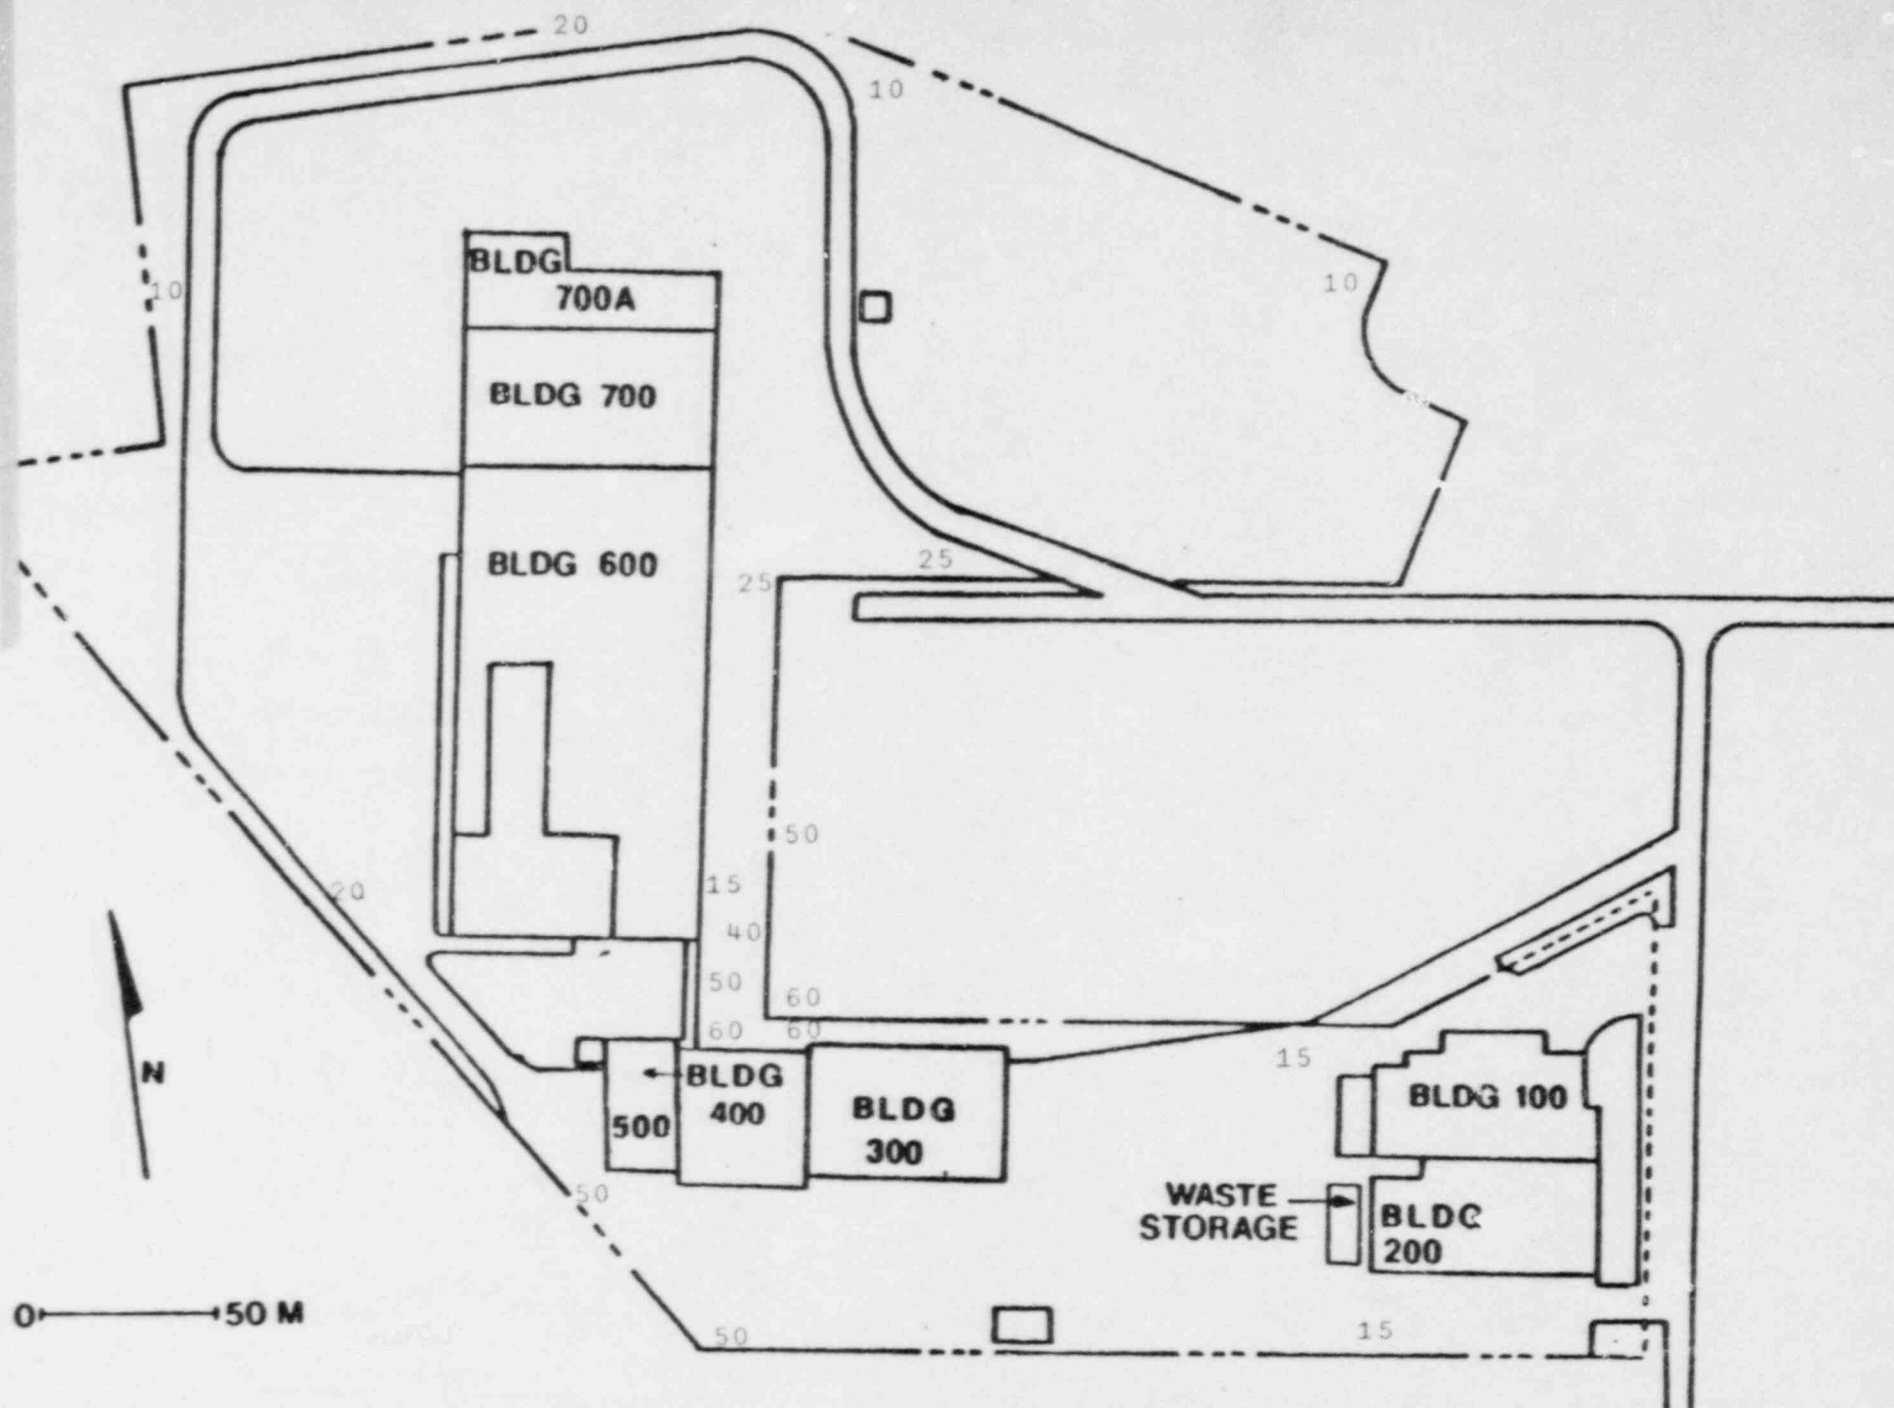
Layout of Mallinckrodt Diagnostics Facility showing results of a direct radiation survey in $\mu\text{R/hr}$.
