SUBJECT: JOSEPH M. FARLEY NUCLEAR PLANT, UNITS 1 AND 2 RE: REQUEST FOR
 ADDITIONAL INFORMATION — CATEGORY I COOLING WATER STORAGE
 POND DAM SAFETY AUDIT

OPERATION INSPECTION REPORT
for
THE NUCLEAR REGULATORY COMMISSION

Date of inspection October 8, 1998

Dam (name) Farley Category I Cooling Water Storage Pond Dam

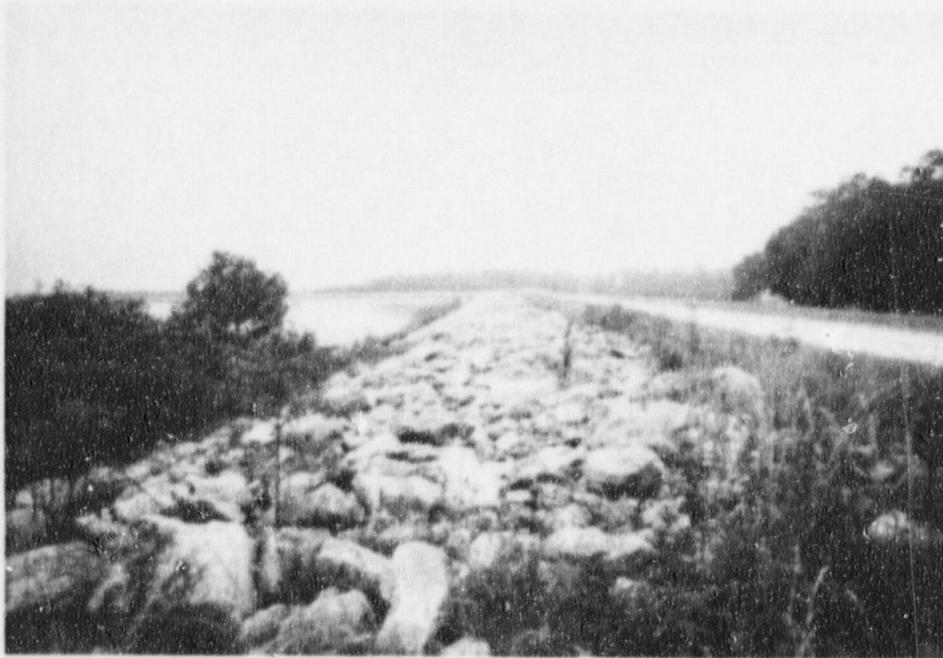
Photograph 1

a. Storage Pond Dam. The dam was inspected by walking the crest and toe. Areas of interest were more closely examined on both the upstream and downstream slopes. The upstream slope (Photographs 1, 3, 4, and 7) was stabilized with stone (riprap) to protect the earth dam from erosion due to wave action. The stone appeared to be in good condition, with no indication of weathering. No abnormalities in the upstream slope such as sliding, sloughing, or subsidence were observed. A considerable amount of vegetative growth was observed in the riprap (Photographs 1 and 4). This vegetation should be treated to prohibit growth and removed as necessary.

- o A considerable amount of undesirable vegetation was found growing in the riprap on the upstream slope of the dam. The vegetation should be eliminated by either physical or chemical means. Environmentally

Upstream slope of the dam as seen from near the right (southwest) abutment. Note the undesirable vegetation in the riprap (stone) along the slope.

safe chemical defoliants are available for this purpose.

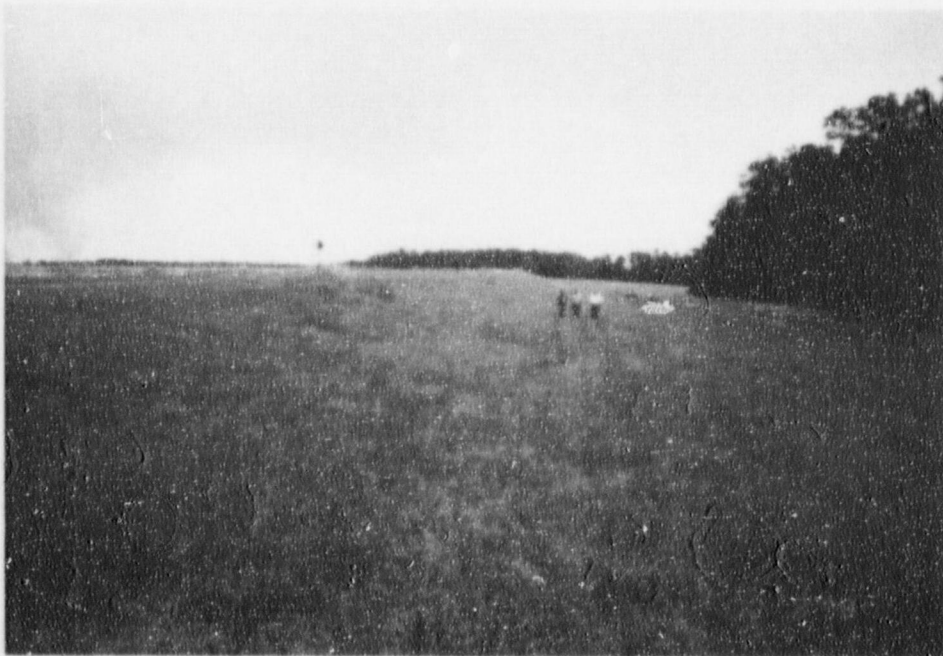
Photograph 2

The downstream slope appeared to be in good condition (Photographs 2 and 11). The slope is protected by a well established grass cover. Some areas along the toe of the slope near the north end of the dam (Photograph 11) supported vegetation typical of that found in wet areas. The licensee's biennial inspection on June 10, 1998, was made after a period of dry weather

Downstream slope of the earth dam as seen from near the right abutment. Note the well established grass cover.

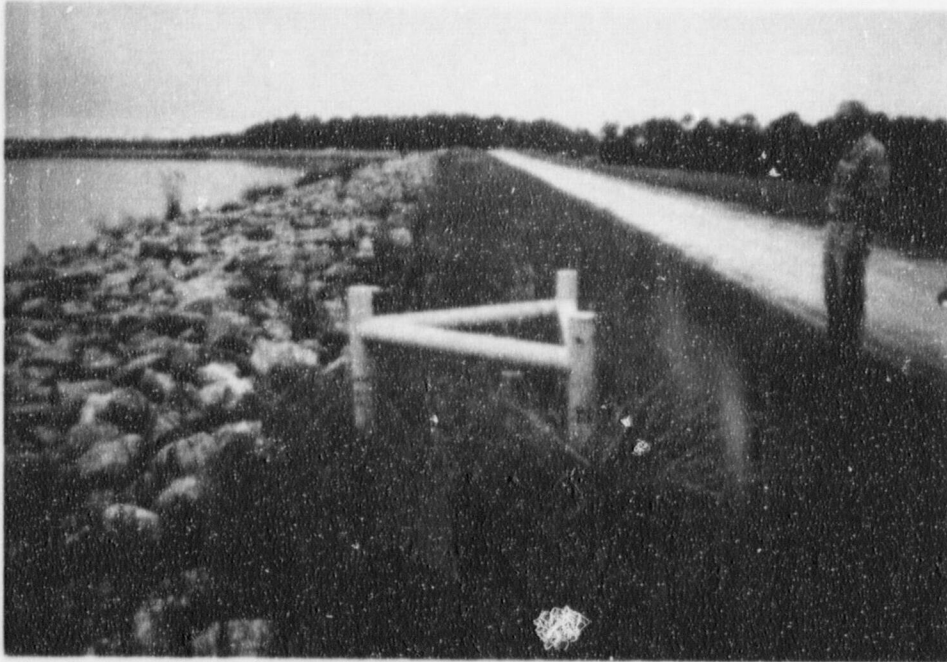
The crest and roadway along the top of the dam (Photograph 3) appeared to be in good condition, with no indication of cracking, sliding, settlement, or erosion. Several fire ant mounds were observed near the crest. These should be eradicated.

2. Instrumentation. Project instrumentation includes 19 surface monuments, 60 observation wells (Photograph 3), and 25 relief wells (Photographs 8 and 9). Water levels in the pond are monitored electronically and remotely monitored. Monuments are located along the crest of the dam to monitor horizontal and vertical movement. Photograph 3 shows typical protective barriers for protection of observation wells and survey reference points. Observation wells are located along the crest of the dam and on selected downstream slope sections. Relief wells are located in the area downstream of the downstream toe and are connected to a pipe collection system typically 6 to 8 feet (2 to 3 m) below the ground surface.

Observation well No. 7. The barrier around the well is typical of all of the wells.

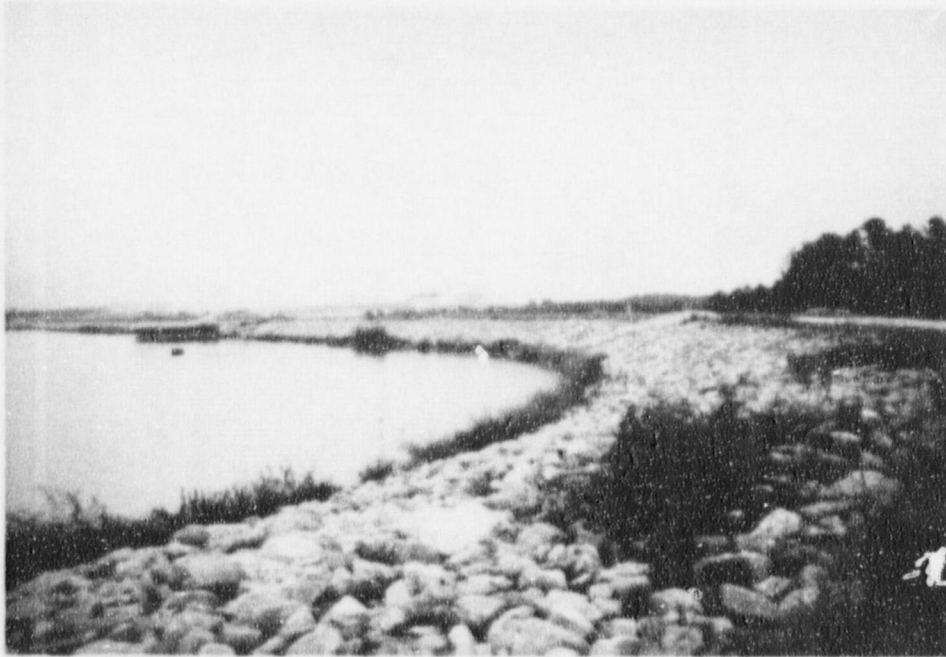
Photograph 4

View of the upstream slope near the center of the dam. Note the vegetation in the riprap.

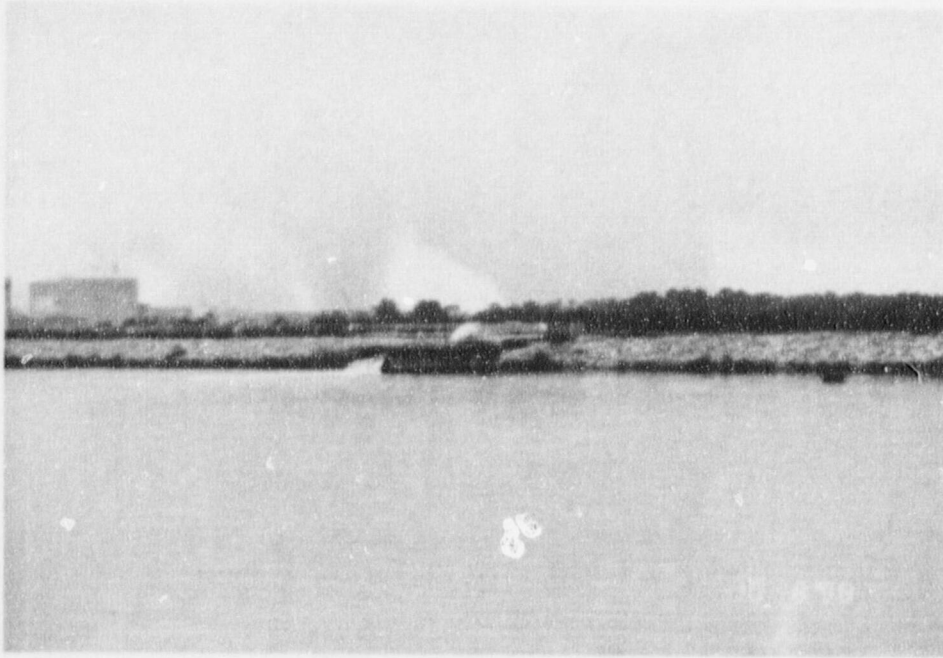
Photograph 5

c. Other Structures. Other structures observed during the course of the inspection included the pond fill discharge (Photographs 5 and 6), the service water intake, the service water return, and the river intake (Photograph 14). No conditions were observed during the inspection that would indicate the need for remedial action, although some routine maintenance such as painting of the steel walkway and handrails at the pond fill discharge was needed.

View of the pond fill discharge structure as seen from the top of the dam on the south side of the pond.

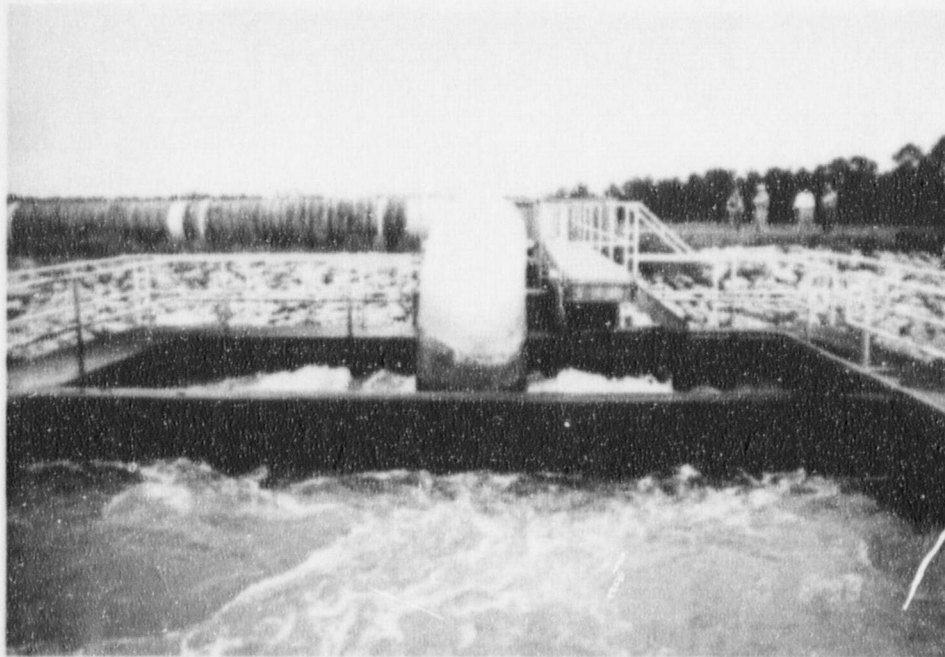
Photograph 6

View of the pond fill discharge structure as seen from the walkway on the pond side of the structure.

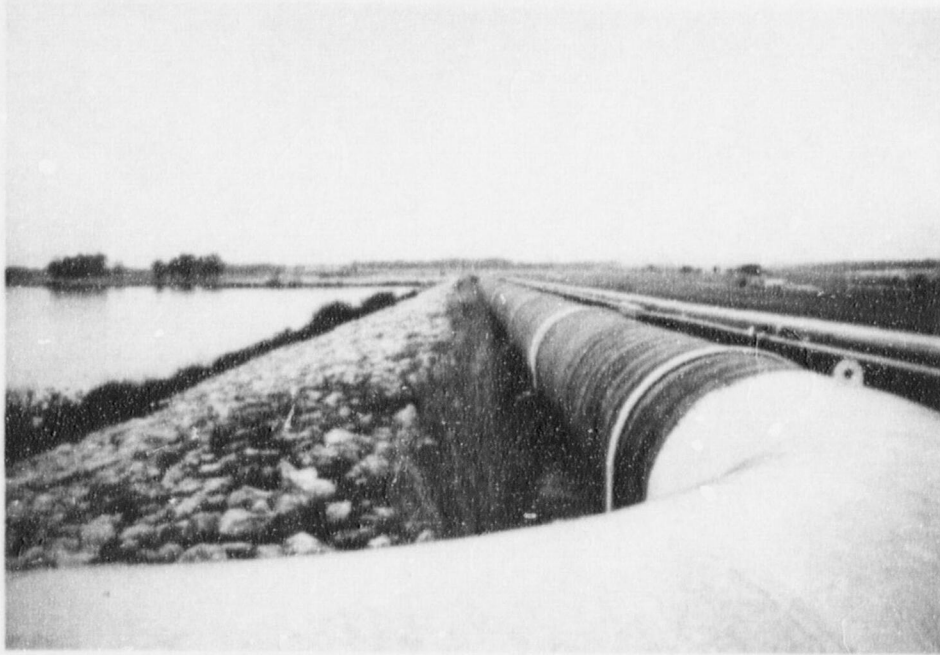
Photograph 7

The water intake pipe and concrete wall along the top of the dam (Photograph 7) were straight and well aligned. Misalignment of these structures can be indicators of shifting or movement in the supporting earth dam. The water intake pipe is a potential source of leaks that could cause erosion of the upstream slope of the earth dam. Ideally, the pipe should be relocated to eliminate this potential hazard. Since the pipe is installed along the top of the dam, it should be inspected for leaks on a regular basis (no less than weekly). The concrete wall protects the intake pipe from traffic on the crest of the dam and would serve to redirect flow into the reservoir from any pipe leak. Previous inspections expressed concern over loss or deterioration of joint material at construction joints in the wall. The joints in the wall are inspected and repaired in accordance with routine inspection and maintenance procedures. Drains at the base of the wall allow rainfall runoff from the crest of the dam to pass through the wall and into the reservoir.

Pipeline to the pond fill discharge structure looking toward the left (north) abutment. Note the undesirable vegetation in the riprap.

Following the inspection, Mr. Dan Rom, of NRC, was advised that the water supply pipe along the top of the dam is a potential source of leakage that could cause erosion of the earth dam. If the pipe cannot be relocated, it should be inspected for leaks at intervals no greater than one week.

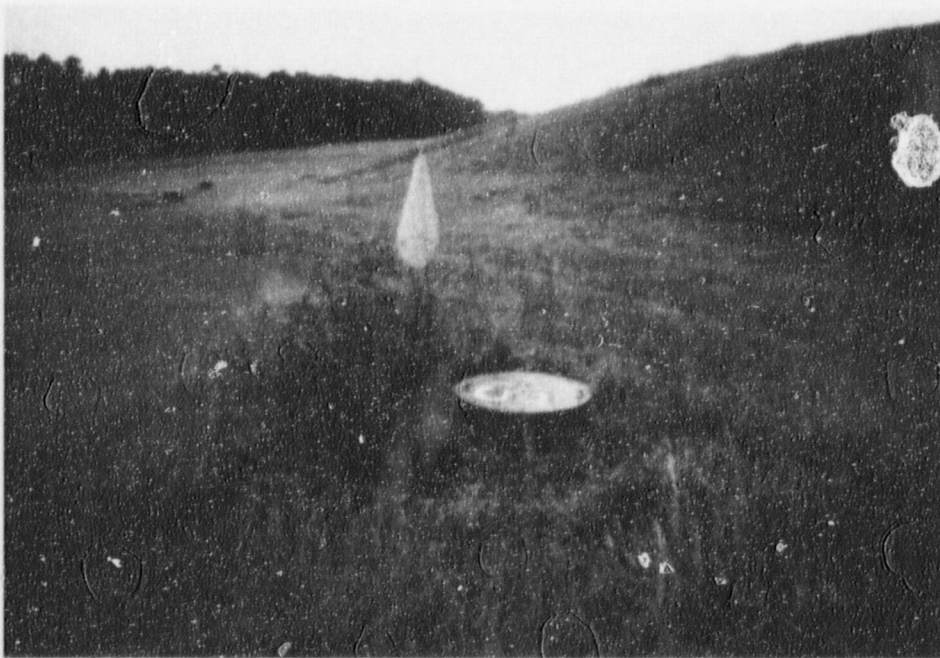
Photograph 8

Manhole for pressure relief well No. 15. The flag warns mower operators of the location of the manhole.

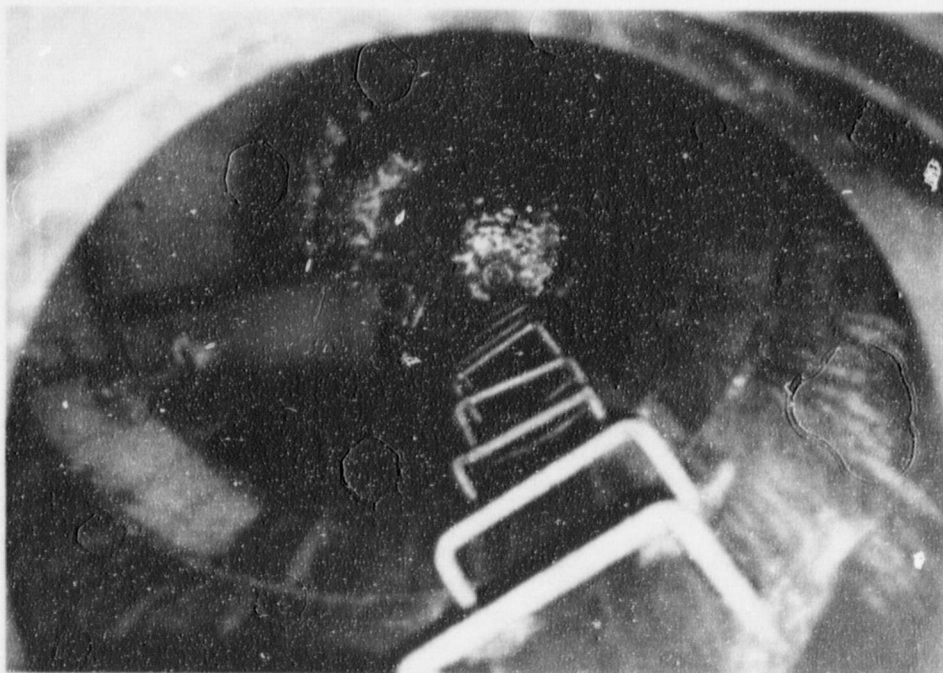
Photograph 9

Inside of relief well No. 15. Effluent from the well flows into a horizontal pipe which connects to an underground collection system.

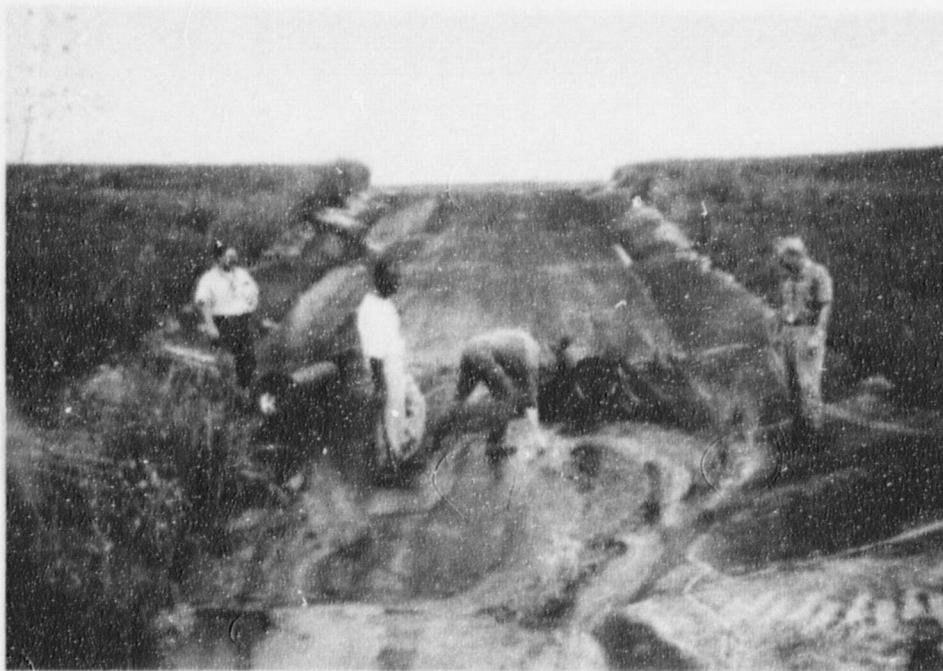
Photograph 10

Outlet for the relief well collection system.

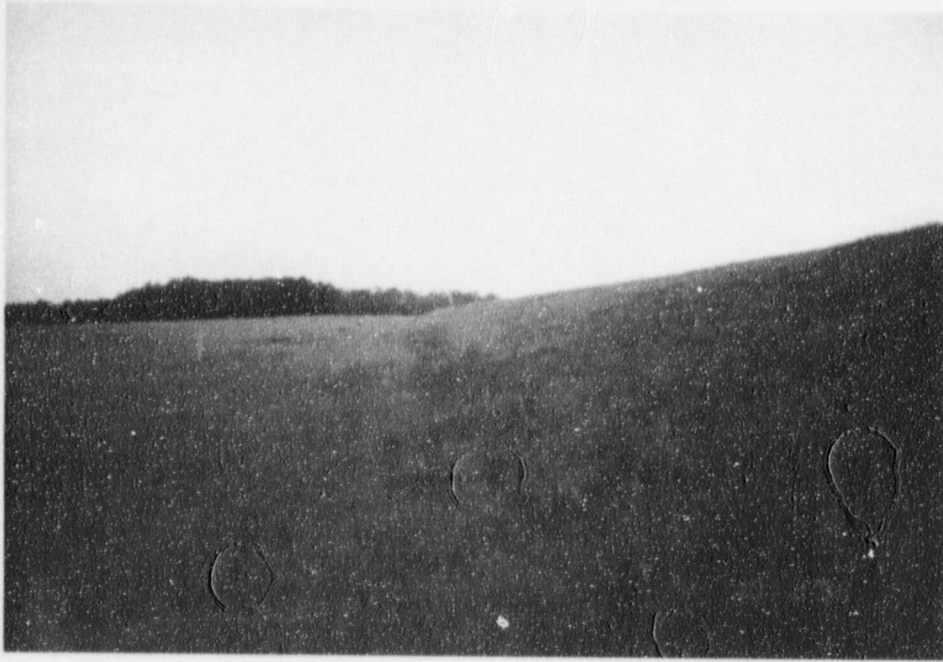
Photograph 11

and found the area to be wet. This indicates the presence of seepage through the dam. The area should be kept under observation during routine inspections. Any change in the condition of the areas should be noted.

View of the downstream slope of the dam from near the left (north) abutment. Note the well established grass cover.

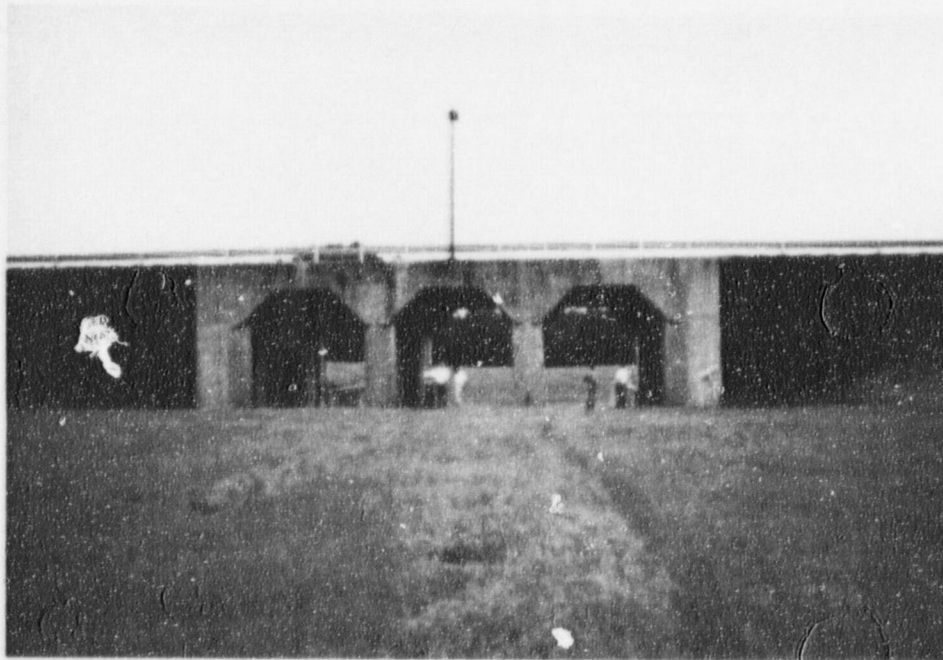
Photograph 12

b. Spillway Structure. The spillway structure (Photographs 12 and 13) is a reinforced concrete, uncontrolled, three bay, drop type structure located northwest of the pond under the main entrance road to the Farley Nuclear Plant. The structure has relief wells equipped with flap valves in the floor to relieve hydrostatic pressure. The spillway channel connecting the pond to the drop structure is a large excavated ditch with grass lined,

Upstream side of the spillway drop structure. Note the steel sheet pile walls.

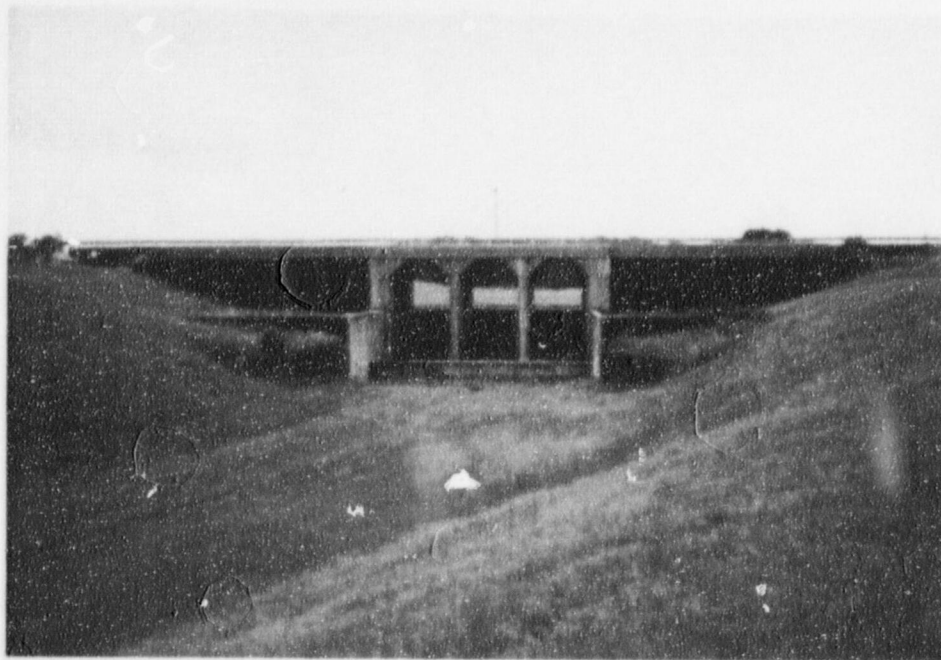
Photograph 13

Downstream side of the spillway drop structure. Note the steel sheet pile walls along the roadway and at the structure wingwalls.

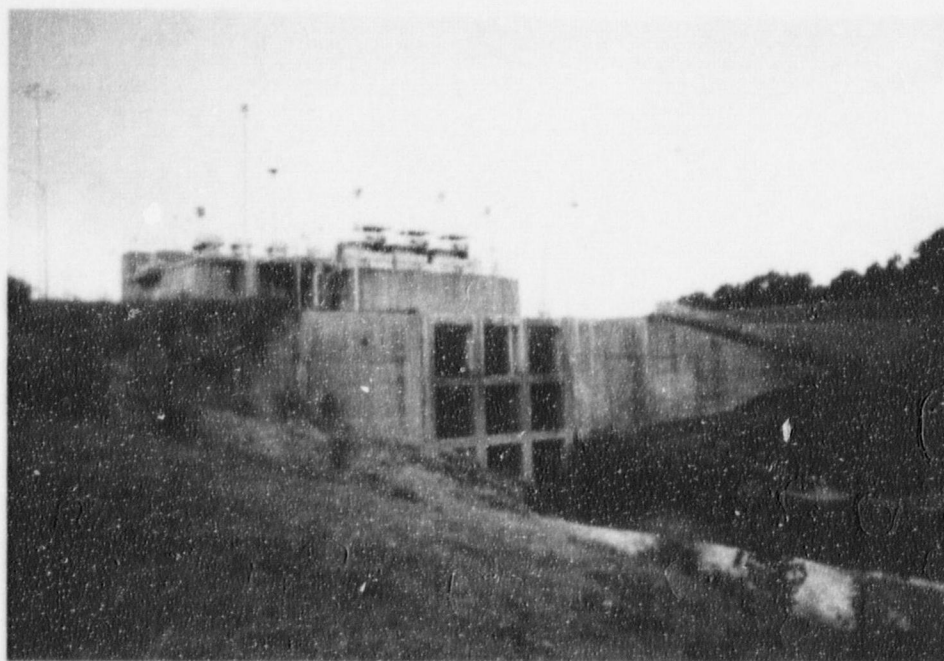
Photograph 14

River intake structure located on the Chattahoochee River.
