**Arizona Nuclear Power Project**

Subject: **Final Report - DER 86-23**  
A 50.55(e) and 10CFR21 Condition Relating to the Failed ASTM A540  
Grade B24 Class 1 Nut  
File: 86-006-216; D.4.33.2

FINAL REPORT - DER 86-23  
DEFICIENCY EVALUATION 50.55(e)  
ARIZONA NUCLEAR POWER PROJECT (ANPP)  
PVNGS UNITS 1, 2, 3

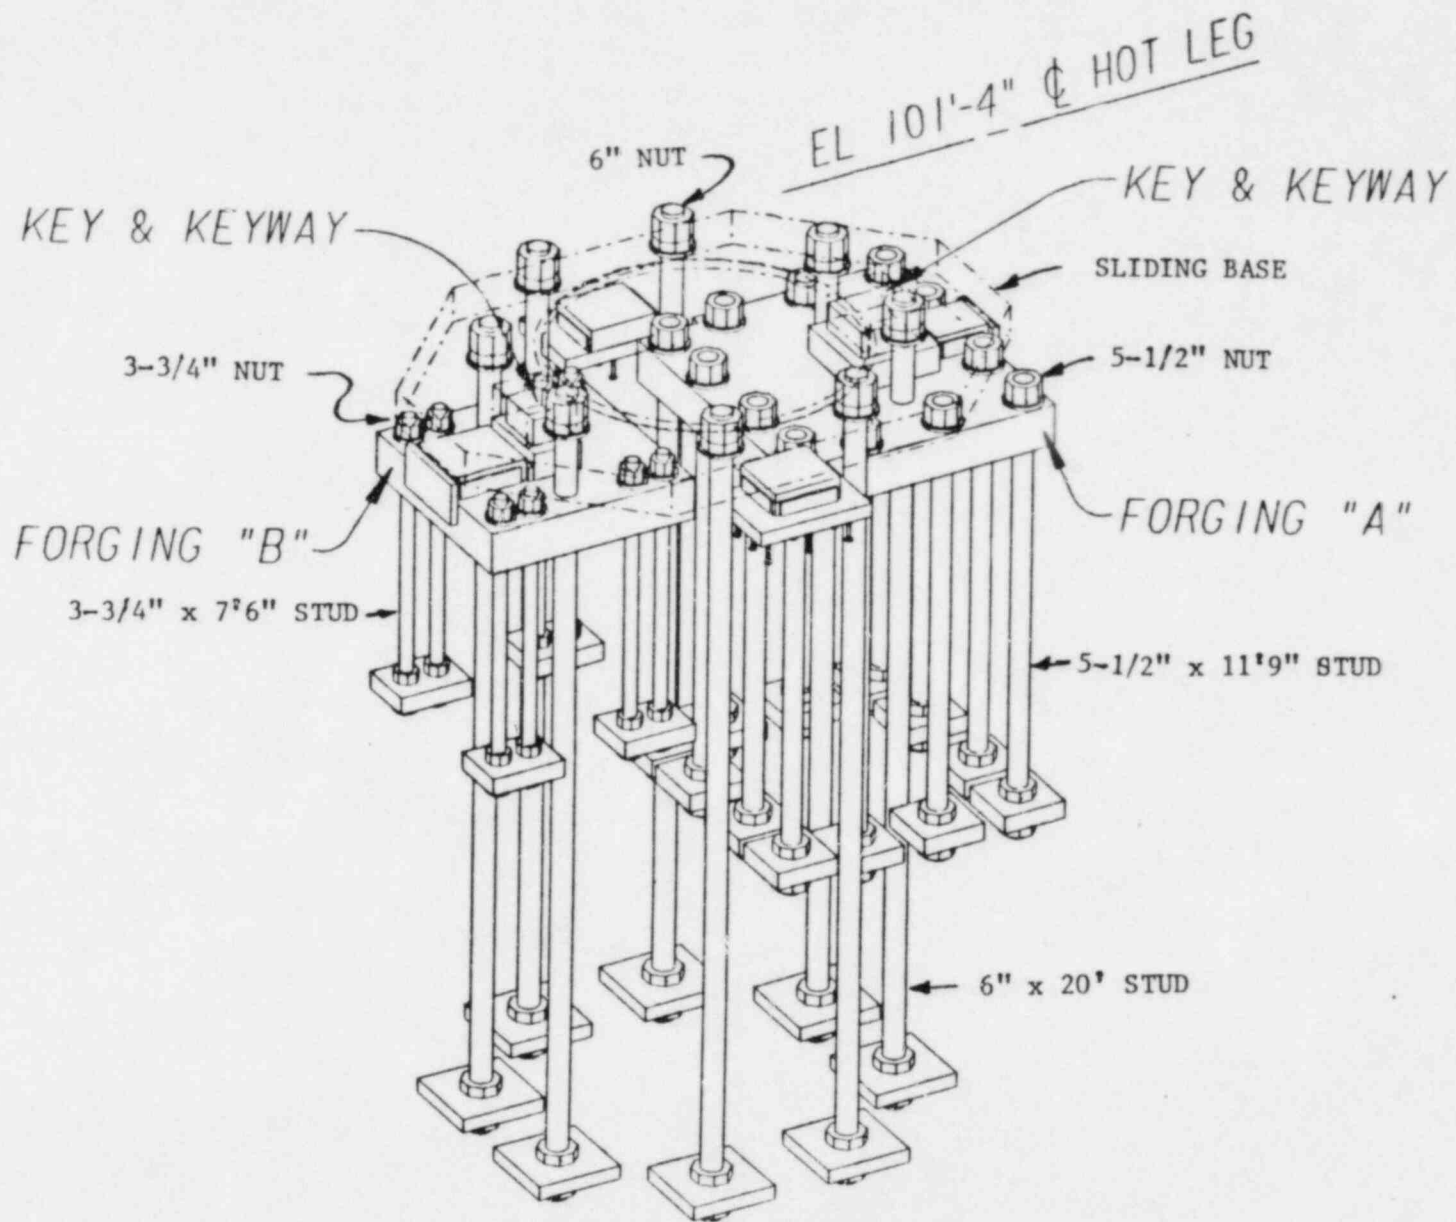
FIGURE 1

The steam generator lower support is composed of two 12 inch thick forgings which resist lateral loads, four vertical support pads to resist downward compressive loads and eight 6 inch diameter anchor bolts to resist uplift forces. The larger of the two forgings of the steam generator lower support is designated as forging "A"; the smaller as forging "B". Forging "A" serves as a key to resist the translational forces transmitted by the steam generator sliding base when the steam generator is subjected to pipe break and seismic loads. Details of the steam generator lower support are shown in Figure 1.

STEAM GENERATOR SLIDING BASE  
EMBEDS
