SUBJECT: REVIEW OF PRELIMINARY ACCIDENT SEQUENCE PRECURSOR ANALYSIS
OF OPERATIONAL CONDITION AT SEABROOK

LER No. 443/96-003

Event Description: Turbine-driven emergency feedwater pump unavailable because of a mechanical seal failure

Plant: Seabrook

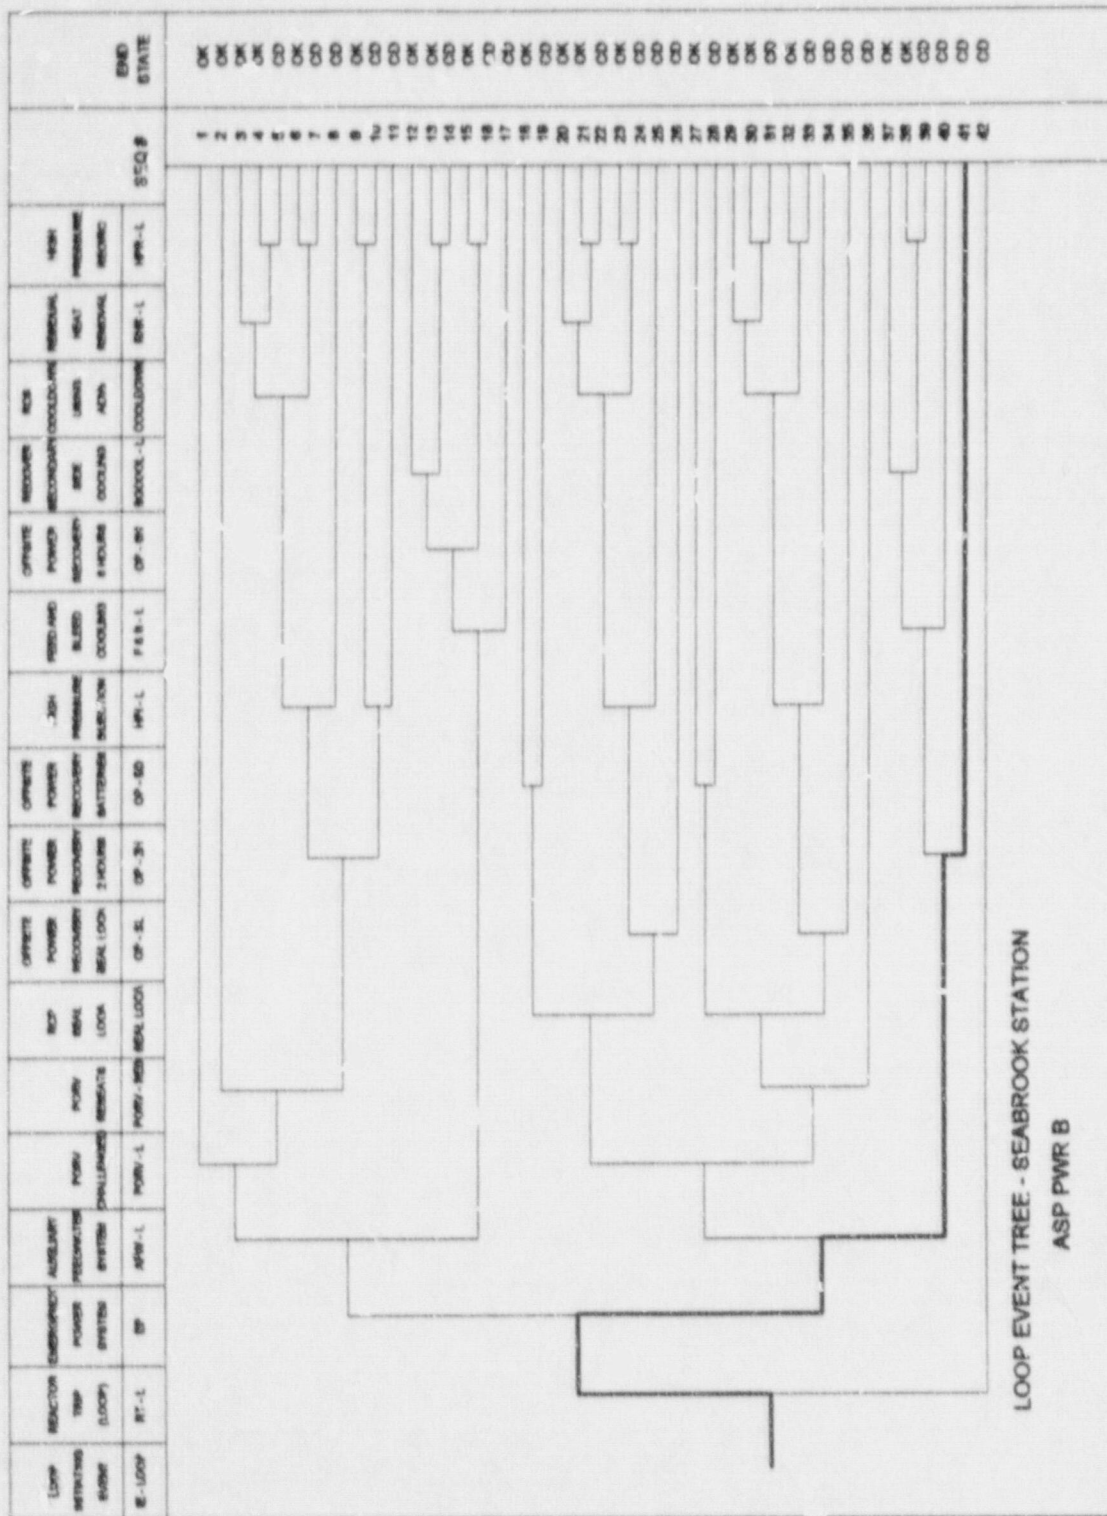
Fig. 1 Dominant core damage sequence for LER No. 443/96-003.

The increase in the CDP during a 3,875-h period for this event is 4.6×10^{-5} . The nominal CDP for the same period is 3.0×10^{-5} . This is a conservative estimate because the TDEFW pump was satisfactorily tested twice (a total run time of ~1-2 h) during the unavailability period (3,875 h). Therefore, the TDEFW pump likely would have operated for a limited period (less than the mission time of 24 h) during the first part of the unavailability period, which would mitigate the calculated CDP. The dominant core damage sequence for this event (sequence 41 on Fig. 1) involves

- a postulated LOOP,
- a successful reactor trip,
- a failure of emergency power,
- a failure of emergency feedwater, and
- a failure to restore electric power prior to steam generator dry out.

This SBO sequence (sequence 41 on Fig. 1) accounts for 56% of the total contribution to the increase in the CDP. The next most dominant sequence (sequence 17 on Fig. 1) contributes 22% to the total increase in the CDP. This sequence involves a LOOP with the success of emergency power, a failure of EFW, and a failure of feed-and-bleed decay heat removal.
