FACILITY NAME (1) **San Onofre Nuclear Generating Station (SONGS) Unit 2** Docket Number (2) **05000-361** Page (3) **1 of 7**

TITLE (4): **Inadequate CREACUS boundary control during HVAC component maintenance.**

EVENT DATE (5)			LER NUMBER (6)			REPORT DATE			OTHER FACILITIES INVOLVED (8)	
MONTH	DAY	YEAR	YEAR	SEQUENTIAL NUMBER	REVISION NUMBER	MONTH	DAY	YEAR	FACILITY NAME	DOCKET NUMBER
11	09	1998	1998	-- 024 --	00	12	9	1998	SONGS Unit 3	05000-362
									FACILITY NAME	DOCKET NUMBER

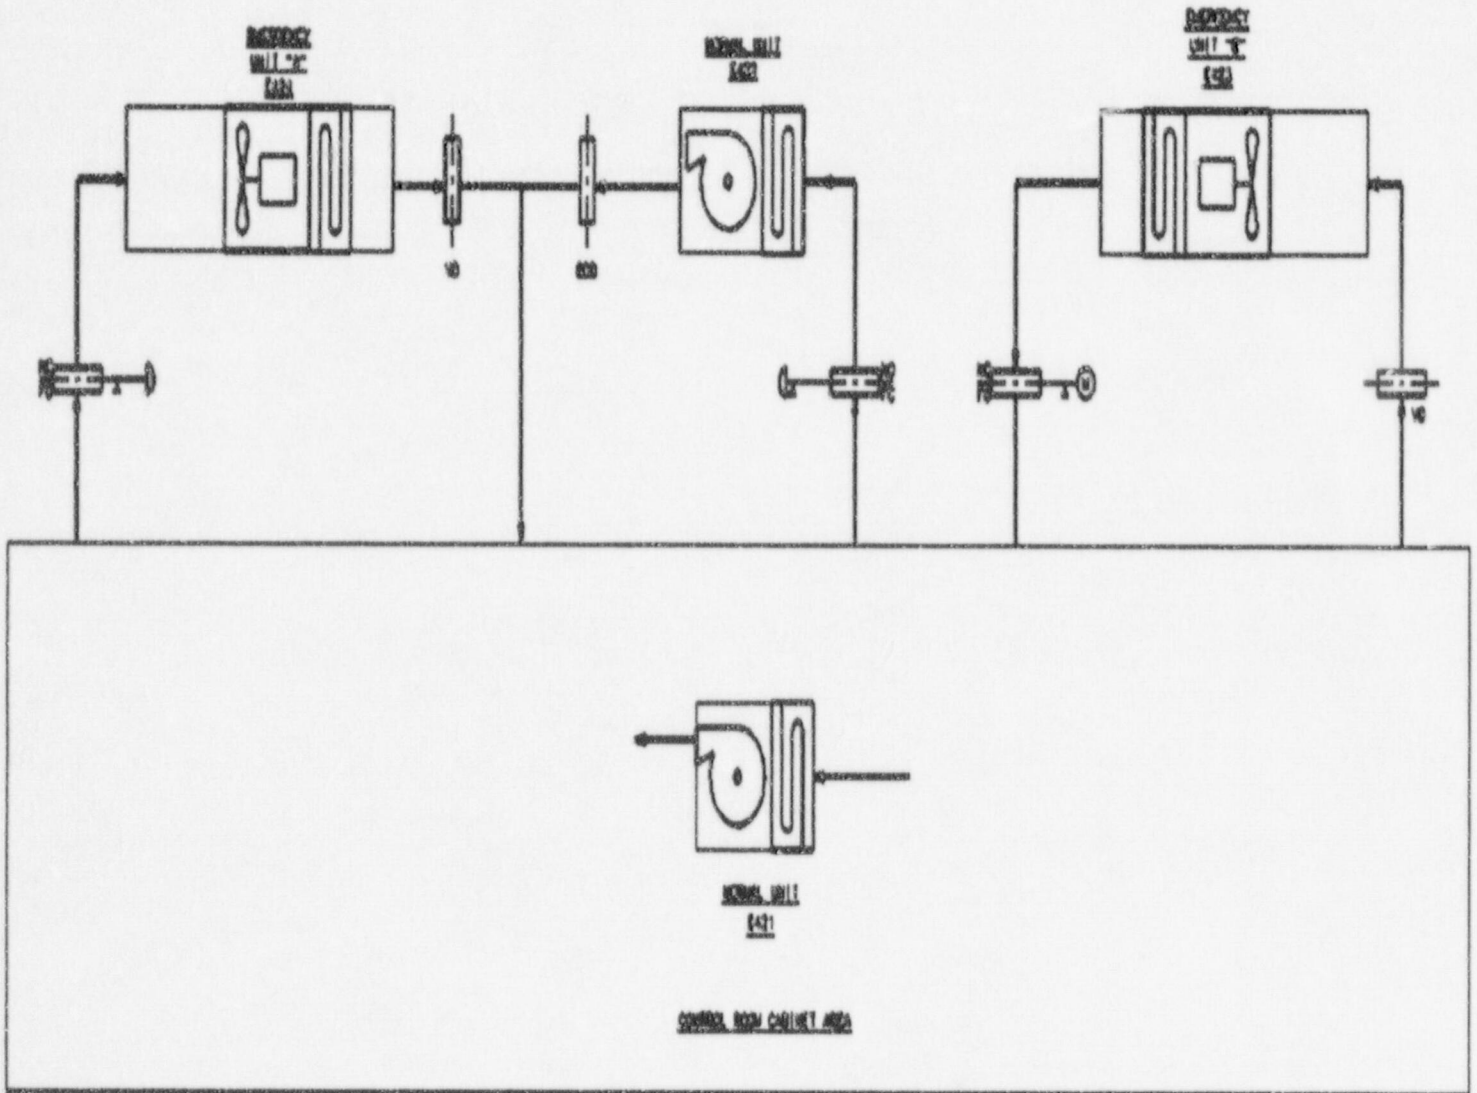
Figure 1

The Unit 2 and 3 control room cabinet areas have additional cooling provided by the emergency cabinet cooler units. The cabinet area emergency cooling units also start on a CRIS or TGIS. As illustrated on figure 1 and 1A, the air in each cabinet area (four zones, Unit 2 and 3) is recirculated through an automatic isolation damper for each fan, a cooling unit and a backdraft damper. Each cabinet area is provided with a normal stand-by cooling unit for recirculating air if the temperature increases above 75 degrees Fahrenheit. This unit is located inside the cabinet area and will not affect the control room complex boundary.

On April 24, 1998, SCE recognized that the train A emergency cabinet cooler, shown on the Piping and Instrumentation Diagram (P&ID) drawing, was a volume damper (DMP) rather than backdraft damper (UDMP) and is fixed in the throttled open position. On November 9, 1998, while processing a drawing and Repetitive Maintenance Order change, the Train B emergency cabinet cooler was also discovered with the same condition.

When the cabinet cooler (FCU) duct access hatches are opened, a hole is created in the CREACUS boundary from the 50 foot elevation to the Control Room Cabinet Area. As noted above, a hole greater than 50 square inches would prevent a single emergency makeup fan to achieve the required 0.125 inches of water gauge positive pressure in the control room. Various equipment maintenance and inspection activities between 1985 and 1998 opened the control room normal and emergency cabinet coolers access hatches without recognizing the impact on the CREACUS boundary.

Plant drawings will be updated to show the installed damper configurations. This is scheduled to be completed by January 15, 1999.
