U.S. NUCLEAR REGULATORY COMMISSION  
REGION I

Report No. 86-01

Facility Name: Brandhurst Incorporated

Inspection Conducted: March 11 and 14, 1986

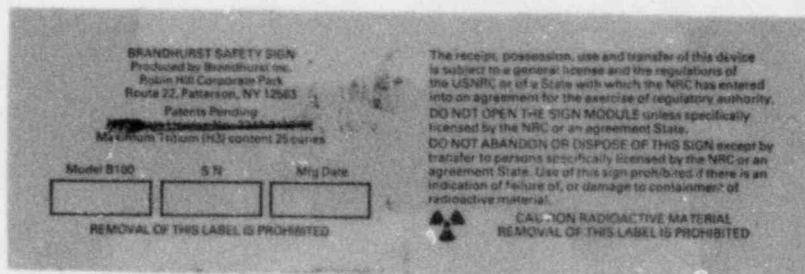
Attachment No. 01  
Combined Report Nos. 030-22096/86-01 and 030-22097/86-01

The inspectors noted that the labels on 10 signs observed had the licensee's former license number.

Please note that the above labels on the Tritium light signs observed by the inspection had the 87 Sand Pit Road, Danbury, Connecticut address along with previous NRC License No. 31-20726-02G. The above are examples of labeling used.

A licensee representative stated that signs with the current license number were on order and the new labels would be used as soon as possible.
