RADIATION SURVEY REPORT  
BML No. 53-00458-05  
Tripler Army Medical Center, Hawaii 96859

c. Reason for survey. Installation of new Cobalt-60 Source on 30 November 1982.

a. Name, Model No., and Serial No. of teletherapy unit: Atomic Energy of Canada Limited (AECL), Theratron-80, Serial No. 336.

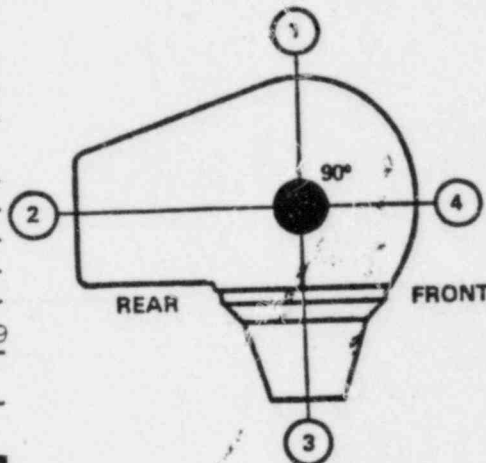
View A-Vertical  
from left side

Position No.	Radiation level (mr/hr)
View A	1 2.0
	2 1.1
	3 3.5
	4 7.2
View B	5 1.2
	6 1.8
	7 0.7
	8 0.4
View C	9 2.0
	10 1.9
View D	11 0.4
	12 0.5
	13 2.1
	14 1.4
Average value	1.87 $\approx$ 1.9
Maximum value	7.2

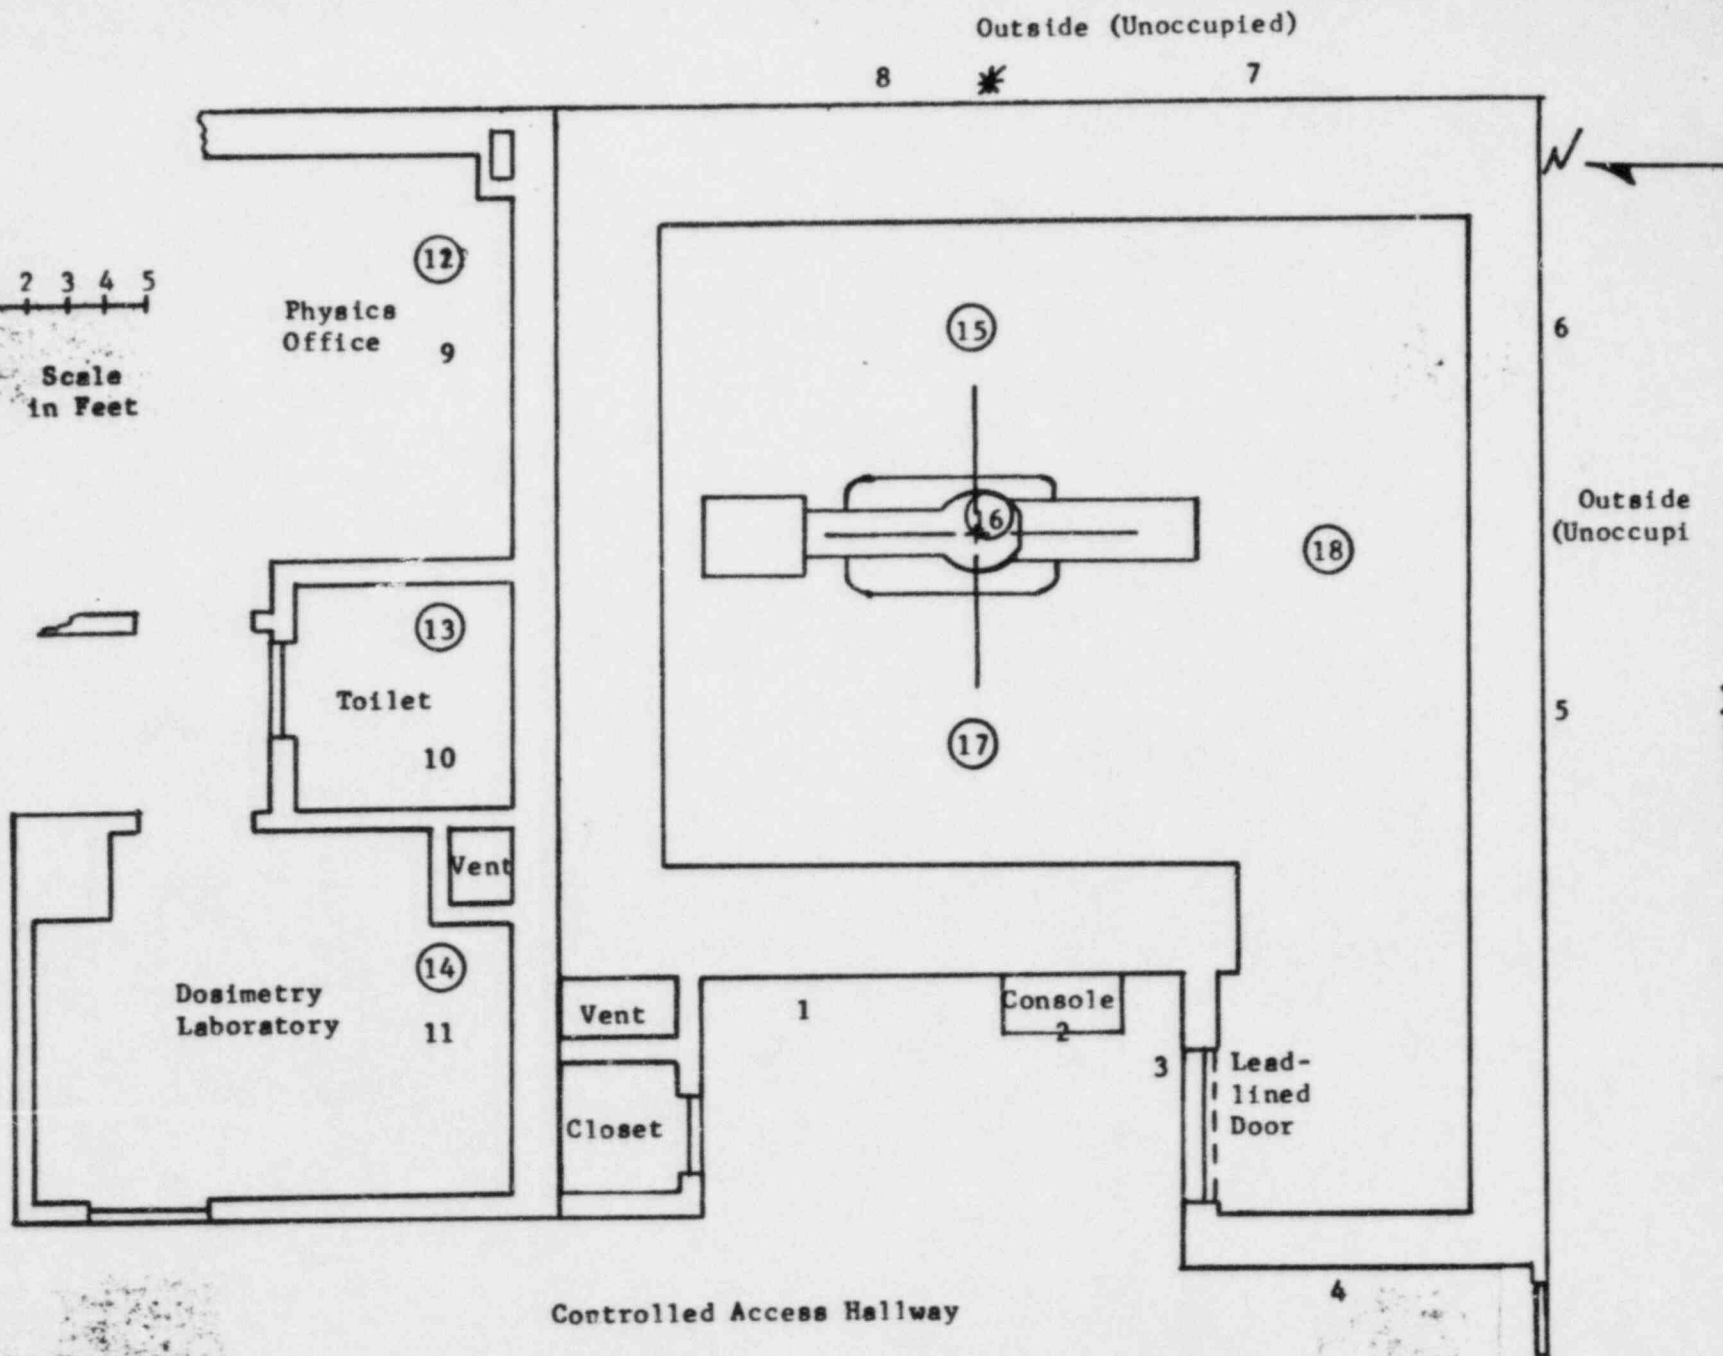
FIGURE 2. Therapy Facility Floorplan and Exposure Measurement Locations  
(Circled location numbers refer to locations on the second floor/roof).

e. The highest exposure measurements were obtained during Run No. 6 at a position outside the east wall of the teletherapy exposure room at a distance of approximately five feet from ground level and extending approximately two feet to either side of that point. The exposure measurements were 10.5 mR/hr at a distance of two feet and 0.3 mR/hr at a distance of five meters from the wall. All other exposure rate measurements are well below the limits specified in paragraphs 20.105(b) (1) and (2) of Title 10 CFR.

\* Highest exposure rate - Run #6

f. The area immediately outside the east wall of the teletherapy exposure room is a unoccupied area and will remain so for the foreseeable future. If a beam configuration as described in paragraph 6c above is required a "Radiation Area" as described in paragraph 20.202(b2) will be identified, roped off and properly posted to preclude personnel exposure during the therapy treatment.
