UNITED STATES
NUCLEAR REGULATORY COMMISSION
WASHINGTON, D. C. 20555

SUBJECT: OPERATING REACTORS EVENTS BRIEFING

OPERATING REACTORS EVENTS BRIEFING (85-12)

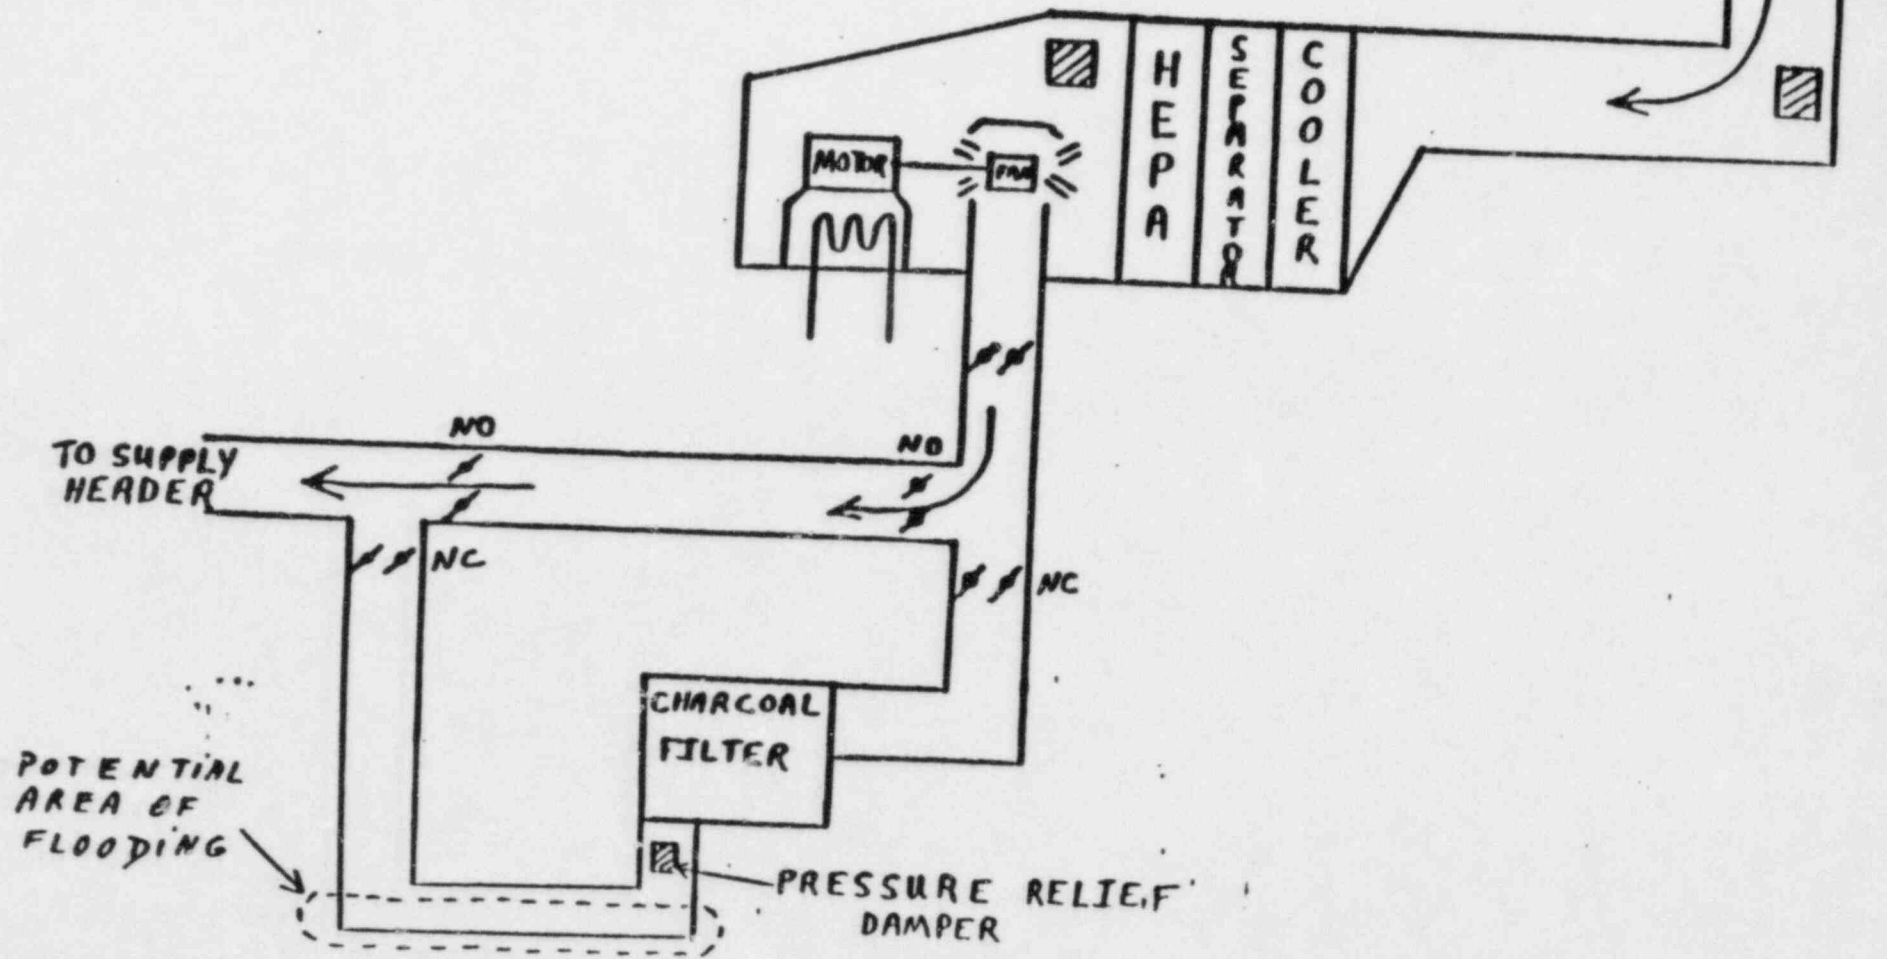
GINNA
REACTOR CONTAINMENT FAN COOLER
(SIMPLIFIED DIAGRAM)

- PROBLEM - PORTIONS OF CHARCOAL FILTER DISCHARGE DUCTS MAY FLOOD FOLLOWING A LOCA
- SAFETY SIGNIFICANCE - POTENTIAL LOSS OF 2 OF 4 FAN COOLER UNITS AND BOTH CHARCOAL FILTERS UNDER ACCIDENT CONDITIONS.
- PROBLEM DISCOVERED BY LICENSEE ANALYSIS, VERIFIED BY CONTAINMENT ENTRY.
- DESIGN DEFICIENCY HAS EXISTED FOR LIFE OF PLANT.
- CORRECTIVE ACTIONS - OPEN MANWAY AND PIN OPEN PRESSURE RELIEF DAMPERS IN DISCHARGE DUCT. MODIFICATION OF DUCTWORK IS BEING CONSIDERED AS A PERMANENT FIX.
- MAY BE PROPOSED TO AEOD AS AN ABNORMAL OCCURRENCE OR "OTHER EVENT OF INTEREST."

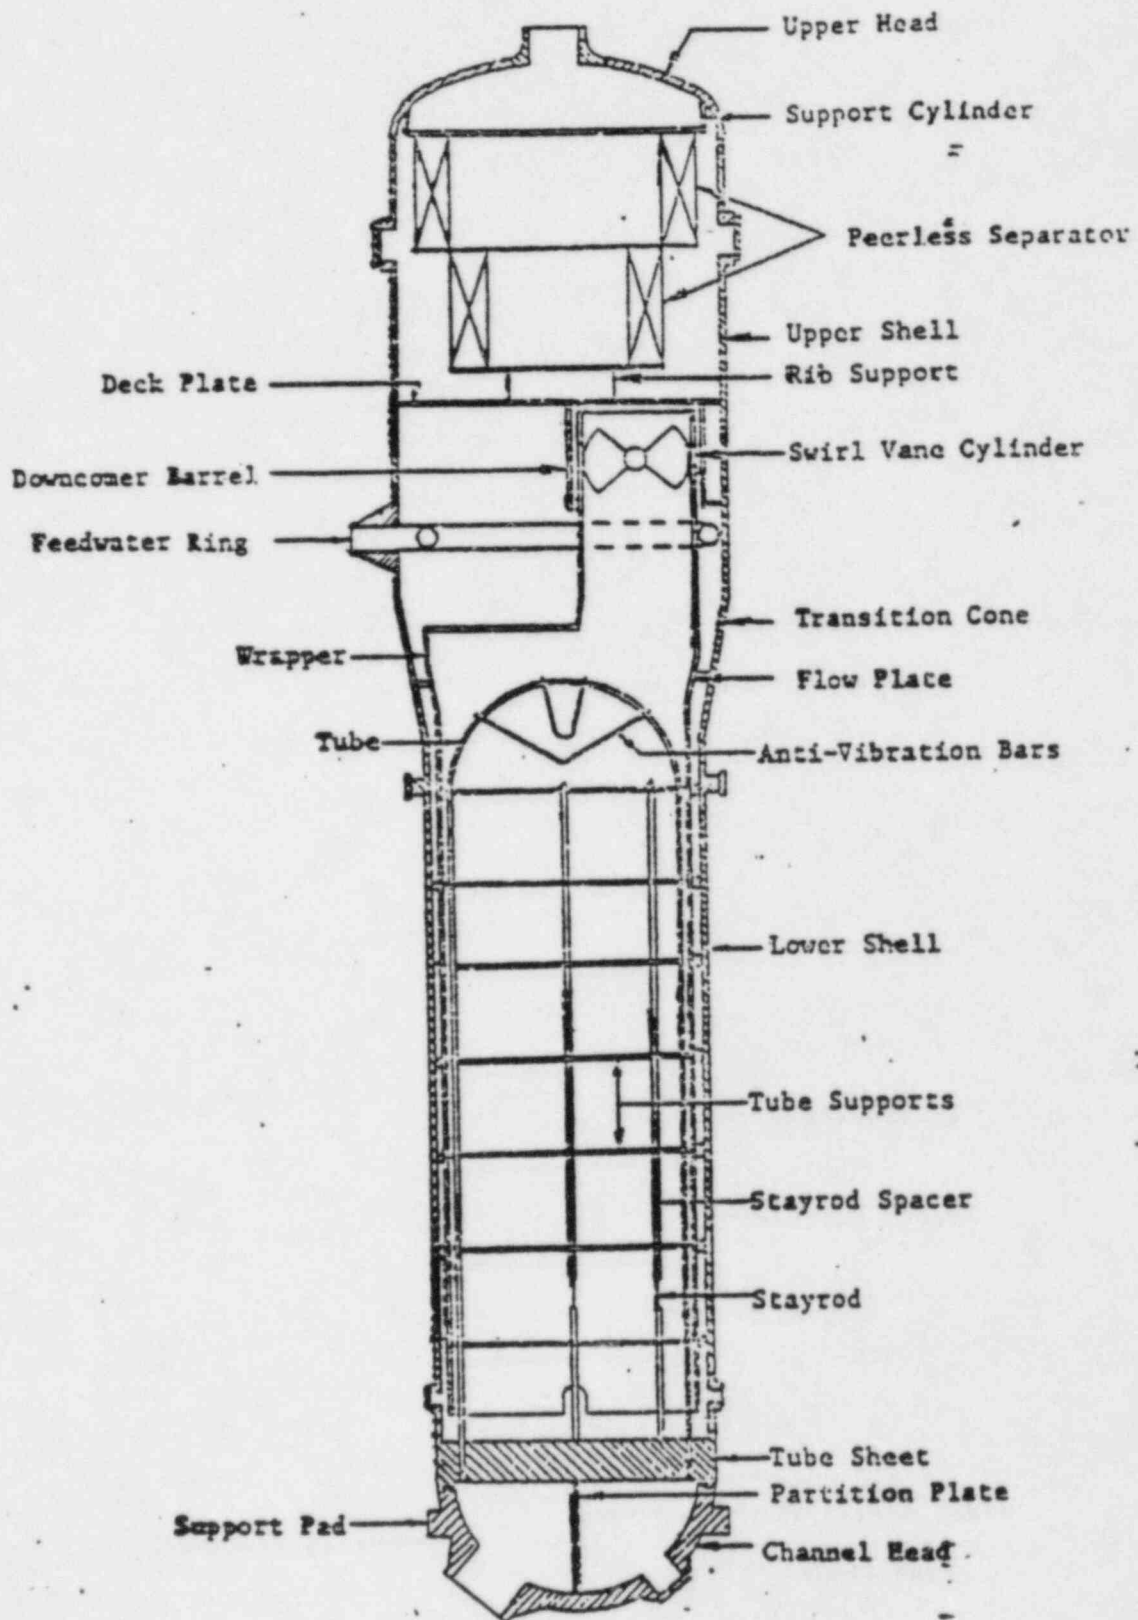
FIGURE 2.3-1
 SERIES 51 STEAM GENERATOR

- T.S. REQUIRES INSPECTIONS OF SG TRANSITION ZONE UPPER GIRTH WELDS

- INDICATIONS FOUND BY UT:
 - SG 31 - 1
 - SG 32 - 2
 - SG 33 - 0
 - SG 34 - 23

- SG-34 HAD WELD REPAIR IN 1983

- MT ON SG-34 SHOWED CLEAN ON 16 OF 23 INDICATIONS

- REMAINING 7 WELDS ON 34, AND 3 ON 31 AND 33 MAY NOT EXCEED CODE

- LICENSEE STILL INSPECTING AND EVALUATING
- *MAY RESOLVE BY FRACTURE MECHANICS*
- NRR HAS LEAD (SINCE 7/15/85)

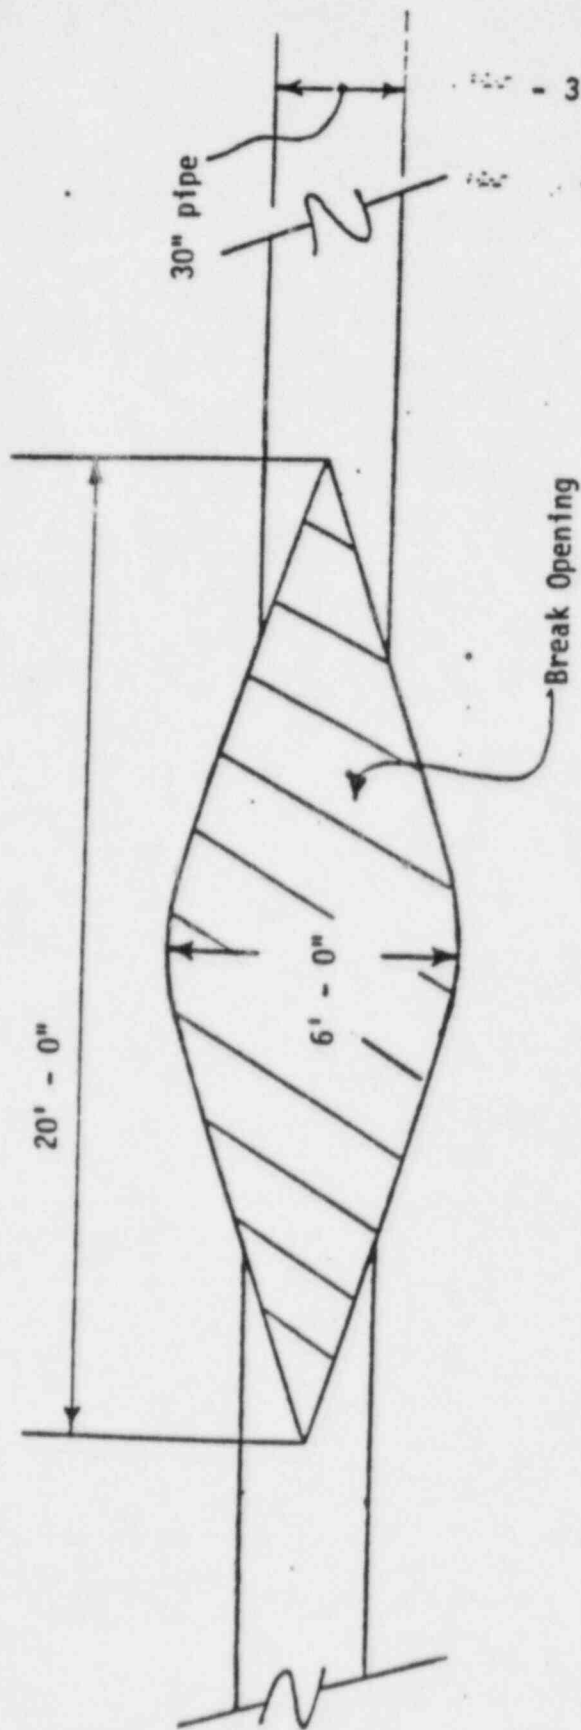
Figure 1 (A): Sketch of Mohave Pipe Rupture

- FAILURE OCCURRED JUNE 9, 1985 WHEN A 30" REHEAT LINE
SUDDENLY SPLIT LONGITUDINALLY

FRACTURE WAS FISH MOUTH RUPTURE APPROXIMATELY
20' x 6' FIG 1A & B

- DESIGNED TO B31.1 CODE FOR STEAM CONDITIONS OF 1000°F AND 600 PSIG
- CONSTRUCTION LATE 1960's COMMENCED OPERATION 1971
- FAILURE IN A HORIZONTAL SPOOL 30"-DIAMETER ROLLED AND WELDED OF A-378 C PLATE (1 1/4 CR-1/2 MO) TO MEET A-155 WELDED PIPE

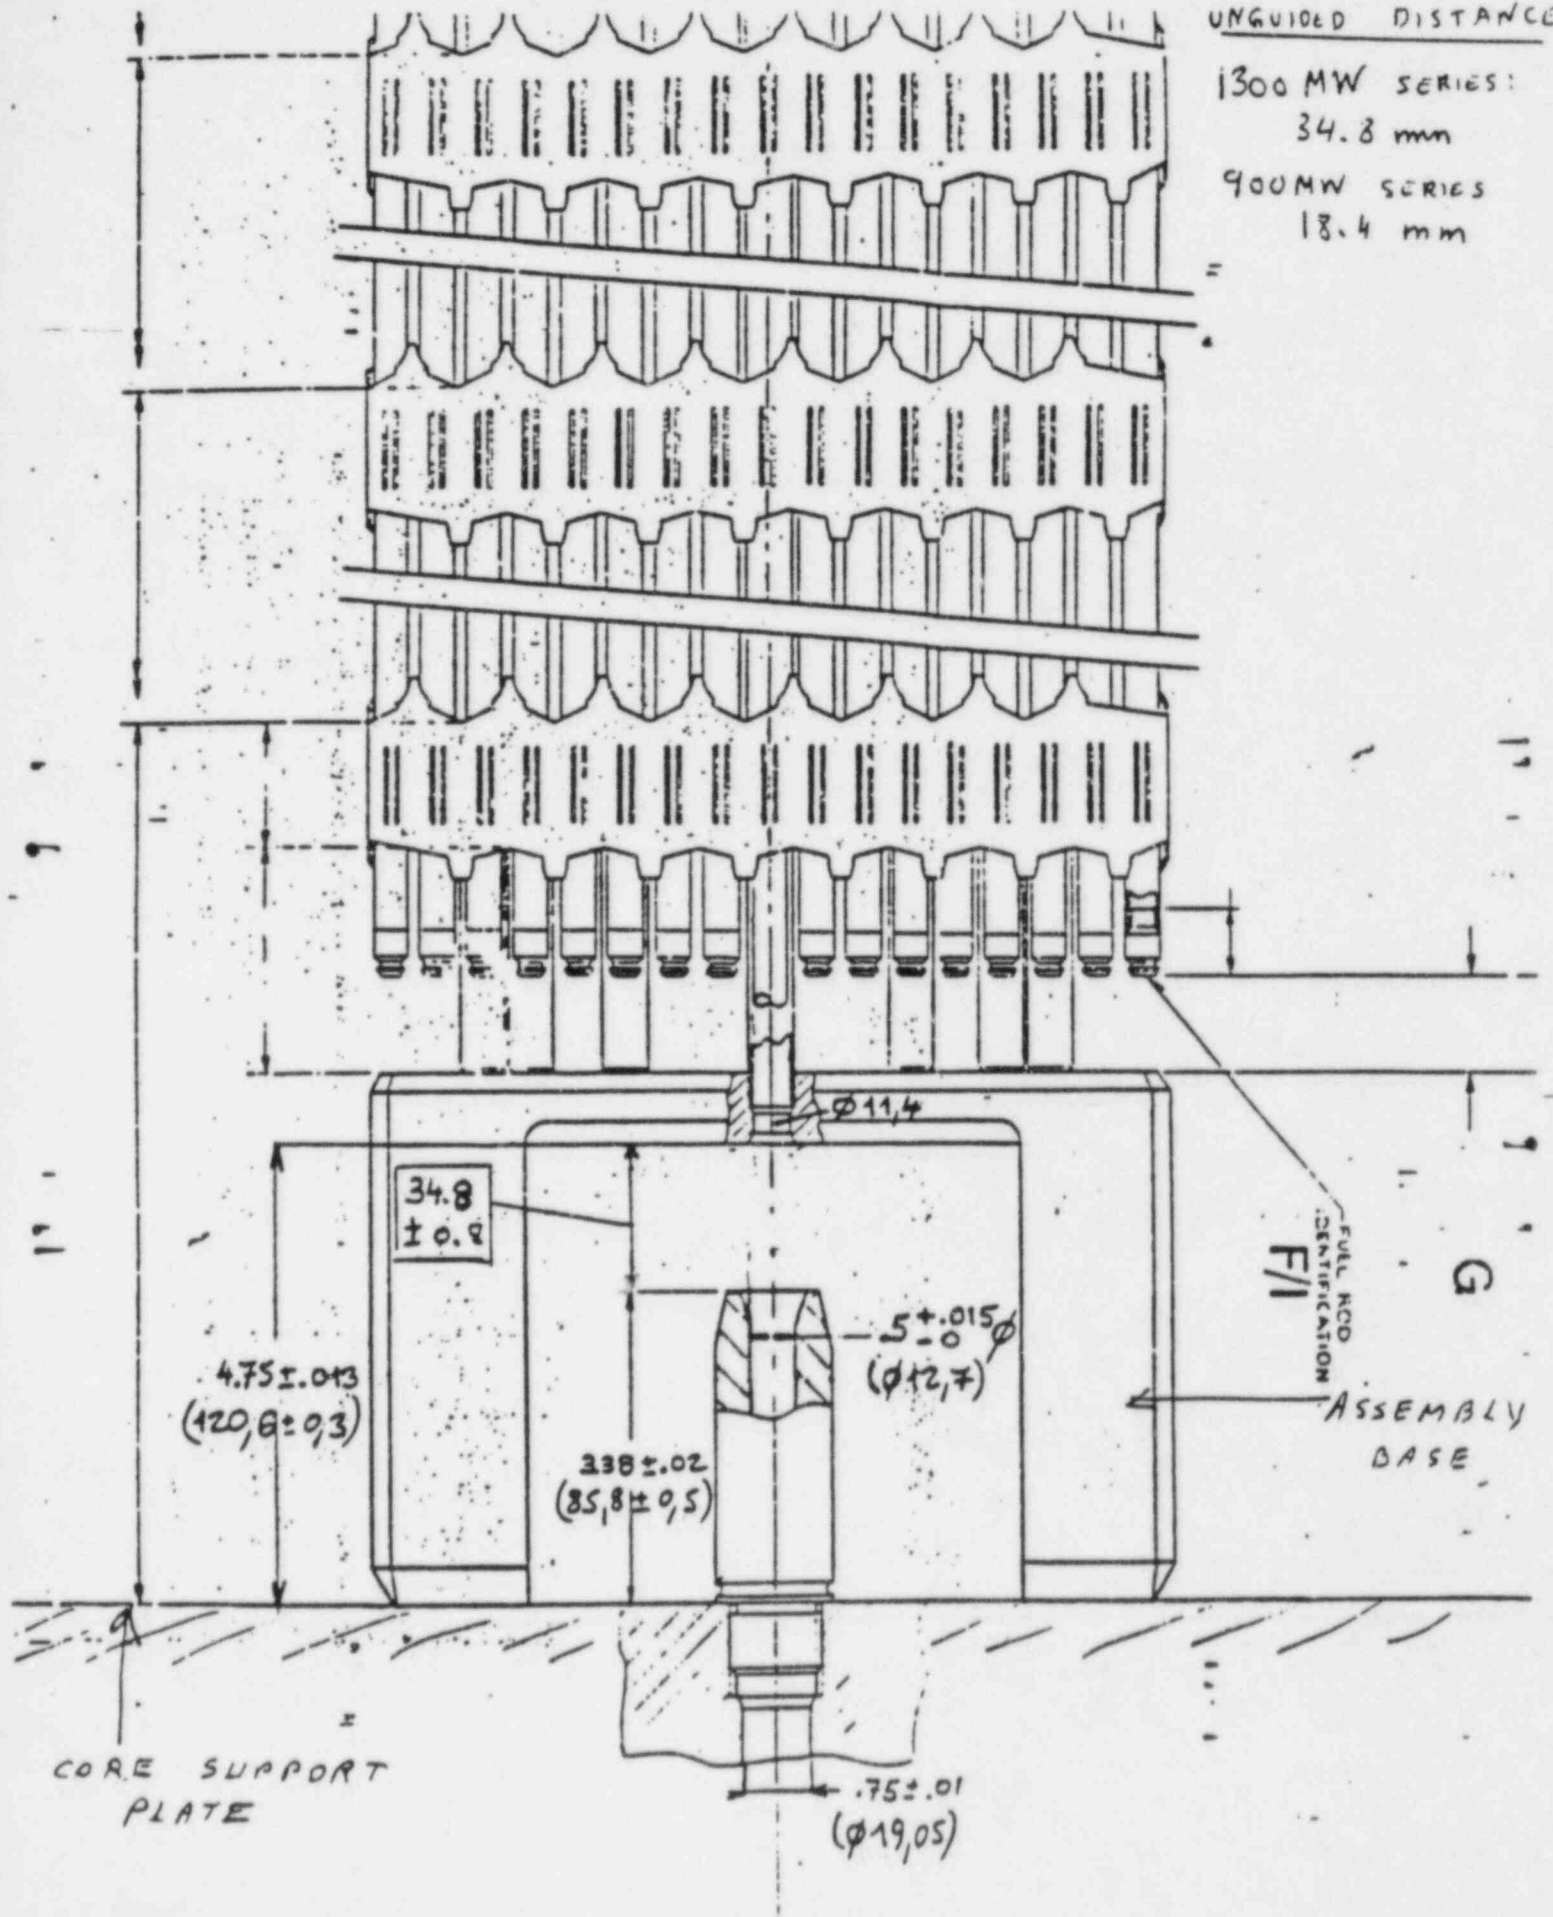
- SAFETY SIGNIFICANCE: REACTOR COOLANT LEAKS, OR: NO FLUX MAPS, POSSIBILITY OF MIGRANT OBJECTS.
- MAJOR POINTS:
 - DEFECTS (OR LEAKS) LOCATED AT DISCONTINUITY IN GUIDING STRUCTURE

- CAUSE THOUGHT TO BE HYDRAULIC EXCITATION DUE TO TURBULENCES IN THE CORE SUPPORT PLATE - BOTTOM OF FUEL ASSEMBLY REGION.
 - DIFFERENCES (FROM 900MWE SERIES) IN LOWER INTERNALS DESIGN AND MEASURED FLOW PARAMETERS SUPPORT THIS HYPOTHESIS.

UNGUIDED DISTANCE

1300 MW SERIES:

34.8 mm

900 MW SERIES

18.4 mm

LONG TERM: MODIFY THIMBLE GUIDING PIECES ON TOP
OF CORE SUPPORT PLATE FOR BETTER
PROTECTION, REDUCE TURBULENT FLOW
AROUND THIMBLES.
