# Rupture of Model 48Y UF<sub>6</sub> Cylinder and Release of Uranium Hexafluoride

Sequoyah Fuels Facility  
Gore, Oklahoma  
January 4, 1986

U.S. Nuclear Regulatory  
Commission

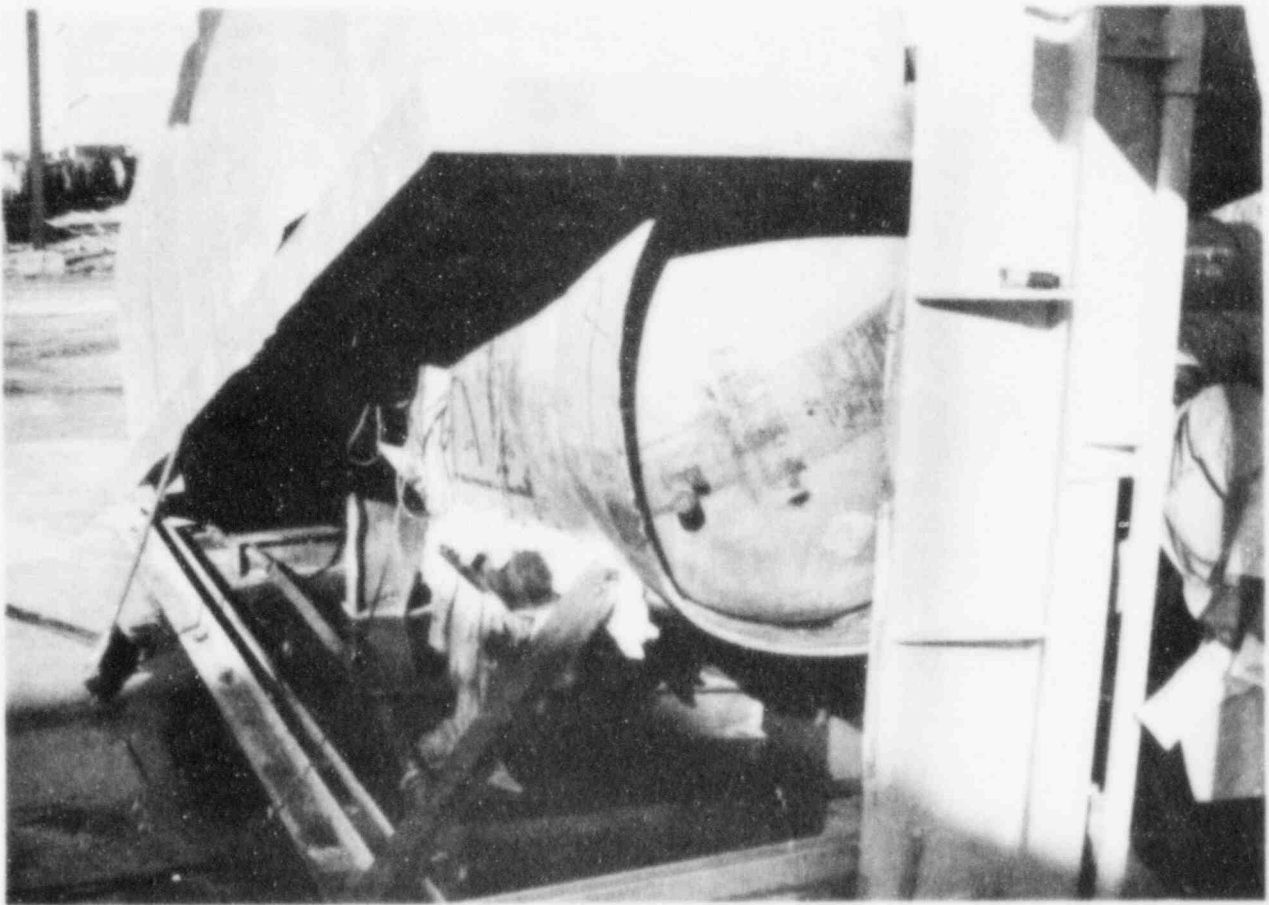
Figure 3.10 Ruptured cylinder

At approximately 11:30 a.m., the cylinder ruptures in the steam chest causing the cylinder to spin in its cradle. The 4-foot, lengthwise rupture which occurred along the top of the cylinder is oriented approximately 120 degrees from its

initial position after the cylinder comes to rest. The force of the explosion also ruptures the top of the steam chest enclosure. (See Figures 3.10 and 3.11.) Liquid  $UF_6$  flows from the rupture and rapidly reacts with moisture in the air to form uranyl fluoride ( $UO_2F_2$ ) and hydrofluoric acid (HF). The resulting vapor cloud is carried south by southeast by a wind gusting to 25 mph.

The ruptured cylinder, with its temporary rag plug in place, rests in the damaged steam chest. The fill valve, in the 8 o'clock position on the near end of the cylinder, was at 12 o'clock before the rupture occurred.

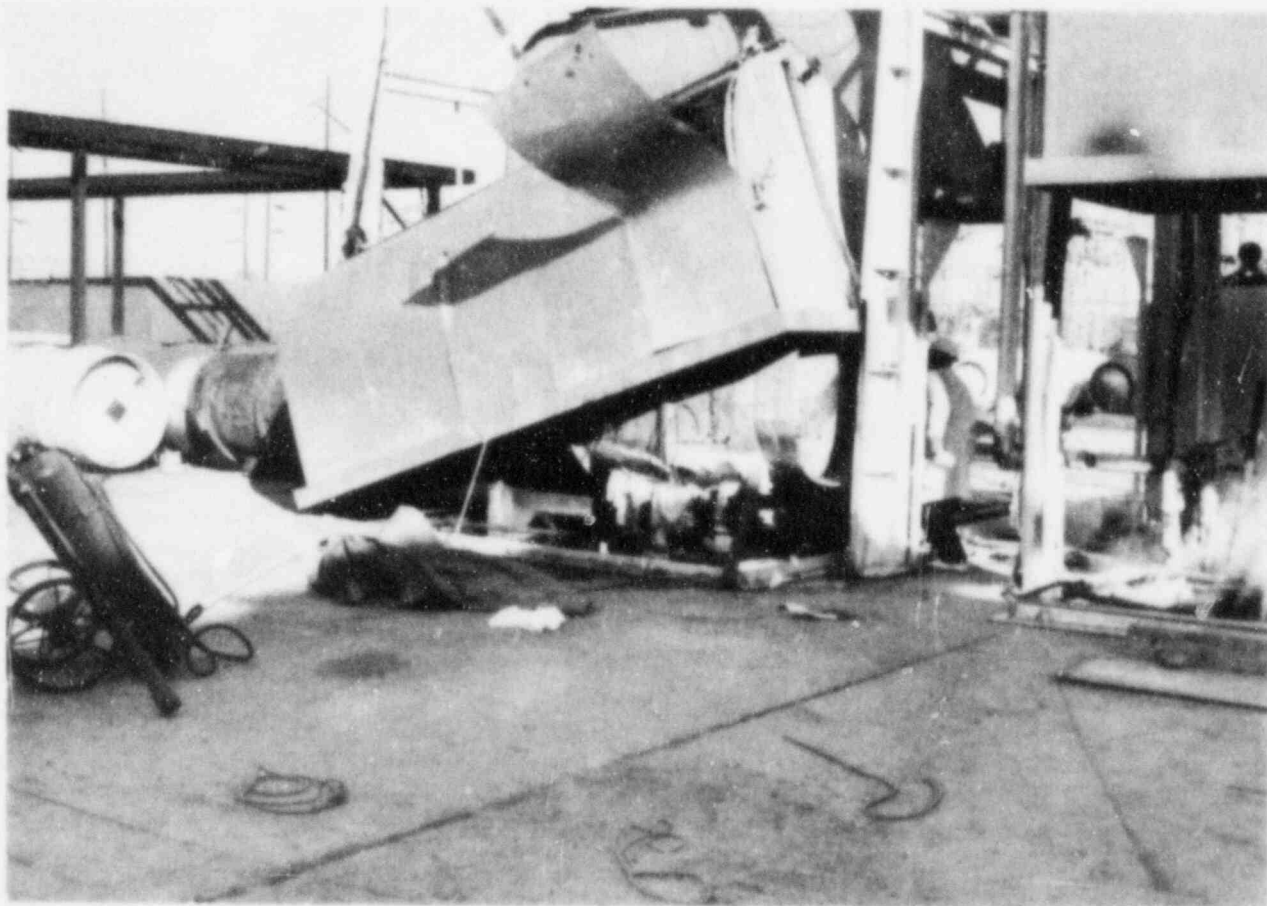
Figure 3.11 Damaged steam chest and cylinder

The force of the release caused damage to the steam chest cover.

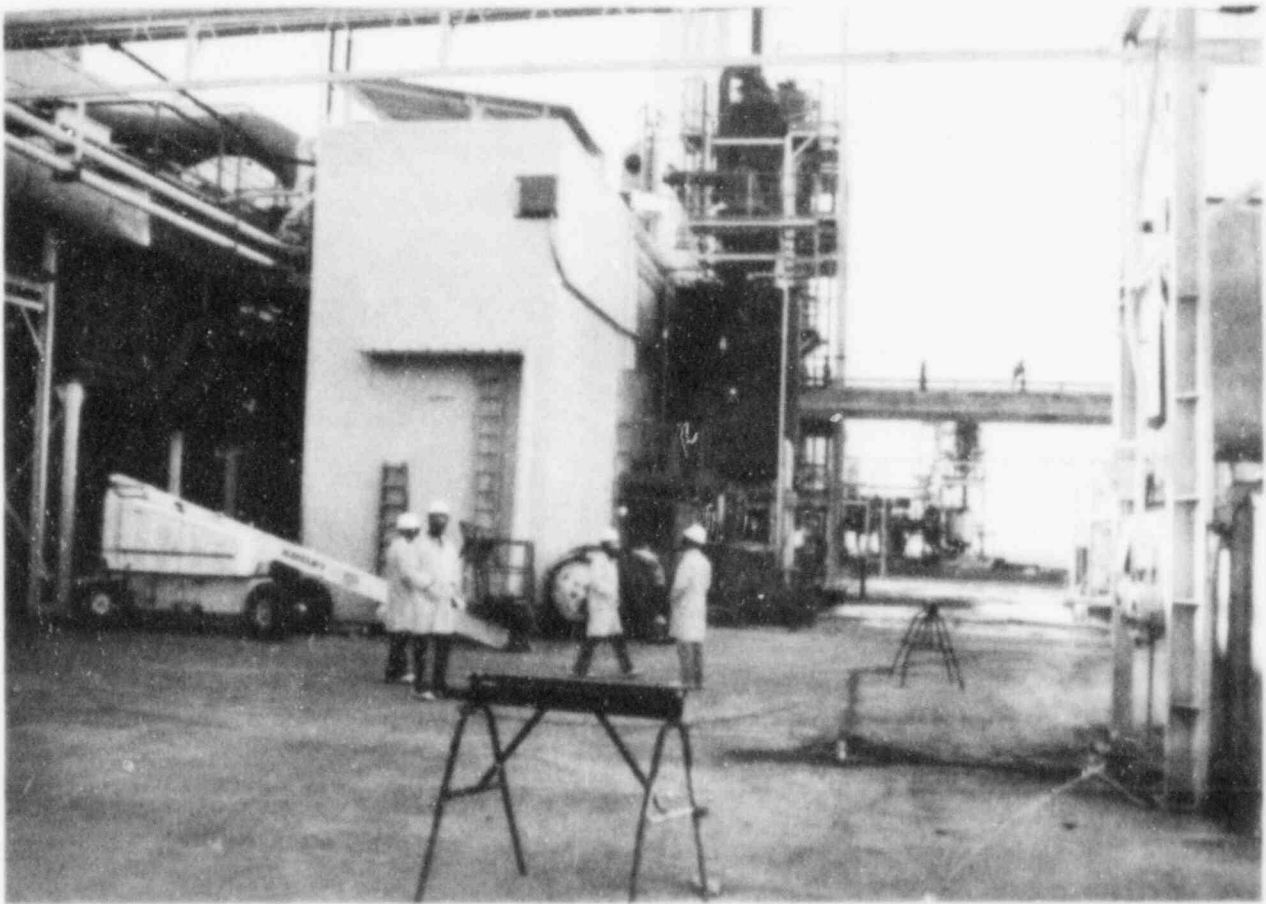
Figure 3.12 Scrubber building

The worker who was fatally injured was working on the upper level of the two-story white structure. He was engulfed by a cloud of vapors and gases consisting of hydrofluoric acid ( $\text{HF}$ ), uranyl fluoride ( $\text{UO}_2\text{F}_2$ ), and uranium hexafluoride ( $\text{UF}_6$ ). The nearest steam chest is barely visible at the right edge of the photograph.

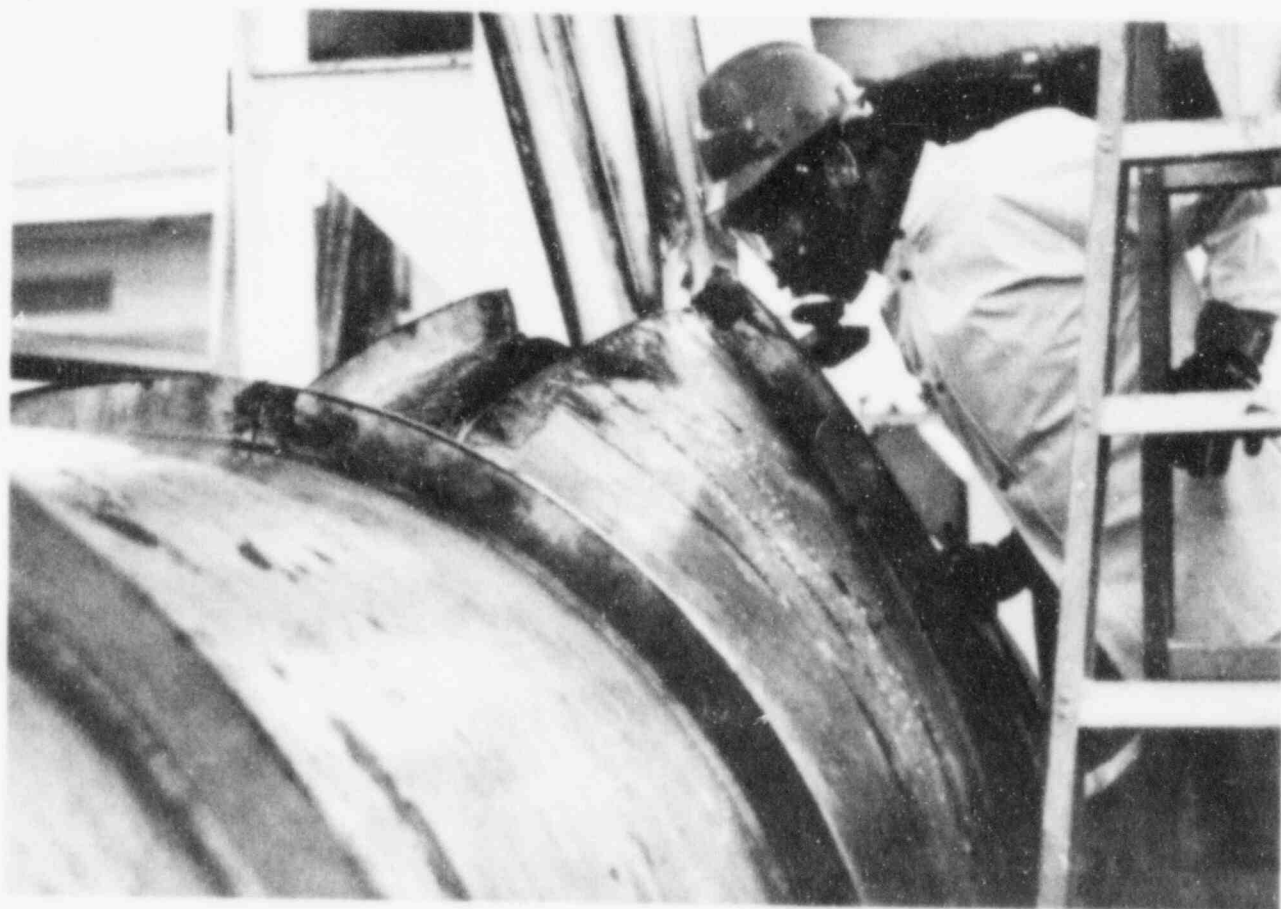
Figure 3.13 Damaged portion of the cylinder

The cylinder was ruptured for a distance of approximately 52 inches in the axial direction along a line passing through the location where the stiffening rings were butt welded closed. The crack resembled a long, narrow slit, approximately 8 inches wide at the widest point. The crack did not appear to be jagged or irregular. (See Figure 3.13.)

The rupture is shown in this picture, which was taken shortly after the temporary rag plug was removed. The cylinder has been rotated from its position immediately after the accident.

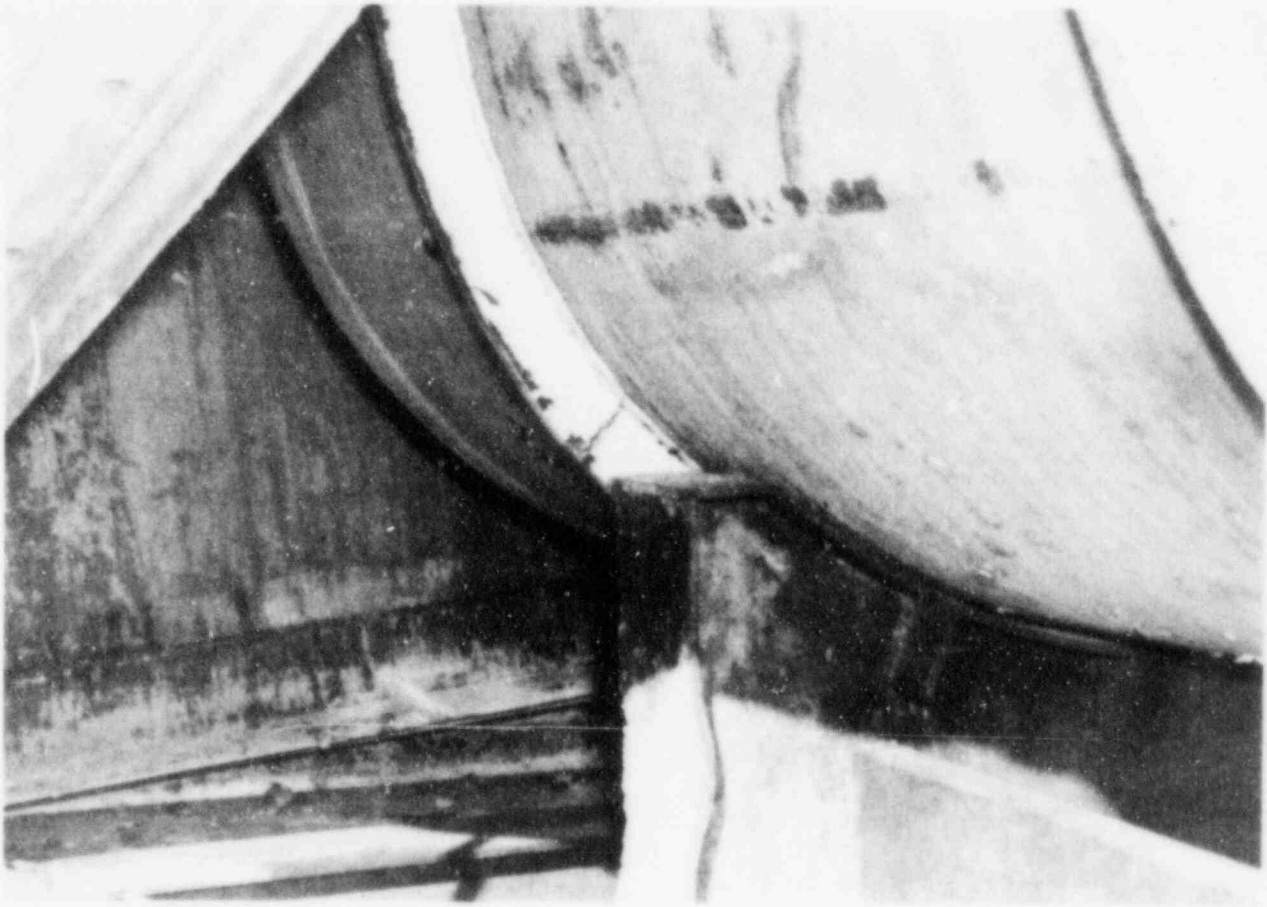
Figure 3.14 Separation of stiffener ring

The three circumferential stiffening rings were separated at the point where they were previously welded closed. The shell bulged radially outward with the maximum deformation appearing to be halfway between the stiffening rings. The cylindrical shell had undergone considerable plastic deformation in both the region of the rupture and in regions away from the rupture at the opposite end of the cylindrical shell. Figures 3.14 through 3.16 show this damage.

The stiffener ring farthest from the rupture clearly shows separation at the butt weld joining the ends of the ring.

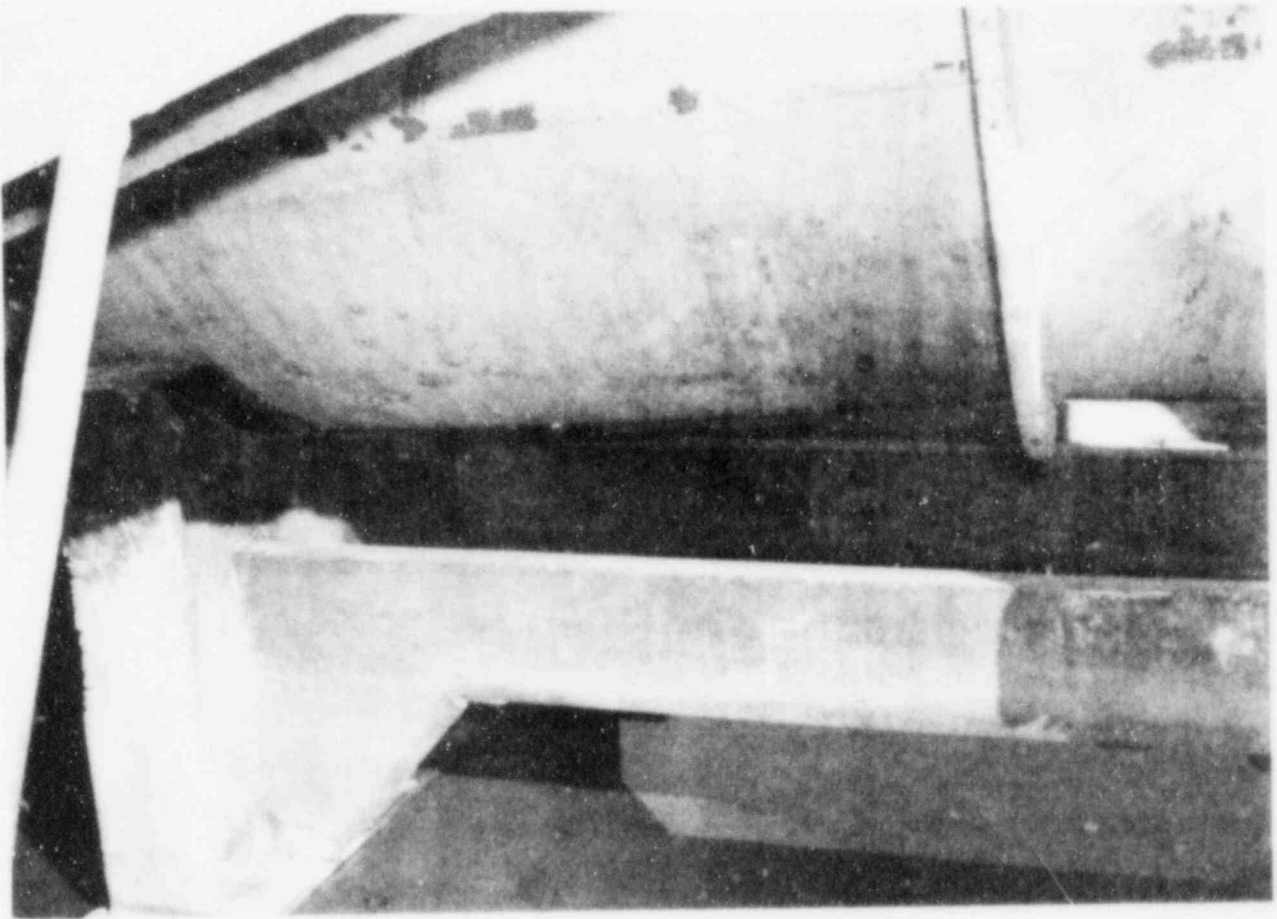
Figure 3.16 Deformation of cylinder wall

The plastic deformation of the shell before rupture indicates that the failure was ductile in nature rather than brittle. Brittle fracture is characterized by crack propagation driven by elastic strain energy. Because the material was strained well beyond its elastic limit, the failure mode was not brittle fracture. Also, if the shell had failed in a brittle manner at stress levels below yield, the loss of contents would have reduced the pressure so that general yielding of the shell would not have occurred in regions of the shell away from the rupture.

Bulging of the cylinder wall between the stiffener rings is clearly evident.

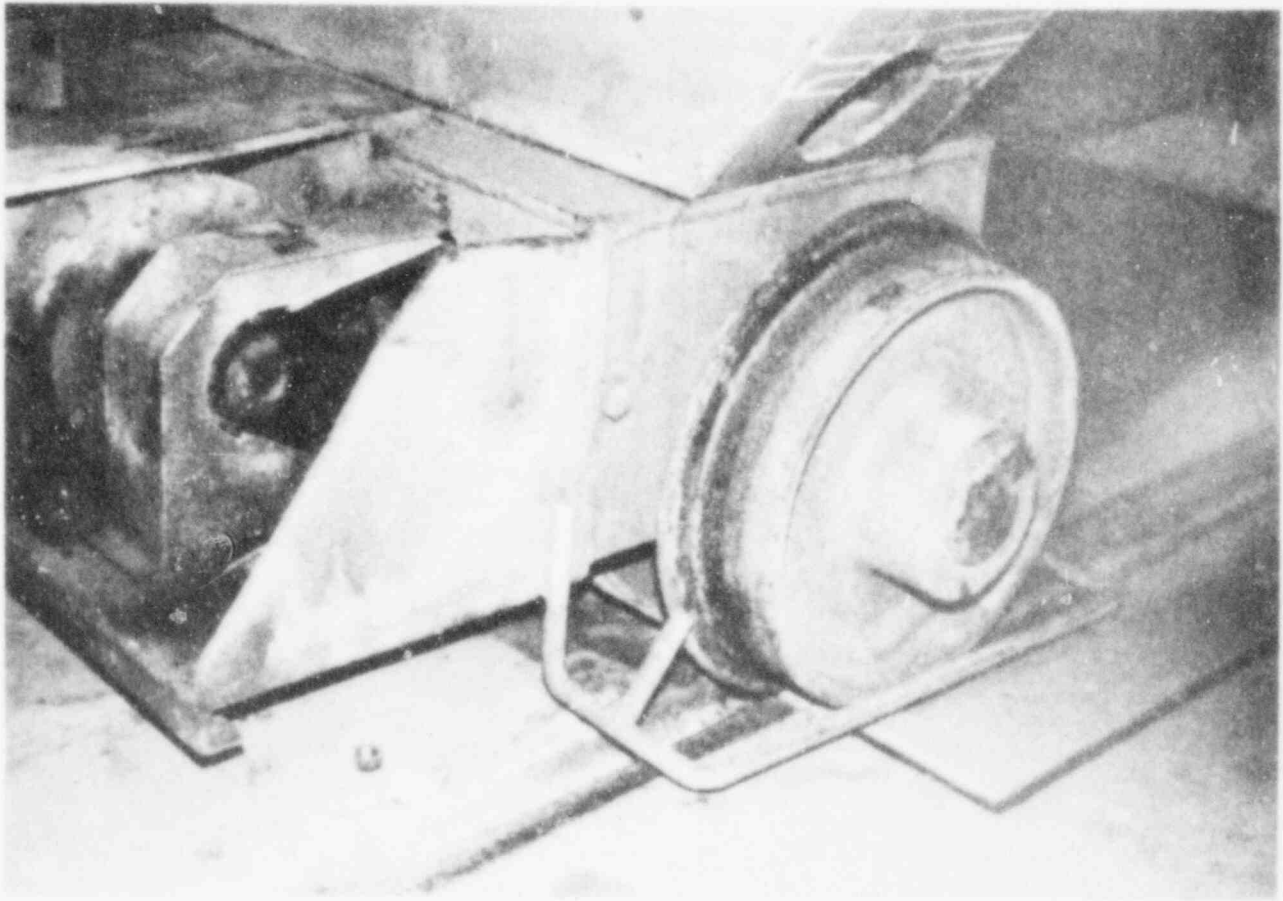
Figure 5.1 Cart wheel alignment

It has been determined, through interviews and observations, that the cylinder that ultimately ruptured was not properly placed on the scales during its filling. This was due, in large measure, to the fact that the 14-ton cylinder being filled was longer than the 10-ton cylinder for which the equipment was originally designed. This caused the cart on which the cylinder rested to be positioned very close to the edge of the scale platform. Because of the misalignment of the cylinder and the cart, one wheel of the cart supporting the affected cylinder was off the platform and was resting on the floor. This caused erroneously low readings on the scale during filling.

- (4) In the conduct of the scale testing and calibration, the investigators noted that the cart used to move cylinders on and off the scale platform apparently had been damaged in the past. As a result, the wheels at the east end of the cart were at an angle, confirming observations that only one of the wheels had hung up.

With a 14-ton cylinder placed in its optimum position on the cart and moved as close as possible to the drain station, the rear wheel is less than an inch from the edge of the scale platform.
