# 1991 Annual Prelicensing Inspection of the Tuba City, Arizona, UMTRA Project Disposal Site

September 1992

U. S. Department of Energy  
Albuquerque Field Office  
Grand Junction Projects Office  
Grand Junction, Colorado

Prepared by  
Chem-Nuclear Geotech, Inc.  
Under DOE Contract No. DE-AC04-86ID12584  
U. S. Department of Energy  
Grand Junction Projects Office  
Grand Junction, Colorado

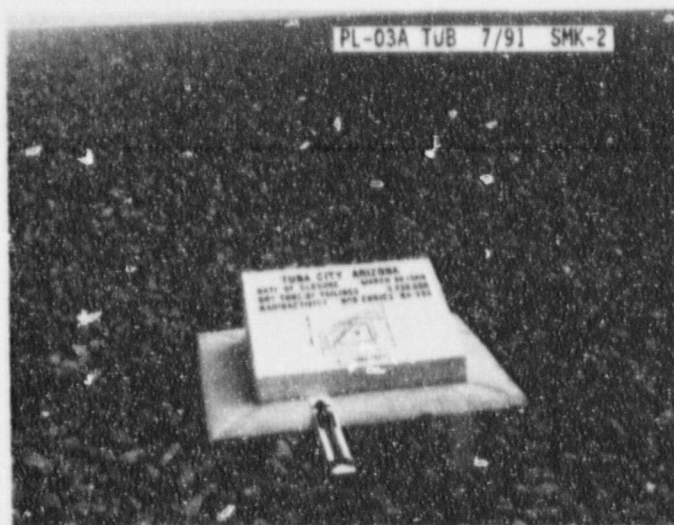
PL-03A TUB 7/91 SMK-2

There are two site markers at the Tuba City disposal site: SMK-1 and SMK-2. SMK-1 is located just inside the entrance gate (PL-2); SMK-2 is centrally located on the flat surface on top of the disposal cell (PL-3A). Both site markers are in excellent condition and show no sign of deterioration.

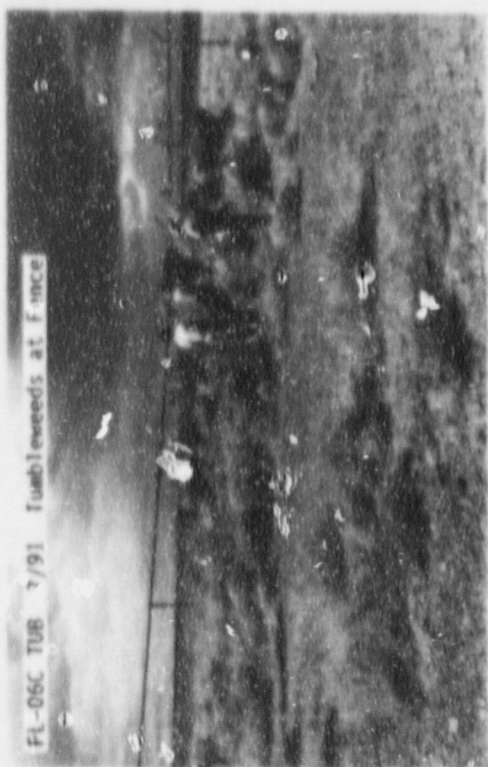
PL-07B TUB 7/91 Tumbleweeds at Fence

The inspection party experienced difficulty locating SM-3/BM-3 and BM-4 because of tumbleweeds trapped in the northeast and southeast corners of the fence line (PL-6C and PL-7B). The weeds had to be cleared before these monuments could be found and photographed. These monuments are in the downwind corners of the site where tumbleweed accumulation can be expected to be a continuing problem. Not only do these tumbleweeds hide survey and boundary markers, they are also unsightly and constitute a range fire hazard. These weeds should be periodically removed.

4. Tumbleweeds are packed in the northeast and southeast corners of the security fence at the site. They are an inconvenience during site inspections because they make it difficult to locate survey and boundary markers. More significantly, these accumulations of tumbleweeds are a potential range fire hazard, they are unsightly, and they may act as baffles, causing wind to deposit sand. If dunes form in fence corners, they may bury survey and boundary monuments. If large enough, the dunes may bury the fence and compromise site security.

Recommendation: The tumbleweeds should be removed. Experience will dictate how frequently the weeds need to be removed. Removal for the first time in the spring of 1992 would be appropriate. Removal at that time will permit removal of the existing weeds as well as the fall 1991 crop in time for the 1992 Annual Prelicensing Inspection. Removal every 2 to 3 years thereafter may be sufficient.

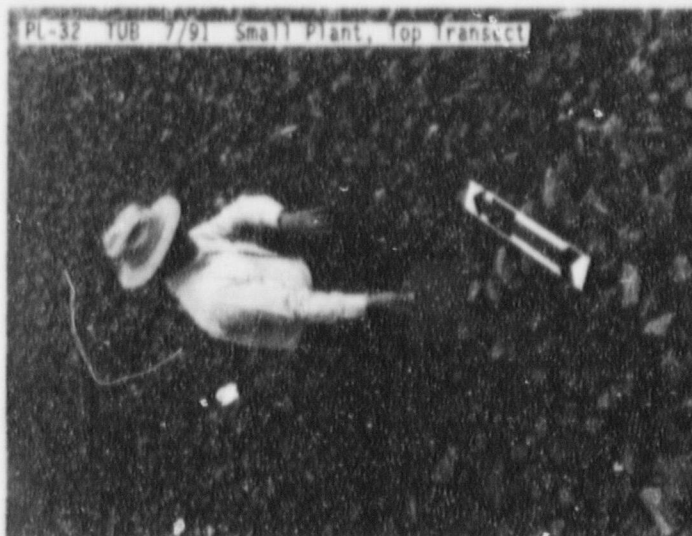
PL-32 TUB 7/91 Small Plant, Top Transect

The top of the disposal cell is mostly free of vegetation. One solitary Russian thistle plant was noted in the southeast corner (PL-32). More plants may be present; but if so, they are too few, small, and far between to be of concern at this time.

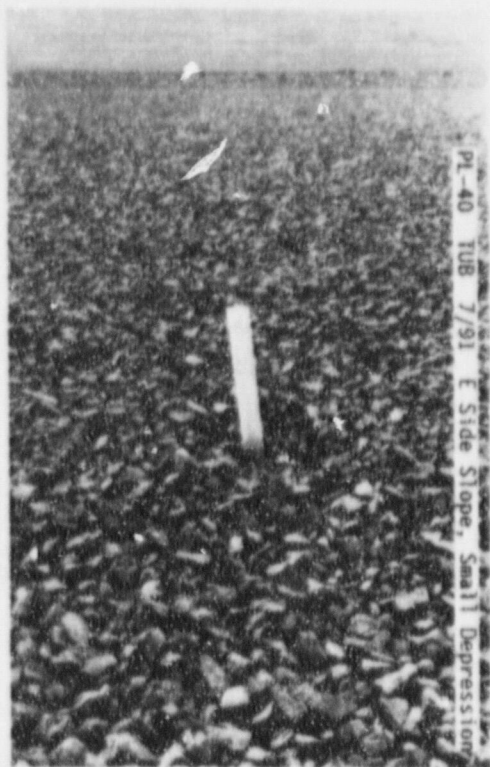
PL-40 TUB 7/91 E Side Slope, Small Depression

**East Side Slope Transect.** The east side slope is generally in excellent condition (PL-38B, PL-39A, PL-39B, and PL-41A); however, a shallow depression was found at PL-40. The depression is roughly circular, about 2 feet in diameter and perhaps 6 inches deep. Consensus of
