SUBJECT: POTENTIAL GENERIC ISSUE CONCERNING RING SETTINGS OF
 CROSBY SAFETY VALVES

SUBJECT: IE NOTICE REGARDING MAIN STEAM SAFETY
VALVE TEST FAILURES AT WYLE LABORATORIES

IE Information Notice No.: 85-xx MAIN STEAM SAFETY VALVE TEST FAILURES AND RING SETTING ADJUSTMENTS

IE INFORMATION NOTICE NO. 86-05: MAIN STEAM SAFETY VALVE TEST FAILURES AND RING SETTING ADJUSTMENTS

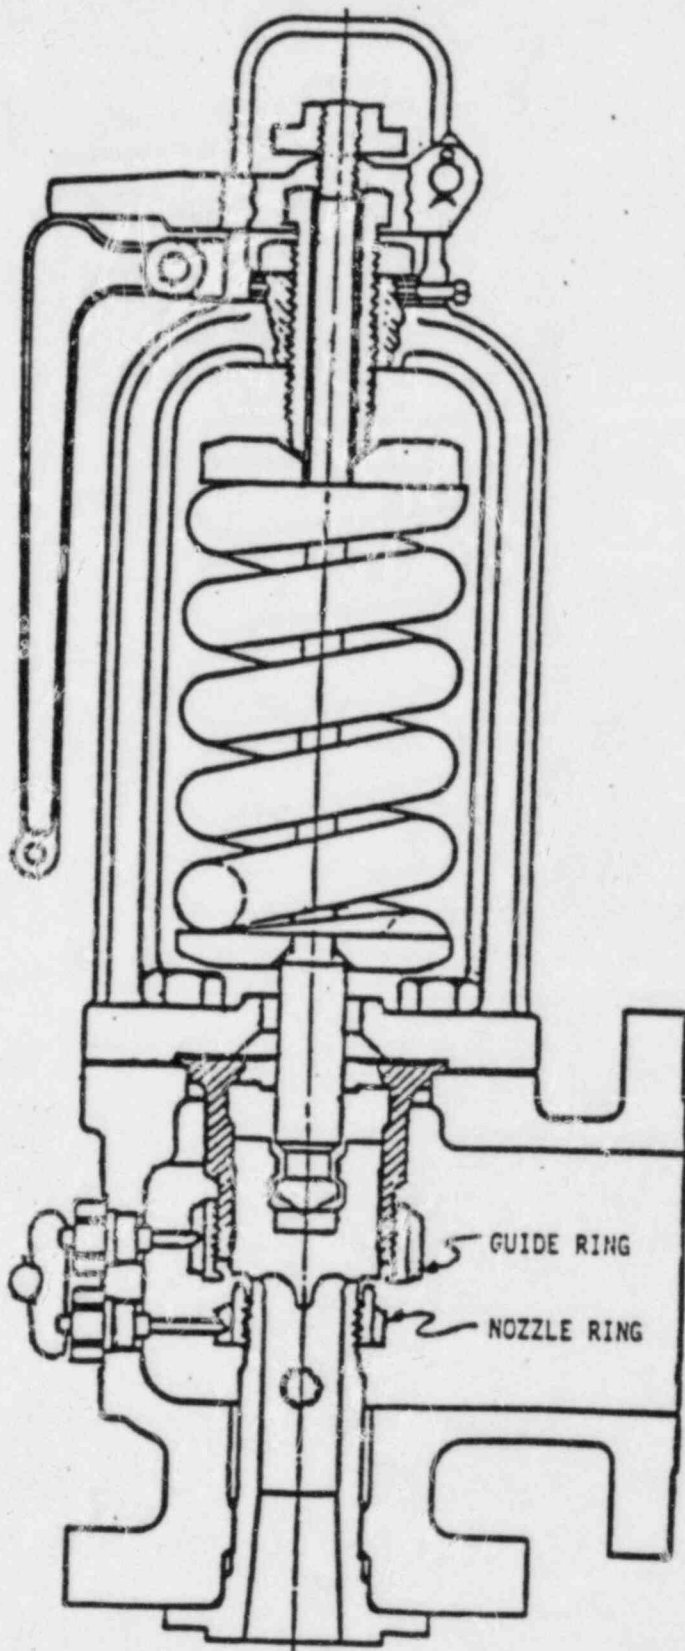
FIG. 1

This Information Notice is being provided as a notification of a potentially significant problem pertaining to spring-actuated main steam safety valves (See Figure 1), that may possess less than the full rated flow capacity required for overpressure protection of the secondary cooling system in PWRs. It is expected that recipients will review the information for applicability to their facilities and consider actions, if appropriate, to preclude a similar problem at their facilities. However, suggestions contained in this Information Notice do not constitute NRC requirements; therefore, no specific action or written response is required.

TYPICAL MAIN STEAM SAFETY VALVE

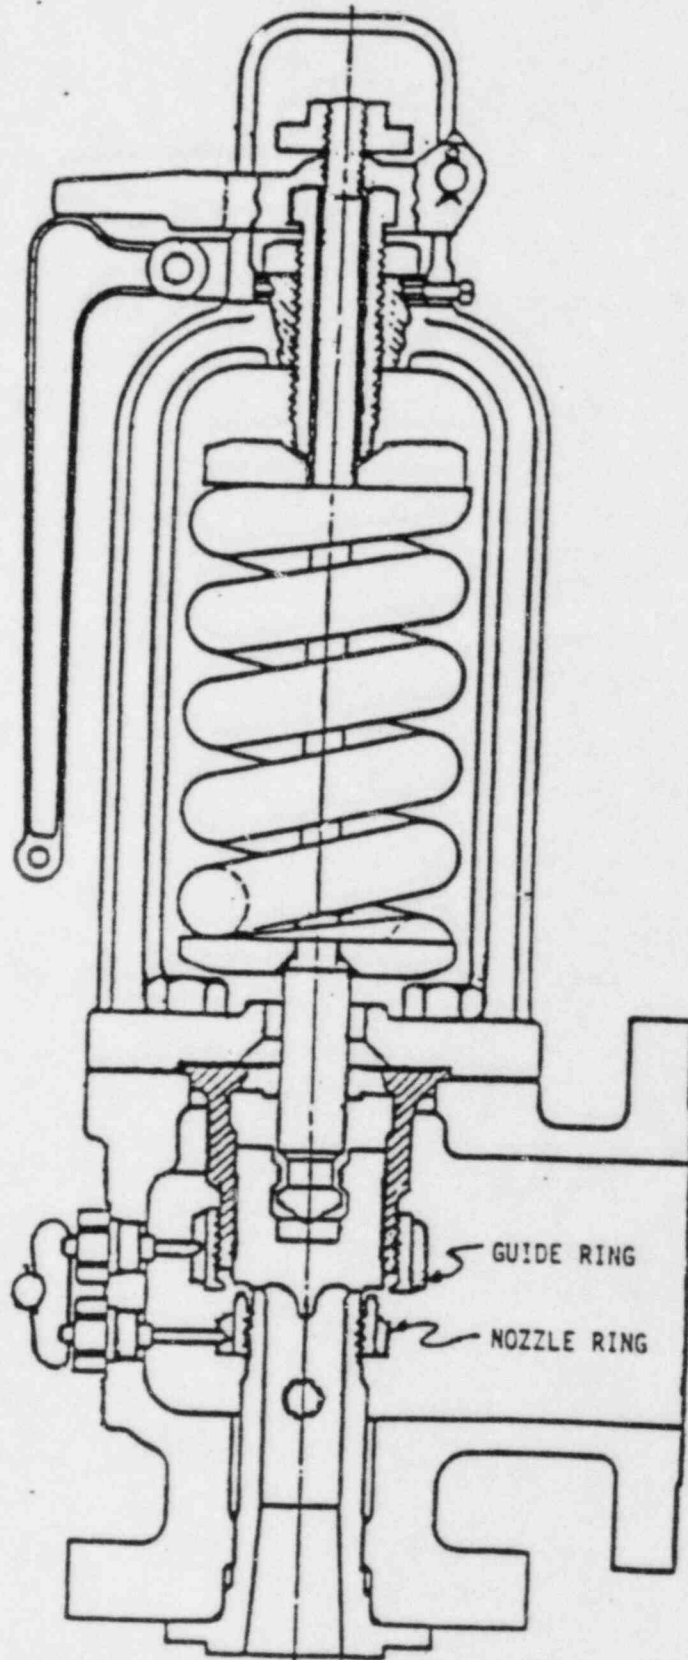
FIG. 1
TYPICAL MAIN STEAM SAFETY VALVE

The MSSVs on most PWRs, while not necessarily the same model or manufacturer as those at Seabrook, are generally at the upper end of the valve size range. This raises the concern that full-sized flow demonstration may never have been performed for many MSSVs and these may have incorrect ring settings. In addition, similar problems with ring settings have been found when full-size tests were performed for PWR primary safety valves. Thus, these MSSVs may not be capable of providing full-relief capacity in accordance with facility design requirements.

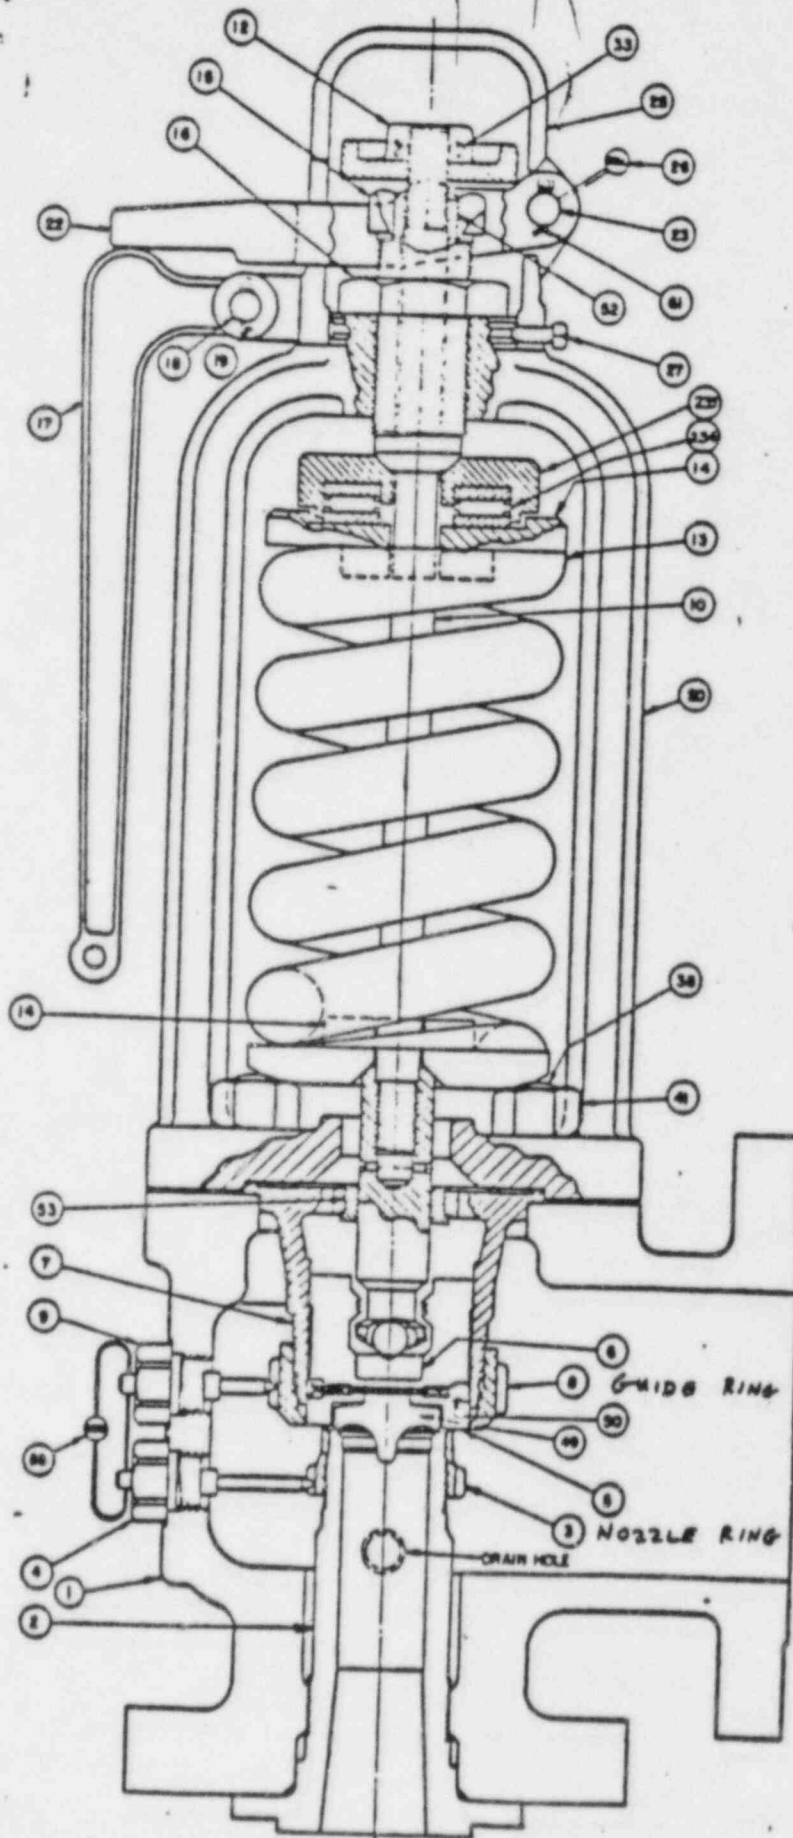
FIG. 1

Company. These ~~two~~ Crosby 6 R 10 MSSVs
 are to be installed by Public Service of
 New Hampshire on the Seabrook main steam
~~secondary~~ cooling system. The tests were
 conducted in order to determine the
 adequacy of various MSSV discharge piping
 arrangements. During the tests the valves were
 instrumented to measure valve disk lift. The
 valves were ^{installed} set up on the test facility with the
 Crosby recommended settings of the valve adjusting
 rings. With these factory ring settings the valve
 achieved only about 50% of the full disk lift
 required to develop full steam flow capacity
 within the ^{ASME Code} required 3% accumulated overpressure
 limit. Adequate lift was not achieved for
