LICENSEE EVENT REPORT (LER)

FACILITY NAME (1) SAN ONOFRE NUCLEAR GENERATING STATION, UNIT 3										DOCKET NUMBER (2) 0 5 0 0 0 3 6 2				PAGE (3) 1 OF 0 4		
TITLE (4) PRESSURIZER INSTRUMENT NOZZLE PRESSURE BOUNDARY LEAK																
EVENT DATE (5)			LER NUMBER (6)				REPORT DATE (7)			OTHER FACILITIES INVOLVED (8)						
MONTH	DAY	YEAR	YEAR	SEQ. NUMBER	REV. NUMBER	MONTH	DAY	YEAR	FACILITY NAMES				DOCKET NUMBER (8)			
0 2	2 7	8 6	8 6	0 0 3	0 0	0 3	2 8	8 6					0 5 0 0 0 0 0 0			
OPERATING MODE (9)		THIS REPORT IS SUBMITTED PURSUANT TO THE REQUIREMENTS OF 10 CFR §: (Check one or more of the following) (11)														
3		20.402(b)				20.405(c)				50.73(a)(2)(iv)				73.71(b)		
POWER LEVEL (10)		0 0 0				20.405(a)(1)(i)				50.36(c)(1)				73.71(c)

Subject: Docket No. 50-362
30-Day Report
Licensee Event Report No. 86-003
San Onofre Nuclear Generating Station, Unit 3

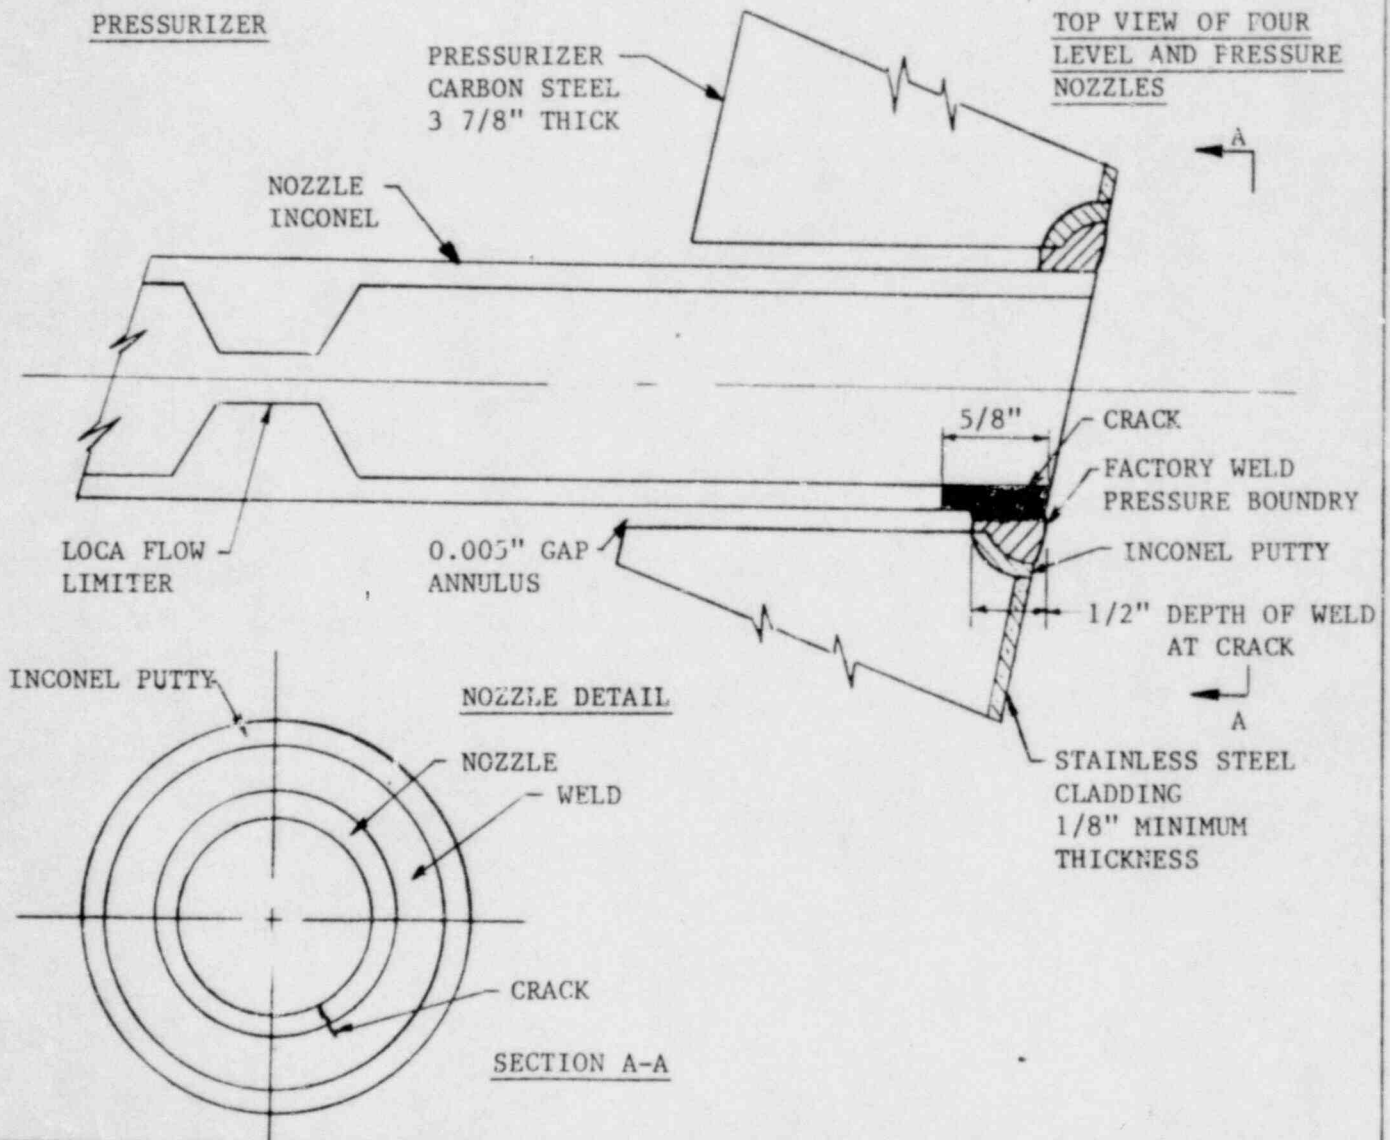
On March 6, 1986, with Unit 3 in Cold Shutdown, penetrant tests (PT) were performed on the instrument nozzle. As a result, a crack was identified in the nozzle, which was through-the-wall and into the pressure boundary weld. The crack was axial to the nozzle and starting from the end of the nozzle inside the pressurizer and extended outward approximately 5/8 inches (see attached sketch). At the point of the crack the weld is approximately 1/2 inch in depth. The crack extended beyond the weld approximately 1/8 inch into the annulus area of the nozzle assembly.

As corrective action, the nozzle was completely cut out including the entire weld. The new nozzle was installed by the NSSS vendor (Combustion Engineering) in accordance with the vendor's fabrication specifications. The new nozzle was machined out of solid inconel bar stock to ensure no seam deficiencies could exist. The installation of the new nozzle was completed on March 10, 1986.
