January 29, 1998

Re: SUA-1475 1997 Ground Water Corrective Action Plan Report

**1997 GROUND WATER CORRECTIVE ACTION ANNUAL REVIEW  
UNITED NUCLEAR CORPORATION'S  
CHURCH ROCK MILL AND TAILINGS FACILITY  
GALLUP, NEW MEXICO**

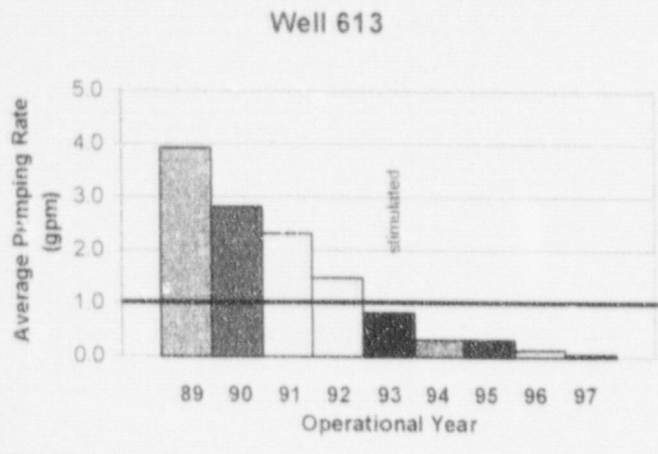
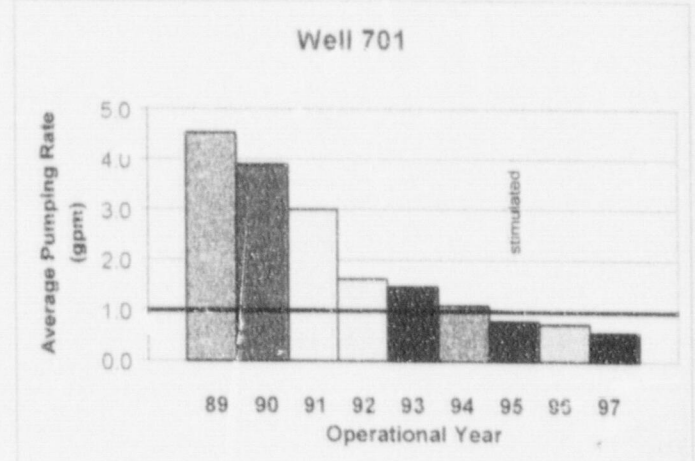
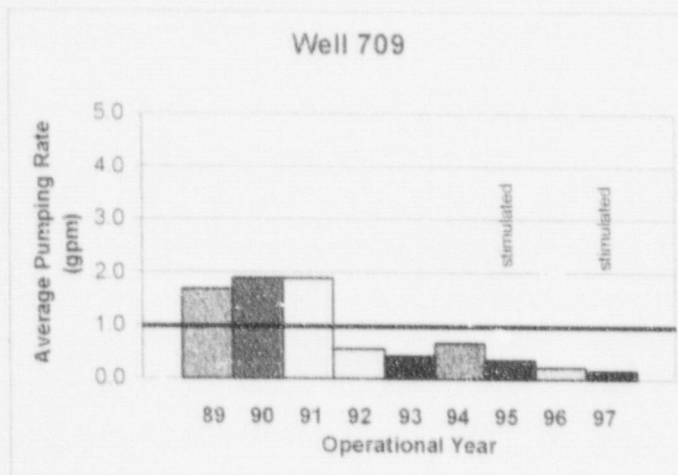
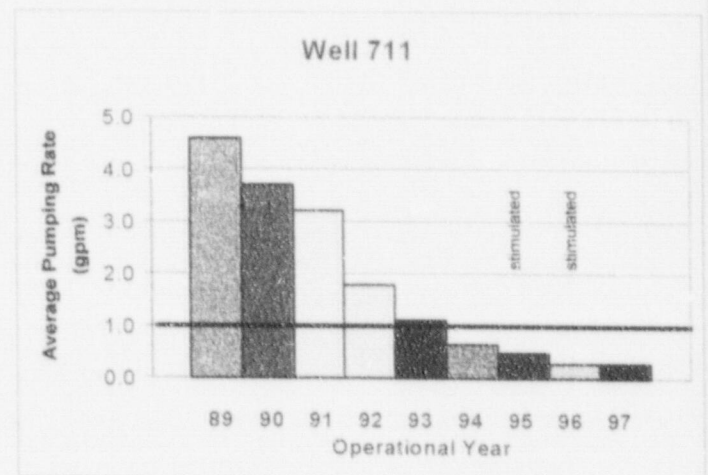
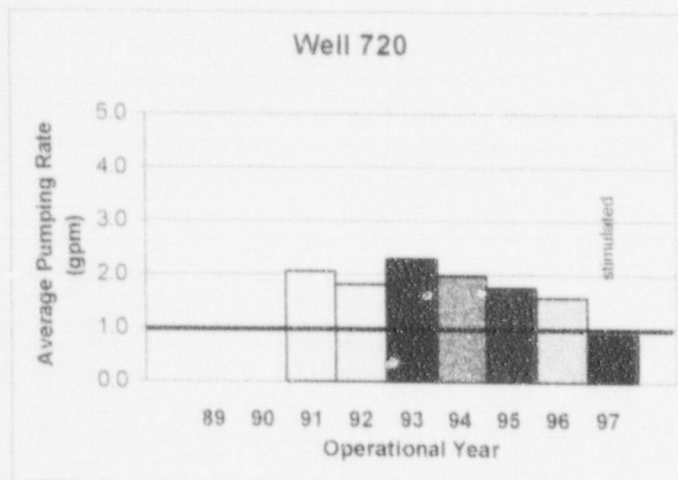
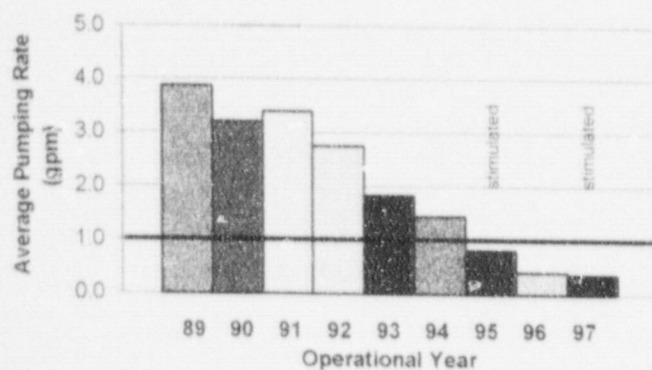
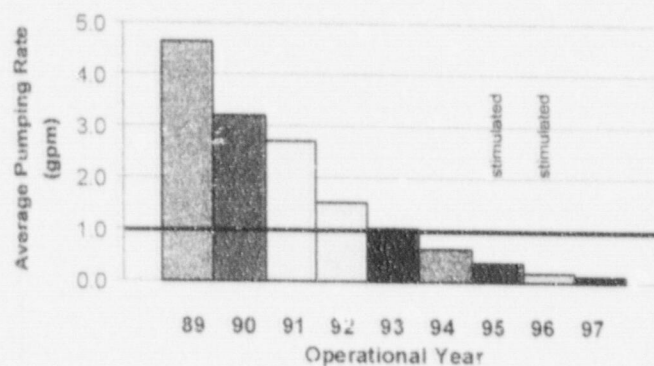
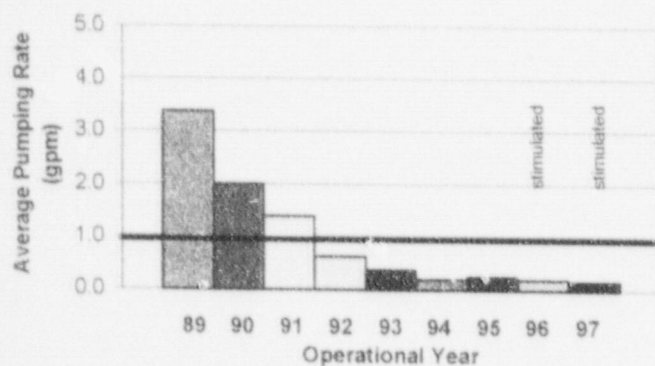
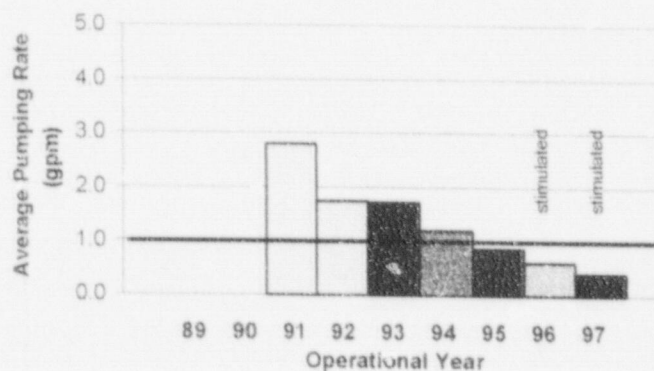
FIGURE ES-1  
SUMMARY OF ZONE 3 EXTRACTION  
WELL PRODUCTIVITY OVER TIME

Figure ES-1 graphically illustrates the decline in productivity of the nine wells over time and how the reduced rates relate to the decommissioning criteria. As shown, with the exception of Well 720, all the wells have pumped at rates below the decommissioning criterion level of 1.0 gallon per minute (gpm) for a minimum of three consecutive years. This condition has persisted even after repeated cleaning and stimulation as required by the Corrective Action Plan (CAP) (United Nuclear, 1989a).

The low productivity and efficiency of the wells significantly affects the operation and maintenance of the Zone 3 system. During 1997, these wells were shut down for an average of more than 11 weeks for repair and cleaning. The cost to maintain these wells far exceeds the benefit gained from continuing operation. Also, replacing these wells is not a viable alternative because the limited saturation in this portion of Zone 3 restricts the efficiency and, therefore, the productivity of wells.

The corrective action in Zone 3 has reached the point where continued extraction is not justified because no benefit will be realized in terms of improving water quality or protecting human health and the environment. Table ES-1 shows that three of the five POC wells are dry as a result of the dewatering. The remaining two POC wells have exceedances of the cleanup standards for 12 of the 21 performance monitoring analyses. Continued extraction will not result in improvement in water quality at the POC wells because, based on the projected declines in well productivity, only approximately half of the impacted water remaining in Zone 3 can be removed. Also, maintenance of the extraction system is requiring a large amount of effort to keep the wells operational. Shutdown of the system for maintenance causes further reductions in productivity. Considering that the corrective action is being implemented in a formation that contains only temporary saturation and is not now and will not be a water resource in the future, Zone 3 corrective action is no longer practical and should be terminated.
