UNITED STATES  
NUCLEAR REGULATORY COMMISSION  
WASHINGTON, D. C. 20555

MEMORANDUM FOR: Vincent S. Noonan, Director  
Comanche Peak Project

SUBJECT: FEEDBACK INTERVIEW OF WITNESS A-4

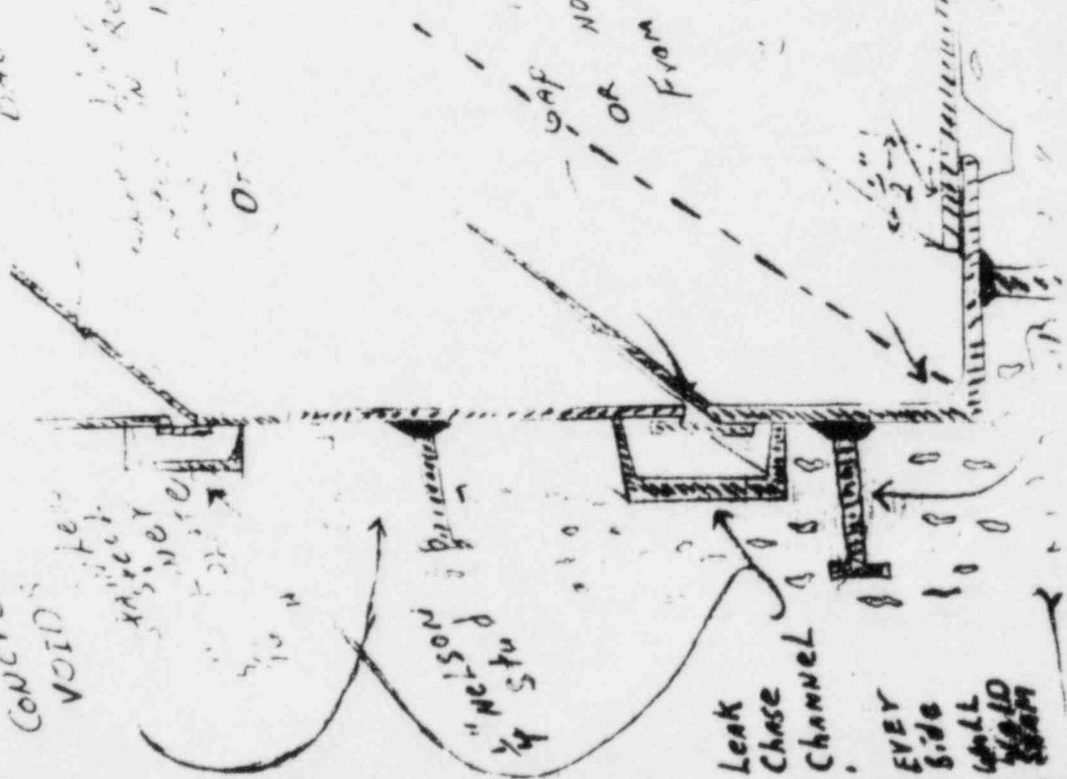
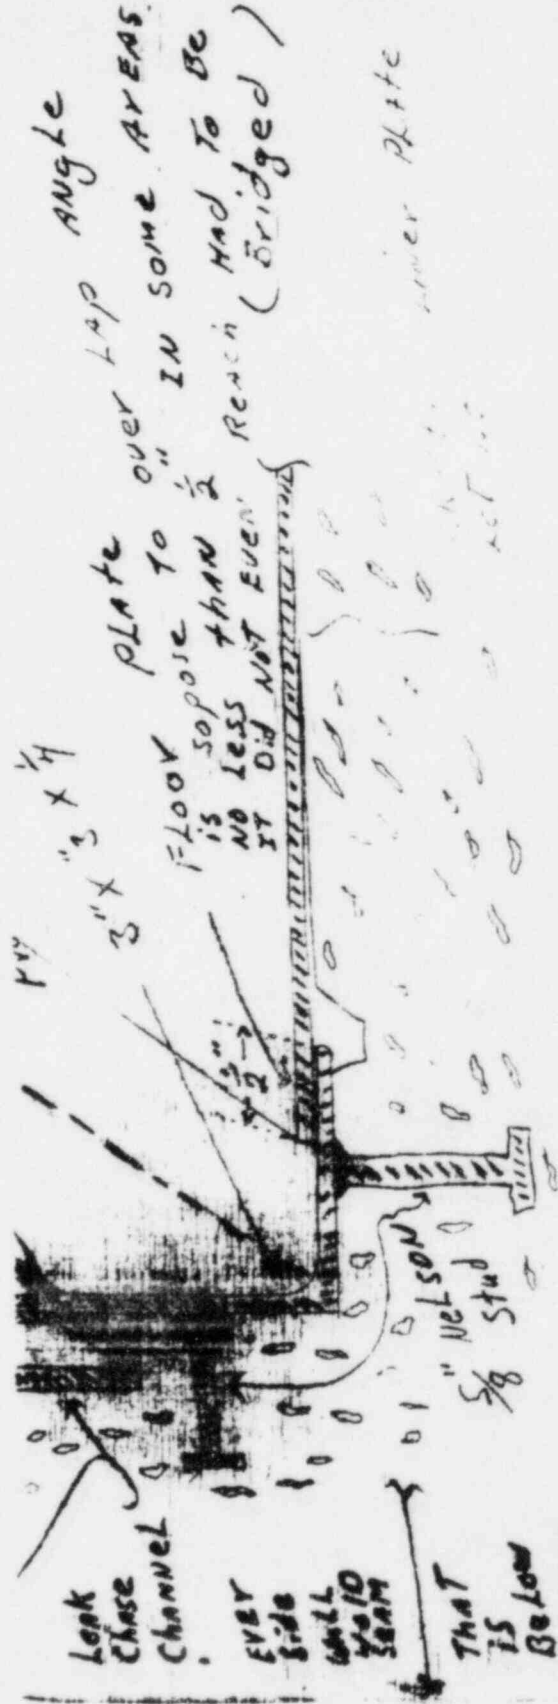
Packing strip improperly located

Concrete H<sub>2</sub>O  
VOID

Leak  
Chase  
Channel

EVERY  
SIDE  
WALL  
VOID  
FOAM

FLOOR TO 10" IN CASE  
IS OF THIN 1/2  
NO LESS THAN 1/2  
IT DID NOT EVEN REACH (1/2)

THAT IS BELOW WATER LEVEL HAS A LEAK CHASE CHANNEL EXCEPT FOR THE BOTTOM SEAMS IN BOTH CONTAINMENT

WHERE THERE WAS NO BACKING STRIP IT WAS BUT NO BACKING STRIP

IN THE FUEL BUILDING WAS IMPROPERLY WELDED

3" x 3/4" FLOOR PLATE TO OVER LAP ANGLE IS SUPPOSE TO BE 1/2" IN SOME AREAS NO LESS THAN 1/2" REACH HAD TO BE IT DID NOT EVEN BRIDGED
