UNITED STATES
NUCLEAR REGULATORY COMMISSION
REGION II
101 MARIETTA STREET, N.W.
ATLANTA, GEORGIA 30323

Report Nos.: 50-369/85-38 and 50-370/85-39

Facility Name: McGuire 1 and 2

Scope: This routine, unannounced inspection was in the area of Nuclear Service Water System Operability.

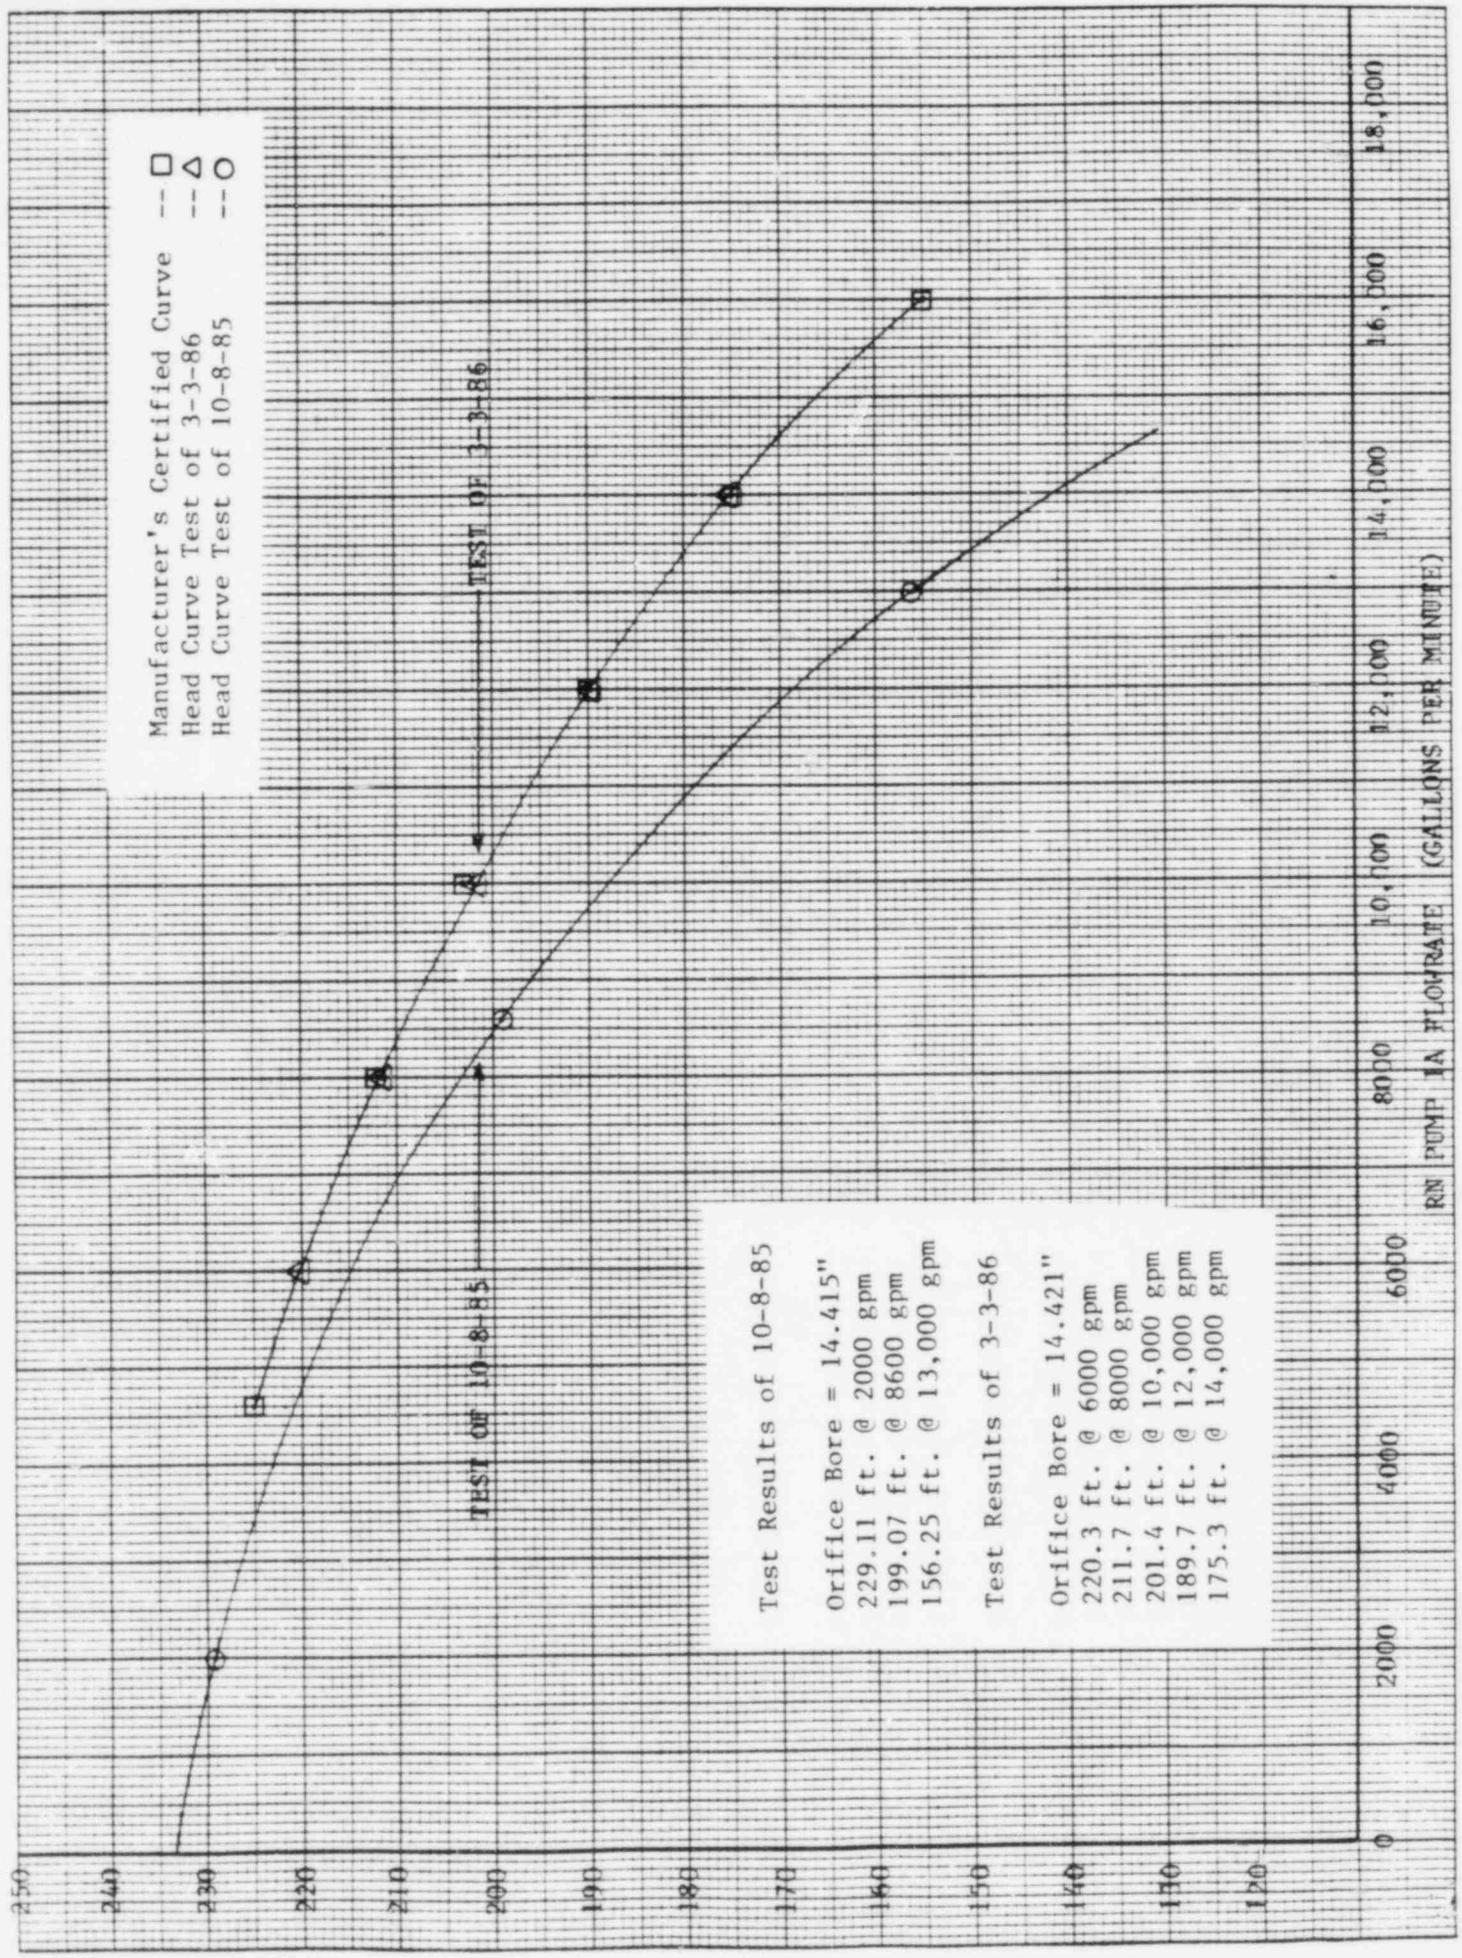
RN PUMP 1A DYNAMIC HEAD VS. FLOWRATE JOHN R. PRING 3-4-86

- * RN Pump 1A did not meet its quarterly IWP acceptance criteria (10/4/85)
- * Replaced impeller (10/5 - 10/6/85)
- * Performed new pump head curve/IWP baseline test (10/7/85)
- * Troubleshooting
- * Evaluated the pump acceptance criteria based on the actual system demand
- * Conducted the pump head curve using the 2A and 1A KC flow elements in series with the 1A RN flow element
- * Using the most conservative head curve results 1A RN pump was declared operable (10/11/85)
- * Optimum replacement was a calibrated 84" flanged spool-piece with a 0.831 beta ratio orifice
- * Installation (February 26-28, 1986)
- * 1A RN Pump head curve conducted with new flow element (March 3, 1986)
- ** Summary - The pump was never inoperable, fouling of the flow element resulted in errors in the conservative direction.

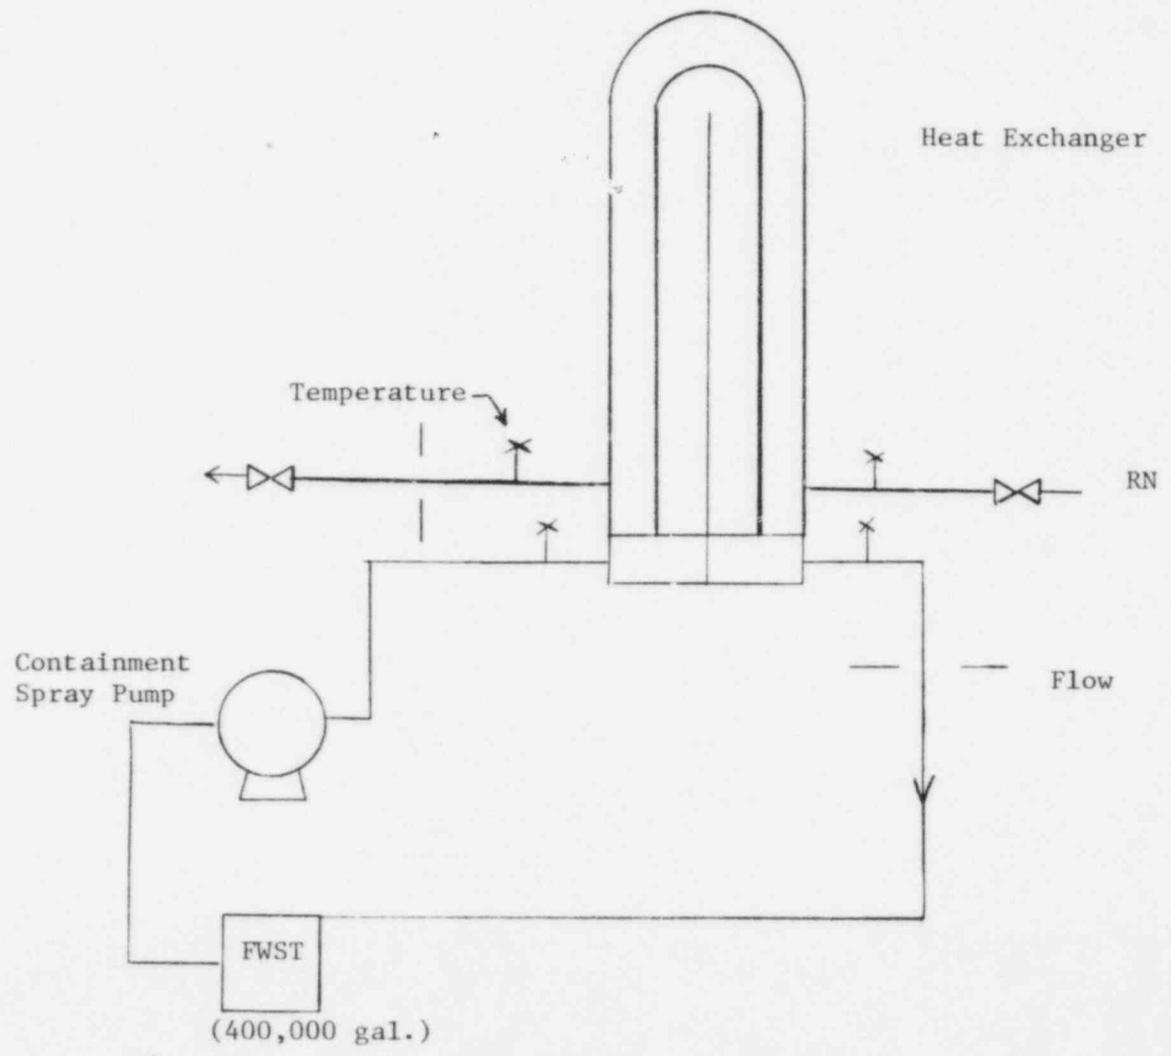
Containment Spray Heat Exchanger Testing

- * 1A NS Heat Exchanger had a high differential pressure
- * Commission expressed concerns of biological attack of stainless steel tubes
- * Testing Performed:
 1. Structural Integrity Test
 2. Minute Leakage Test
 3. Heat Balance Test
- * Structural Integrity and Minute Leakage Test indicated insignificant leakage
- * Visual Examination of the tubes
- * Heat Balance Testing quantified the extent fouling had occurred
- * Peak Containment Accident Pressure (LOTIC) calculations showed the heat exchanger could still perform its function
- * Cleaning iterations
- * Tested and cleaned the other NS heat exchangers based on 1A experience
- ** Summary:
 1. NS Heat Exchangers are intact
 2. The NS Heat Exchangers were fouled; however reanalysis proved operability
