U.S. NUCLEAR REGULATORY COMMISSION

AUGMENTED INSPECTION TEAM

Report No.: 50-461/97018

Facility: Clinton Power Station

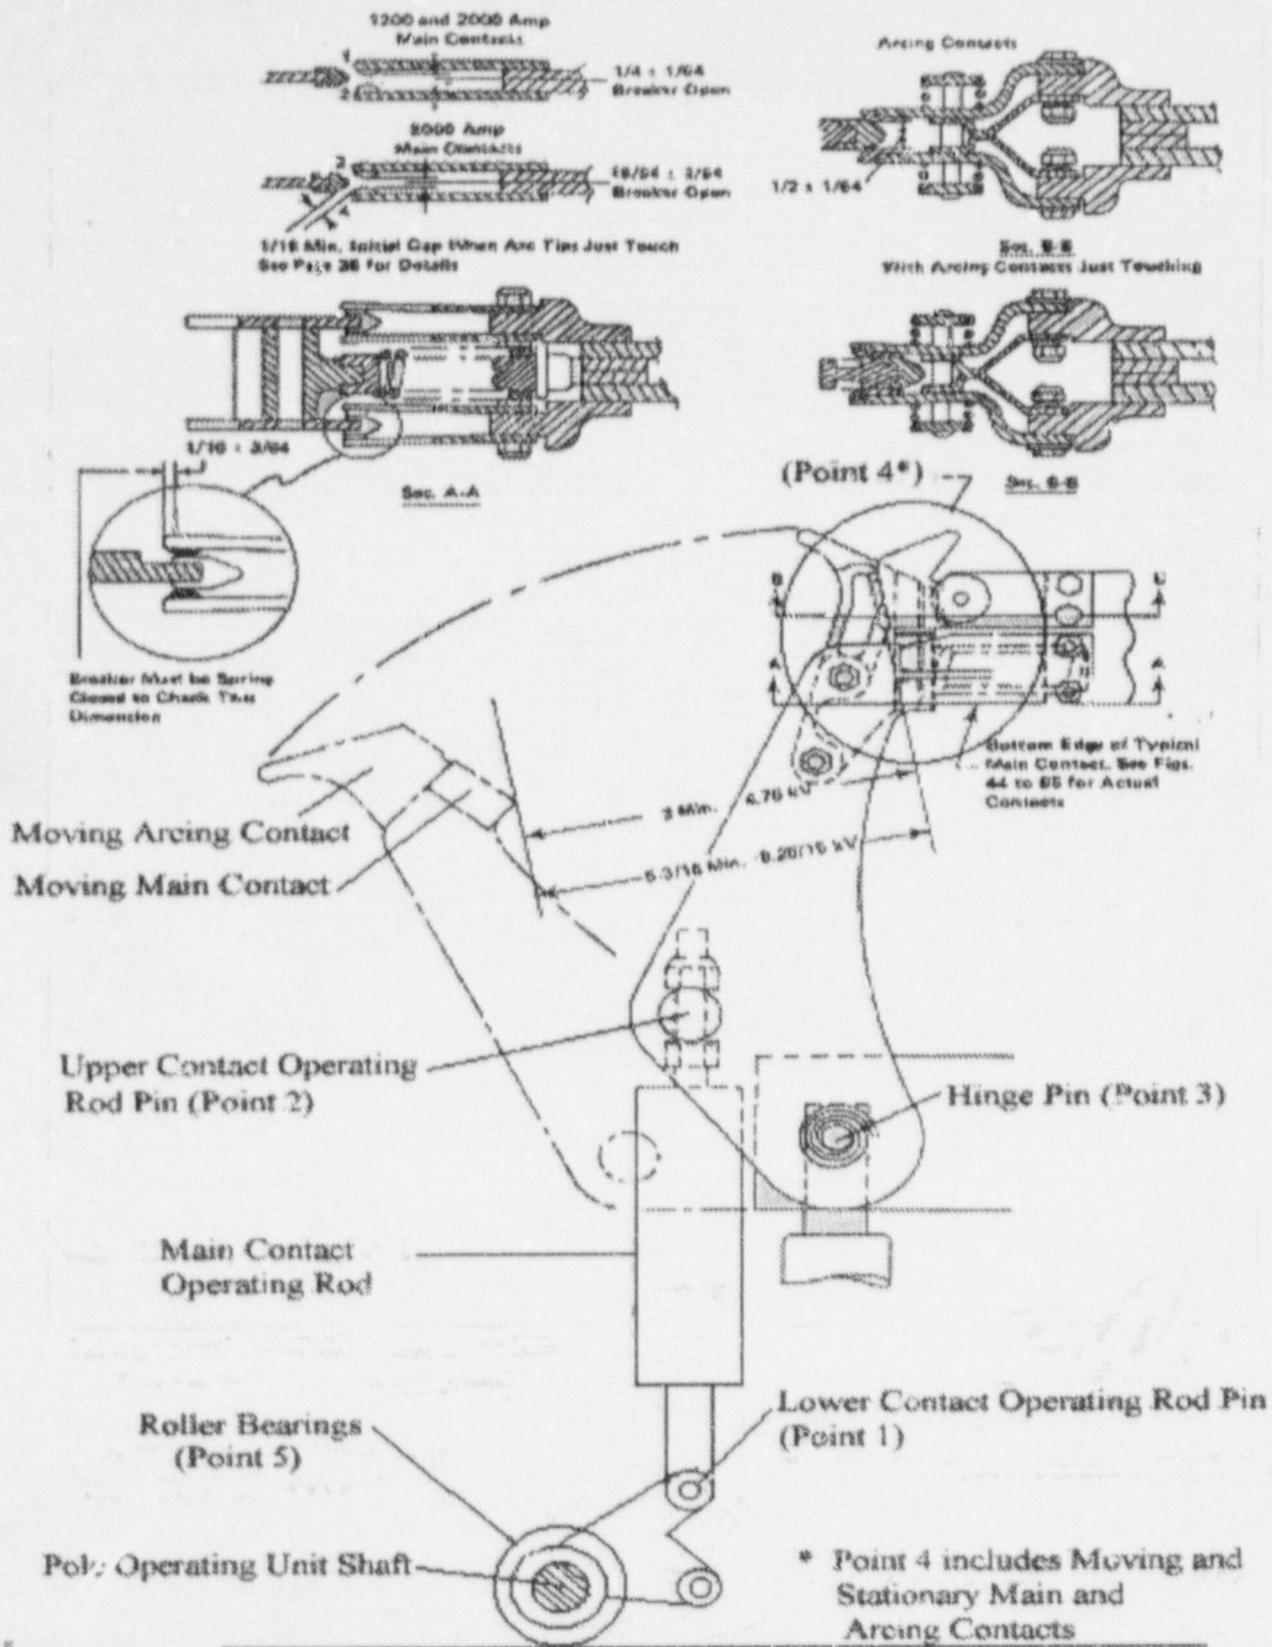
CONTACT ASSEMBLY (FIGURE 2)

The vendor's manual stated that lubrication of the contact surfaces (Point 4 of Figure 2) at normal maintenance intervals would be beneficial. However, the licensee overlooked this recommendation while developing their breaker maintenance procedures. Compounding the omission was the fact that previous CPS maintenance practices of using files, plastic scouring pads, and unapproved solvents on the main contacts may have removed lubricant applied at the factory. Lubrication of the upper and lower contact operating rod pins (Points 1 and 2 of Figure 2) was not mentioned in the vendor's manual or CPS' maintenance procedures. The vendor manual stated that lubrication of the

moving hinge contact point (Point 3 of Figure 2) was unnecessary unless the contacts were replaced and that lubrication of the pole shaft roller bearings (Point 5 of Figure 2) should not normally be required because these bearings were packed at the factory with a "top grade slow oxidizing grease that should last for many years." The manual further stated these bearings should remain undisturbed unless the breaker exhibited sluggishness or evidence of dirt existed. The vendor's manual also recommended that the roller bearings should be cleaned and relubricated if the parts were dismantled for some reason. Although the vendor manual described routine lubrication points, its use of wording such as "beneficial" and "for many years" did not emphasize or ascribe appropriate level of importance to these actions.

Electricians interviewed by the AIT indicated they did not lubricate Points 1, 2, 3, 4, and 5 of Figure 2. The electricians stated that during routine breaker maintenance they had used plastic scouring pads and files to dress the contacts as necessary (i.e., when pits or burrs were found). The electricians also indicated that the main contacts were not lubricated with conductive grease following maintenance. Further, the electricians stated that while they had not recently used unapproved solvents, such as Freon, on the breaker main contacts, unapproved solvents had been used on these areas in the past.
