**LICENSEE EVENT REPORT (LER)**

Millstone Nuclear Power Station Unit 2

Pressurizer Spray Line Fatigue Limits Exceeded Due to Insufficient Thermal Effects Analysis

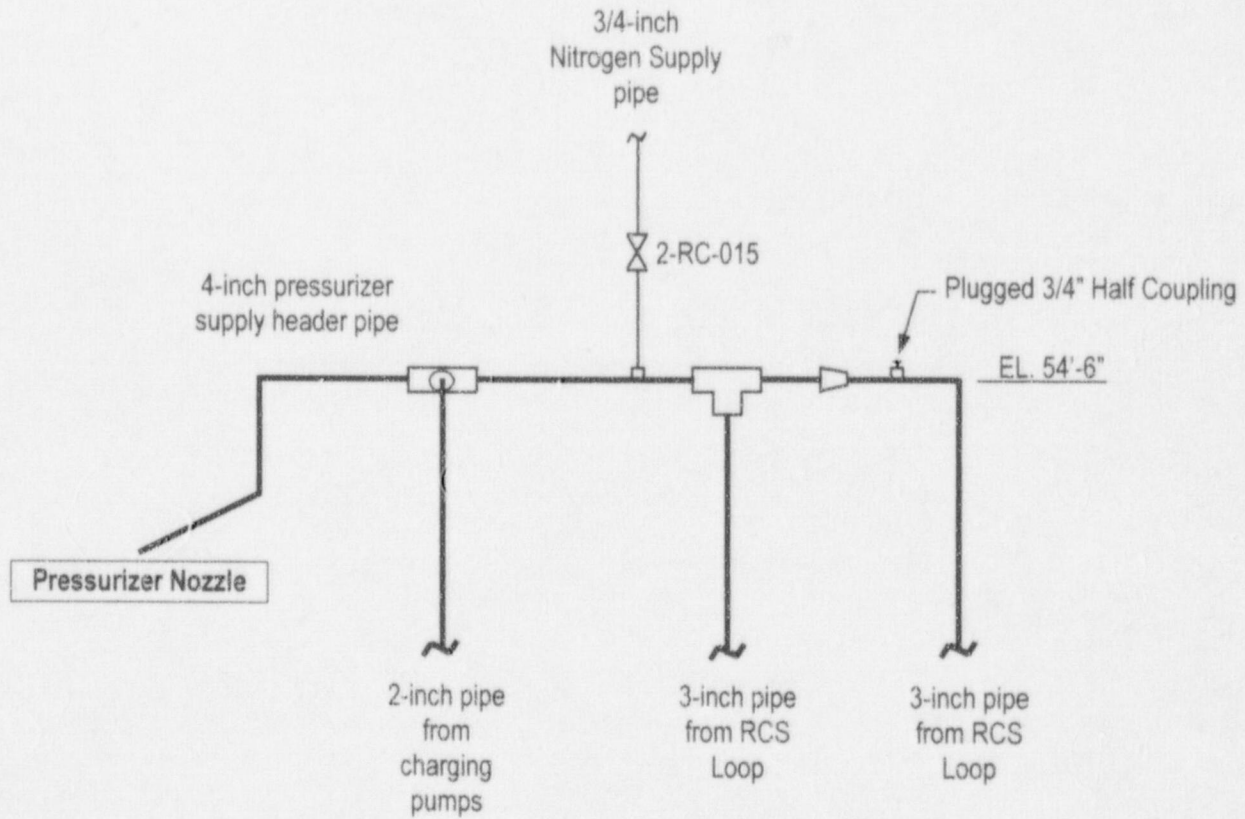
**FIGURE 1:**

On December 23, 1998, following a detailed design review of the pressurizer [PZR] spray [AB] piping (see Figure 1), it was self-identified that several inconsistencies existed between the design basis analysis, design specification, and actual operation of the pressurizer spray piping, such that fatigue criterion, as prescribed in Section III of the American Society of Mechanical Engineers (ASME) Boiler and Pressure Vessel Code, 1971 edition), had not been satisfied. This review was initiated in response to issues identified during configuration management program review as well as applicability review for phenomenon discussed in Information Notice 88-08 and other issues regarding pressurizer spray line thermal transients. At the time of discovery, the unit was defueled.

1. There is inadequate consideration of pressurizer spray header piping reheating following termination of auxiliary spray flow due to the ensuing inflow of steam that will condense onto the cooler piping;
2. The temperature range of auxiliary spray transients is underestimated. This is caused by use of an incorrect temperature indicator [TI]. This indicator is located immediately downstream of the regenerative heat exchanger [HX] and is not representative of the temperature of stagnant water inside approximately one hundred fifty (150) feet of auxiliary spray piping which must be cleared out first. This condition was reported in LER 50-336/97-022; and
3. The effect of thermal stratification in the upper horizontal spray header piping run, during low flow conditions existing when the Reactor Coolant Pumps (RCPs) [P] are first started, is not appropriately addressed.

Of particular interest was the increased stresses to the pressurizer auxiliary spray line "tee" (a special Taylor Forge tee with an integral boss) that is the most limiting/highly stressed component in the piping evaluated. It was determined that when the main and auxiliary spray events are correctly modeled in the piping stress analysis for the design life of the components, the calculated fatigue usage factor exceeded the factor allowed in the ASME Code.

Prior to entering Mode 4 from the current outage, design modifications will be implemented to ensure compliance with the ASME Code requirements (this includes revising applicable design documents to reflect the design modifications implemented).
