LICENSEE EVENT REPORT (LER)

CONSUMERS ENERGY COMPANY - PALISADES NUCLEAR PLANT

CONTROL ROD DRIVE SEAL HOUSING LEAK

EVENT DATE (5)			LER NUMBER (6)			REPORT DATE (7)			OTHER FACILITIES INVOLVED (8)		
MONTH	DAY	YEAR	YEAR	SEQUENTIAL NUMBER	REVISION NUMBER	MONTH	DAY	YEAR	FACILITY NAME	DOCKET NUMBER	
12	27	1998	98	-- 014	-- 00	01	26	1999	FACILITY NAME	DOCKET NUMBER	
										05000	
									FACILITY NAME	DOCKET NUMBER	
										05000	
OPERATING MODE (9)		N		THIS REPORT IS SUBMITTED PURSUANT TO THE REQUIREMENTS OF 10 CFR 5: (Check one or more) (11)							
POWER LEVEL (10)		000		20.2201(b)		20.2203(a)(2)(v)		50.73(a)(2)(i)		50.73(a)(2)(viii)	
				20.2203(a)(1)		20.2203(a)(3)(ii)		X 50.73(a)(2)(ii)		50.73(a)(2)(x)	
				20.2203(a)(2)(i)		20.2203(a)(3)(ii)		50.73(a)(2)(iii)		73.71	
				20.2203(a)(2)(ii)		20.2203(a)(4)		50.73(a)(2)(iv)		OTHER	
				20.2203(a)(2)(iii)		50.36(c)(1)		50.73(a)(2)(v)		Specify in Abstract below or in NRC Form 366A	
				20.2203(a)(2)(iv)		50.36(c)(2)		50.73(a)(2)(vii)

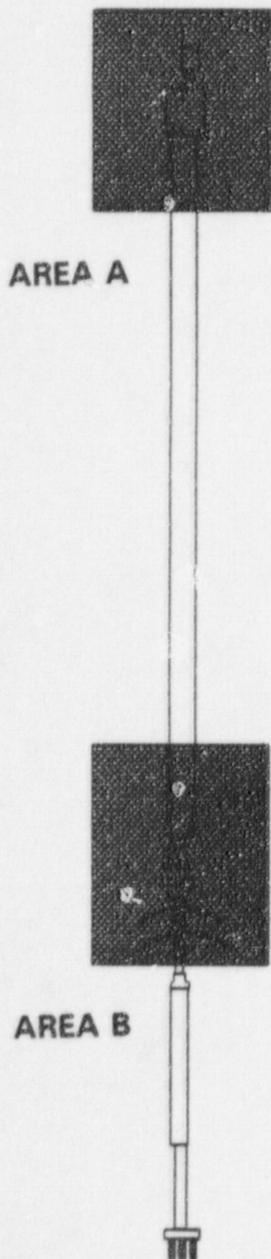
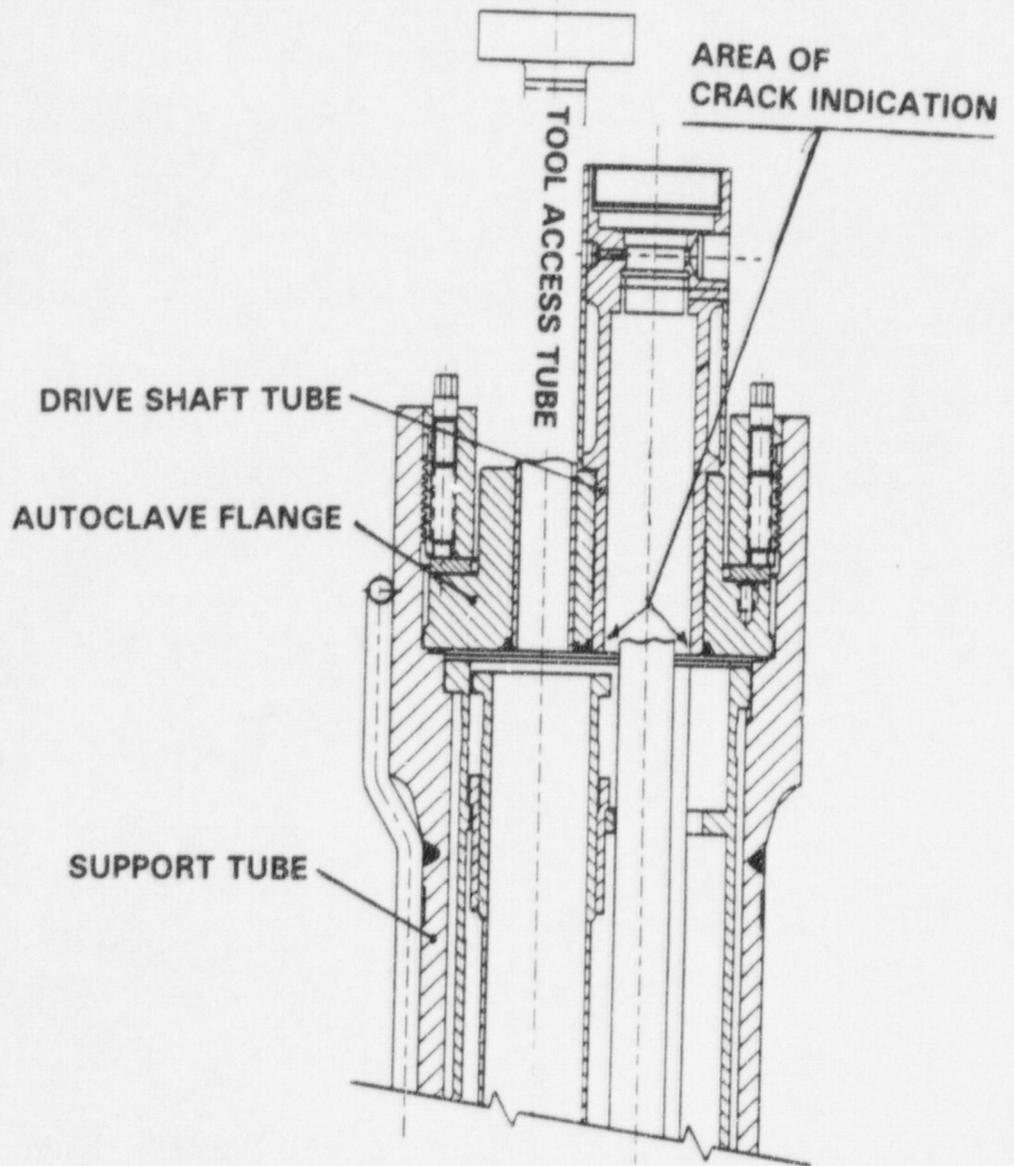
SKETCH SHOWING CRACK INDICATION LOCATION

The plant was cooled down to a cold shutdown condition. A complete external visual inspection of all CRD housings was conducted during the cooldown with no additional active leaks being identified. Following removal of the CRD-2 seal housing, initial inspection on December 30, 1998, revealed a circumferential crack in the seal housing drive shaft tube approximately ¼ inch from the lower flange face. The crack extended for approximately 180 degrees around the circumference of the seal housing.

The CRD-2 seal housing was removed and inspected by plant and nondestructive examination (NDE) personnel on December 30, 1998, using visual and dye penetrant (PT) examination techniques. Visual inspection of the seal housing ID revealed a circumferential crack in the seal housing drive shaft tube approximately ¼ inch from the lower flange face. The crack extended for approximately 180 degrees around the circumference of the seal housing with the center of the crack opposite the tool access tube penetration (See Sketch). The length of

the crack was determined visually; the PT indication was intermittent due to the tightness of the crack and/or water within the crack. The housing was also placed on a test stand and pressurized with water to 2100 psi for 30 minutes, but no leakage was observed. A preliminary metallurgical evaluation (including acid etching and replication) indicated transgranular stress corrosion cracking as the most likely cause of the crack. The single flaw extended for approximately 3 inches directly through areas that had been reworked using weld repairs during original manufacturing. This was the only crack observed in the housing. An ABB review of the eddy current base line shop inspection of this housing revealed extensive cold working in the area that cracked. This finding is consistent with the preliminary conclusion that the cracking was due to transgranular stress corrosion.

The apparent cause of this condition is transgranular stress corrosion cracking in a region of extensive cold work introduced during manufacturing. Additional nondestructive examination and destructive metallurgical testing of the failed seal housing will be completed to verify the root cause of the failure.

The faulted CRD-2 seal housing was replaced on January 2, 1999. Plant heatup was performed on January 4, 1999, and the plant was returned to service.

1. The faulted CRD-2 seal housing was examined using visual and PT methods to assess the failure mechanism.
2. Two additional seal housings with comparable materials and service were removed and examined internally for similar indications. None were found.
3. The exterior surfaces of all other CRD seal housings were visually examined during this outage with no evidence of similar leakage noted.
4. The faulted CRD-2 seal housing was replaced with a spare housing.
