LICENSEE EVENT REPORT (LER)

| FACILITY NAME (1) Duane Arnold Energy Center | DOCKET NUMBER (2) 0 5 0 0 0 0 3 3 1 | PAGE (3) 1 OF 0 5 |

TITLE (4)
Manual Scram in Response to Feedwater Level Control Problems During Reactor Startup

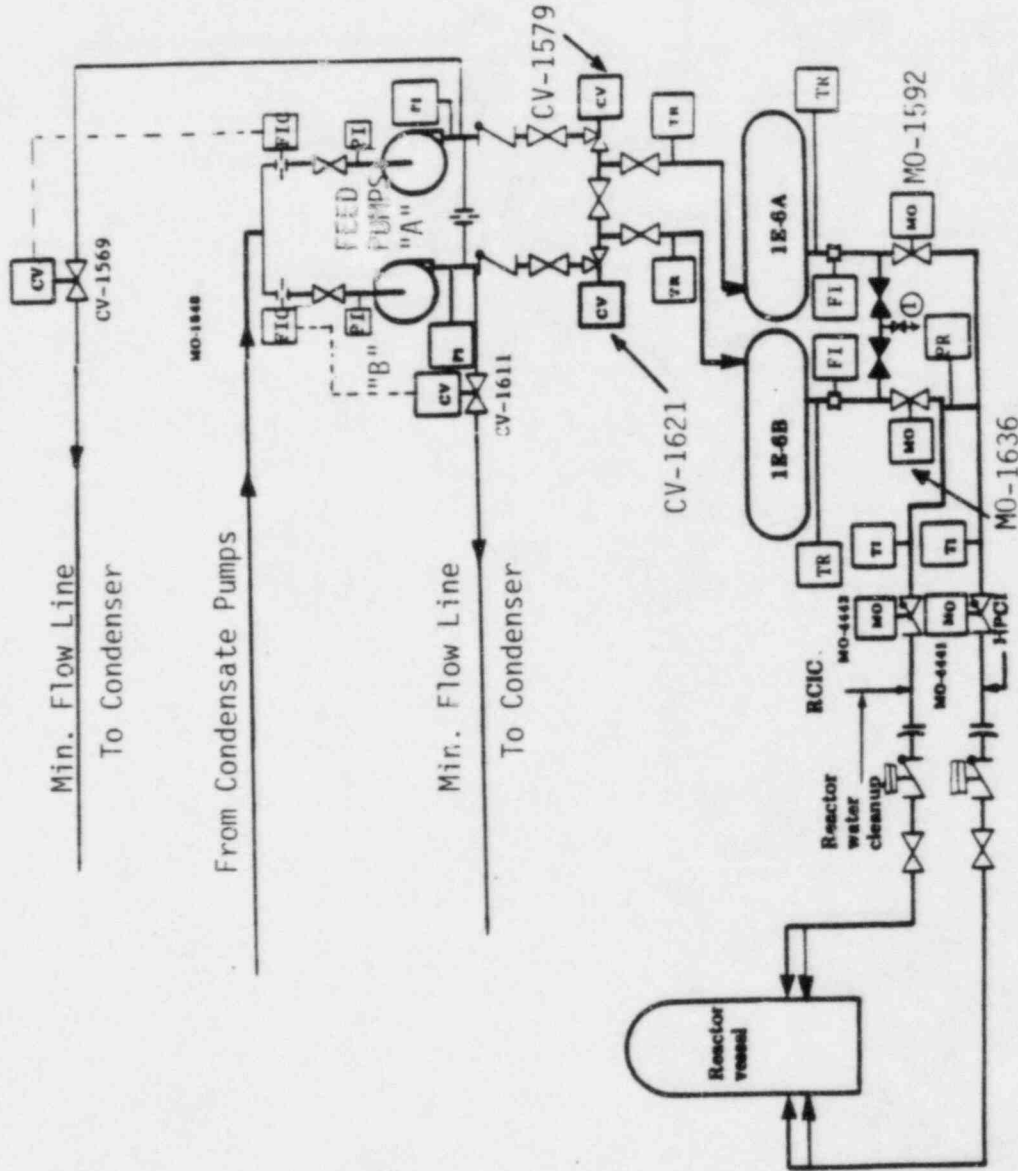
Figure 1
Feedwater Schematic

Investigation following the scram revealed that the Moore position controllers (Moore Products - Model 74G) on the Feedwater Control Valves CV-1621, and CV-1579 were found to cause excessive valve position hunting/ position fluctuations near the closed position. This condition was caused by desiccant in the instrument air lines, which restricted air flow through the inlet orifices in the positioners. With the Reactor at low pressure, the block valves MO-1636 and MO-1592 are unable to open against Feedwater Pump Pressure, as these valves are not designed to open against a large pressure differential. In conclusion, the fluctuating control valves were unable to close enough to sufficiently control flow. It was then necessary to close the block valve. This combination of the regulating valve being too far open and the block valve being too far closed created too high a differential pressure across the block valve and prevented it from opening. (See attached Figure 1 for feedwater flow paths.)
