**LICENSEE EVENT REPORT (LER)**

| FACILITY NAME (1)<br>Millstone Nuclear Power Station Unit 3 | | DOCKET NUMBER (2)<br>05000423 | PAGE (3)<br>1 of 5 |

TITLE (4)  
Verification of ECCS Piping Full of Water Per Technical Specification 4.5.2.b.1 Not Being Met

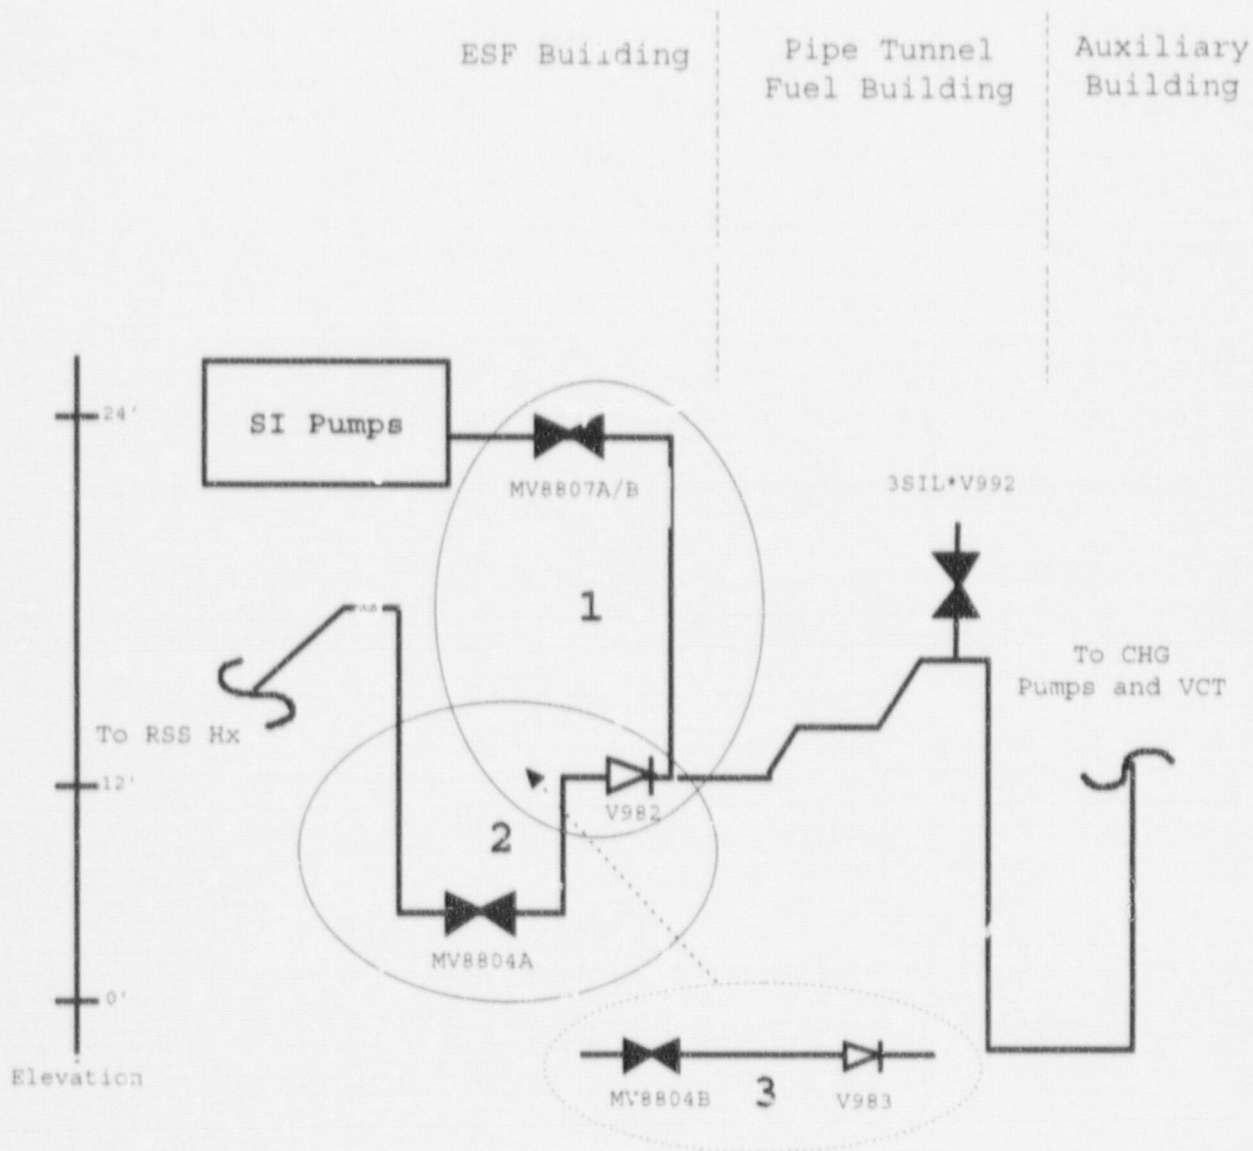
The investigation into this issue, which included detailed discussions with system/design engineers and operations personnel, as well as a review of the applicable surveillance procedures and isometric drawings, identified three segments of ECCS pump suction crossover piping that were neither included in, nor specifically excluded from, the verification process. See Figure 1 for a simplified sketch of the segment configurations. The three piping segments identified were: upstream of valves MV8807A&B and downstream of valve V982 (suction cross-tie between the Safety Injection [SI] and Charging [CHS] pumps), between valve V982 and valve MV8804A (common CHS suction from pump RSS\*E1A), and between valve V983 and valve MV8804B (common SI suction from pump RSS\*E1B). Of these segments, the cross-tie section (Segment 1) between the SI and CHG pumps (between valve MV8807 A/B and valve V982) is a system high point while segments 2 and 3 are not high points in the system, i.e., not locations where gases would be expected to collect.

Currently, the ability to vent the piping section between the 'B' SI pump and valves MV8807A&B (segment 1) is through the pump casing and this activity is performed within a venting procedure, however, the MV8807 valves are not opened. Thus, the segment between valves MV8807A&B and the check valve is not specifically vented and it can not be demonstrated that this piping segment is free of air. Opening the MV8807 valves to vent through the pump casing requires management of an abnormal valve lineup which eliminates the separation between RHR and SI systems. This scenario was not considered during the development of the venting procedure.

Segments 2 and 3 are at a mid-point in the system. There are no vent points within these piping segments. These segments link the RSS pump discharge to the SI or charging pumps following switchover to recirculation mode.

However, these piping segments were not considered during the initial procedure development due to their physical location (at mid-point) and physical lack of venting capability. Check valves were added to these piping segments during development of the original Westinghouse design in 1972. No provisions for venting these piping segments were included at that time.

On January 9, 1998, after performance of normal filling of the system, ultrasonic testing (UT) of these piping segments was performed as part of an evaluation into other related RSS activities. Results of UT examinations did not reveal the presence of air or gas pockets in piping segment 1, although a small amount of trapped air was found at a low point in piping segment 3 (between valves MV8804B and V983). It was subsequently determined that the amount of air found was insignificant and would not adversely impact the ECCS system from performing its accident mitigating function. Therefore, there was minimal safety significance from this condition.

1. Prior to entry into Mode 3, the ECCS venting surveillance procedure will be revised to include the applicable portions of the Emergency Core Cooling System piping.
2. Prior to entry into Mode 3, the revised surveillance procedure will be performed to assure that the ECCS piping is verified "full of water."
3. By May 15, 1998, a Technical Specifications BASES section change will be prepared and implemented to clarify Emergency Core Cooling System venting process information.
