LICENSEE EVENT REPORT (LER)

FACILITY NAME (1) Calvert Cliffs, Unit 2										DOCKET NUMBER (2) 050003118										PAGE (3) 1 OF 013	
TITLE (4) Inadvertent Engineered Safety Features Actuation Due to Failed Logic Module																					
EVENT DATE (5)			LER NUMBER (6)				REPORT DATE (7)			OTHER FACILITIES INVOLVED (8)											
MONTH	DAY	YEAR	YEAR	SEQUENTIAL NUMBER	REVISION NUMBER	MONTH	DAY	YEAR	FACILITY NAMES			DOCKET NUMBER(S)									
03	15	86	86	003	00	04	11	86				050003									
OPERATING MODE (9) 3		THIS REPORT IS SUBMITTED PURSUANT TO THE REQUIREMENTS OF 10 CFR 5: (Check one or more of the following) (11)																			
POWER LEVEL (10) 01010		20.402(b)				20.408(e)				<input checked="" type="checkbox"/> 80.73(a)(2)(iv)		73.71(b)

LER # 86-003-00

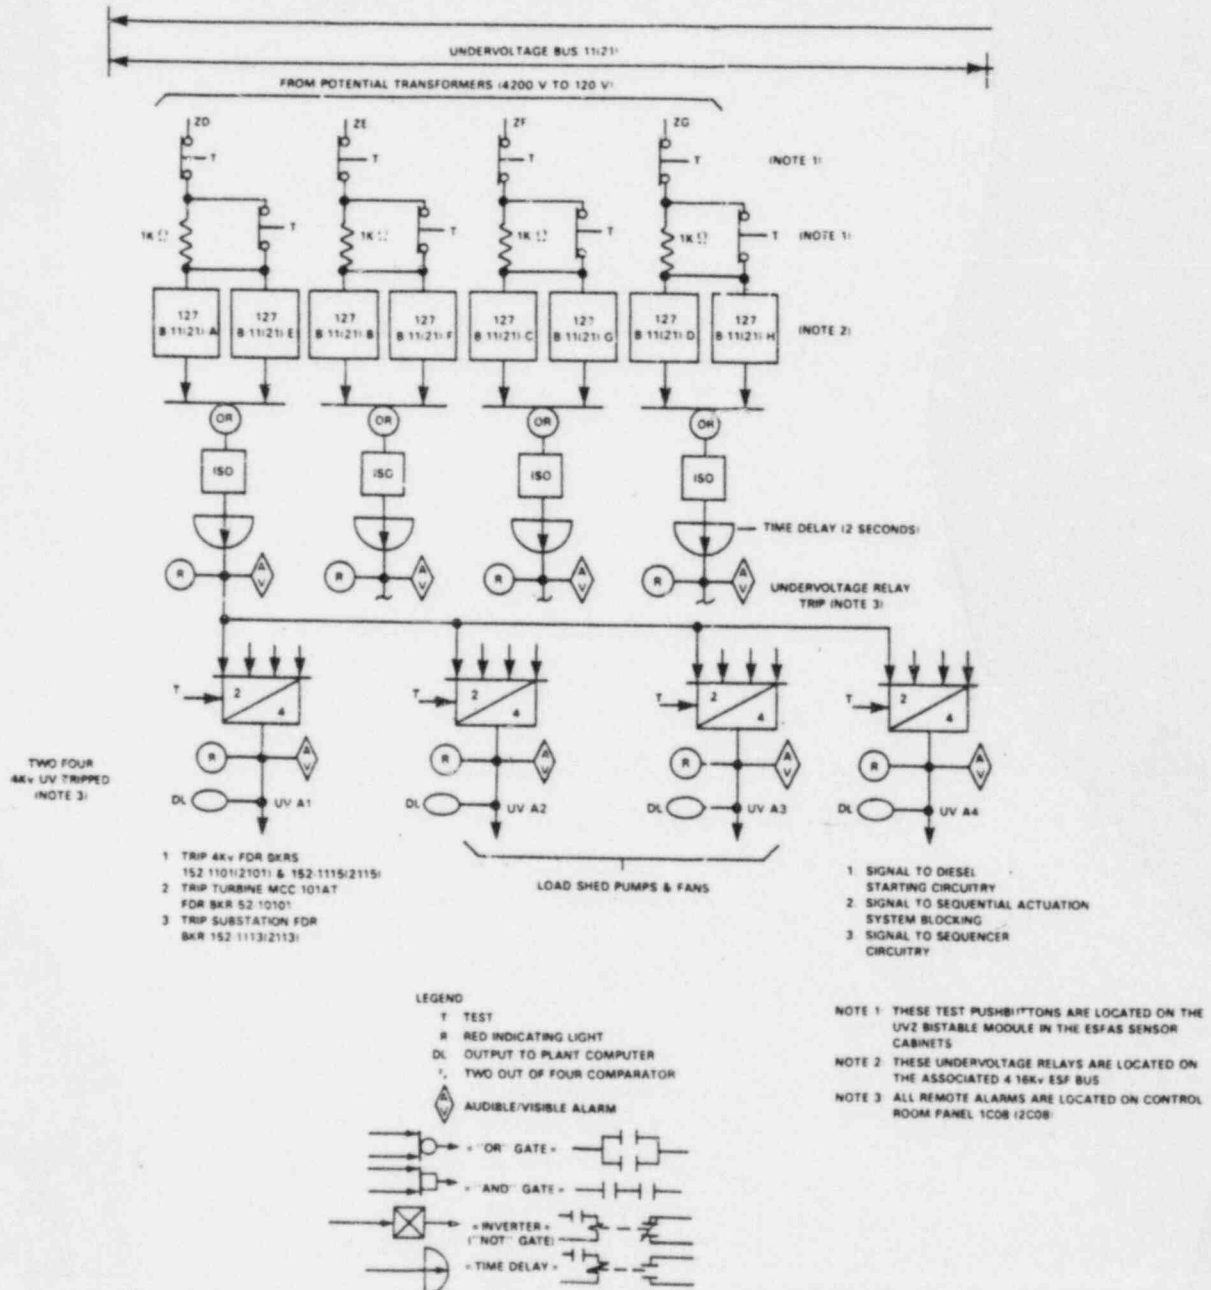
FIGURE 1

At 0247 on March 15, 1986 while shutdown in MODE 3 (hot standby), #21 4KV Emergency Bus (EHS EB-BU) inadvertently de-energized when the normal feeder breaker (EHS EB-52) to Bus #21 tripped. Number 12 Emergency Diesel Generator (EHS-EK) started automatically due to Bus #21 undervoltage, but did not close on the bus because #12 Emergency Diesel Generator is the swing Diesel Generator shared with Unit 1 and will not automatically close on a bus unless there is a coincident Safety Injection Actuation Signal. Control Room operators properly evaluated the event and inspected #21 Bus. After they found no protective relays tripped, an attempt was made to reclose the normal feeder breaker, but the breaker immediately tripped. At 0305 March 15, 1986, #21 Bus was re-energized by manually closing in #12 Emergency Diesel Generator. Operators then inspected the Engineered Safety Features Actuation System (EHS JE) cabinets and found the UVA-1 (Undervoltage Actuation - Subchannel 1) logic module (EHS JC-IMOD) failed in the tripped condition. The UVA-1 logic module normally trips or actuates upon receiving two out of four bus undervoltage input signals. Its function is to ensure Bus #21 is de-energized by tripping bus feeder breakers such that the Emergency Diesel Generator will close on a dead bus in an accident condition (i.e. Safety Injection Actuation) (see figure 1). Similar logic modules (UVA-2, UVA-3, and UVA-4) (EHS JC-IMOD) receive the same input signals and actuate to shed bus loads (UVA-2 and UVA-3) or start the Emergency Diesel Generator (UVA-4). Logic modules UVA-2, 3, and 4 did not initially actuate when UVA-1 failed but did actuate after the UVA-1 failure caused an actual bus undervoltage. Except for the UVA-1 failure all systems responded properly. The failed UVA-1 logic module was replaced and tested and #21 4KV Bus returned to normal by 0435 on March 15, 1986.

Immediate corrective actions consisted of replacing the failed UVA-1 logic module with a new module from stock (Vitro Model 1628-1033), functionally testing the new module, verifying the logic power supplies were operating properly, and functionally testing the other UVA logic modules. Additional planned corrective actions include: 1) returning the failed UVA-1 logic module to the vendor for failure analysis and repair; 2) researching maintenance history to determine mean time between failures for this type of module; and 3) an engineering evaluation of the vendors failure analysis will be conducted to determine the need for additional corrective actions, if any.
