James A. FitzPatrick
Nuclear Power Plant
268 Lake Road
P.O. Box 41
Lycoming, New York 13093
315-342-3840

Subject: **Docket No. 50-333**
LICENSEE EVENT REPORT: LER-97-012-01

Drywell Personnel Airlock Outer Door Seals Local Leak Rate Test Not Properly Performed

TITLE (4)
Drywell Personnel Airlock Outer Door Seals Local Leak Rate Test Not Properly Performed

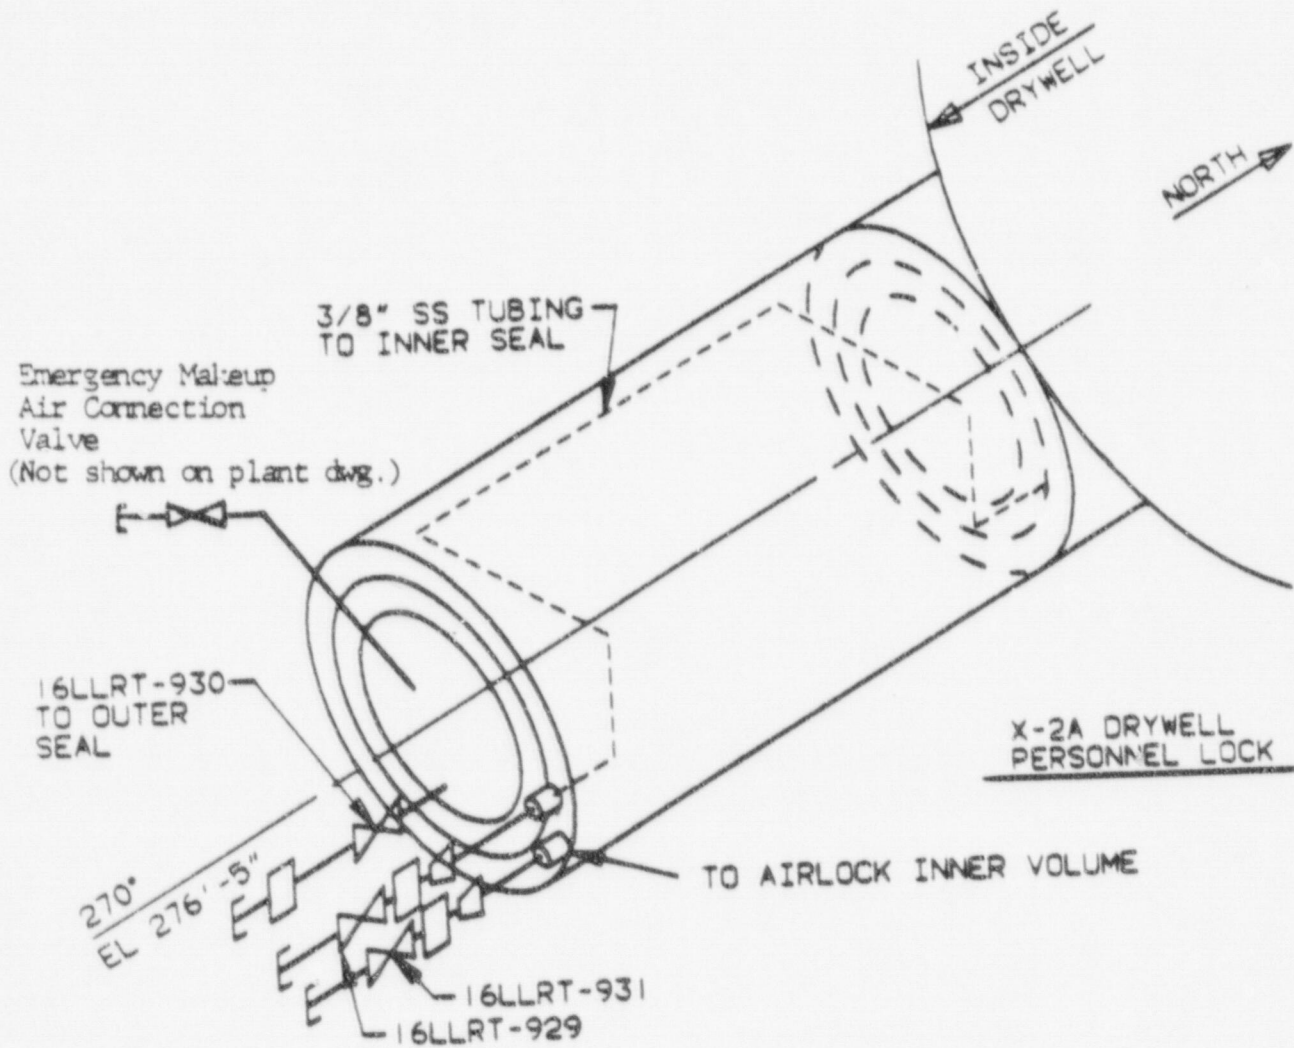
FIGURE 1

- 11/15/96 2 of the 3 LLRT valves in the drywell entrance are replaced by mechanical maintenance under WRs 95-3853-00 and 95-3854-00. As part of the valve replacement work the temporary labels were replaced with permanent labels. A permanent plant label for valve 16LLRT-930 (airlock outer door seals test connection valve) is incorrectly installed on the airlock emergency makeup air connection valve at the completion of this maintenance. The other 2 LLRT valves were properly labeled. In addition, the mechanical maintenance installer incorrectly replaced the air lock emergency makeup air connection valve (an identical valve) instead of one of the LLRT valves (16LLRT-930) as planned. Due to the fact that the valves were identical, the improper valve replacement did not result in any further plant impact.

- 11/17/96 The configuration label coordinator incorrectly performed an independent verification of the installation of the 3 permanent plant labels utilizing drawing DSK-16G ("LLRT Connections"). Contributing to this error was the absence of the airlock emergency makeup air connection valve (which was not an LLRT connection) on drawing DSK-16G. (see figure 1)

The cause for this failure to properly perform the TS required surveillance test was a loss of configuration control of the correct test valve, 16LLRT-930. Based on review of plant records and photographs of field walkdowns, it appears the mislabeling of 16LLRT-930 occurred during planned maintenance on November 15, 1996. The maintenance mechanic, however, has no specific recollection of the maintenance activity or the labeling he performed of the LLRT test valves for the personnel airlock. The reason for the mislabeling event is not known, but it is assumed to be a human performance error. The independent verification of the valve labeling performed by the configuration label coordinator was inadequate in that he failed to identify that the correct component had not been properly labeled. The root cause evaluation confirmed the maintenance mechanic and label coordinator failed to identify and verify the correct test valve, resulting in improper labeling and maintenance on the wrong valve which resulted in a loss of configuration control.

6. Plant drawing DSK-16g will be updated to reflect the presence of the emergency makeup air connection valve and provide additional clarification to the LLRT connections. (Completed January 23, 1998)
