Licensee Event Report #97-031-02 Docket #050-373 is being submitted to your office to update the safety analysis.

**FACILITY NAME (1):** LaSalle County Station Unit One  
**DOCKET NUMBER (2):** 05000373  
**PAGE (3):** 1 of 12

**TITLE (4):** Leak Detection Area Temperature Calculation Errors Result in Plant Operation Outside Design Basis and Technical Specifications Due to Inadequate Technical Review

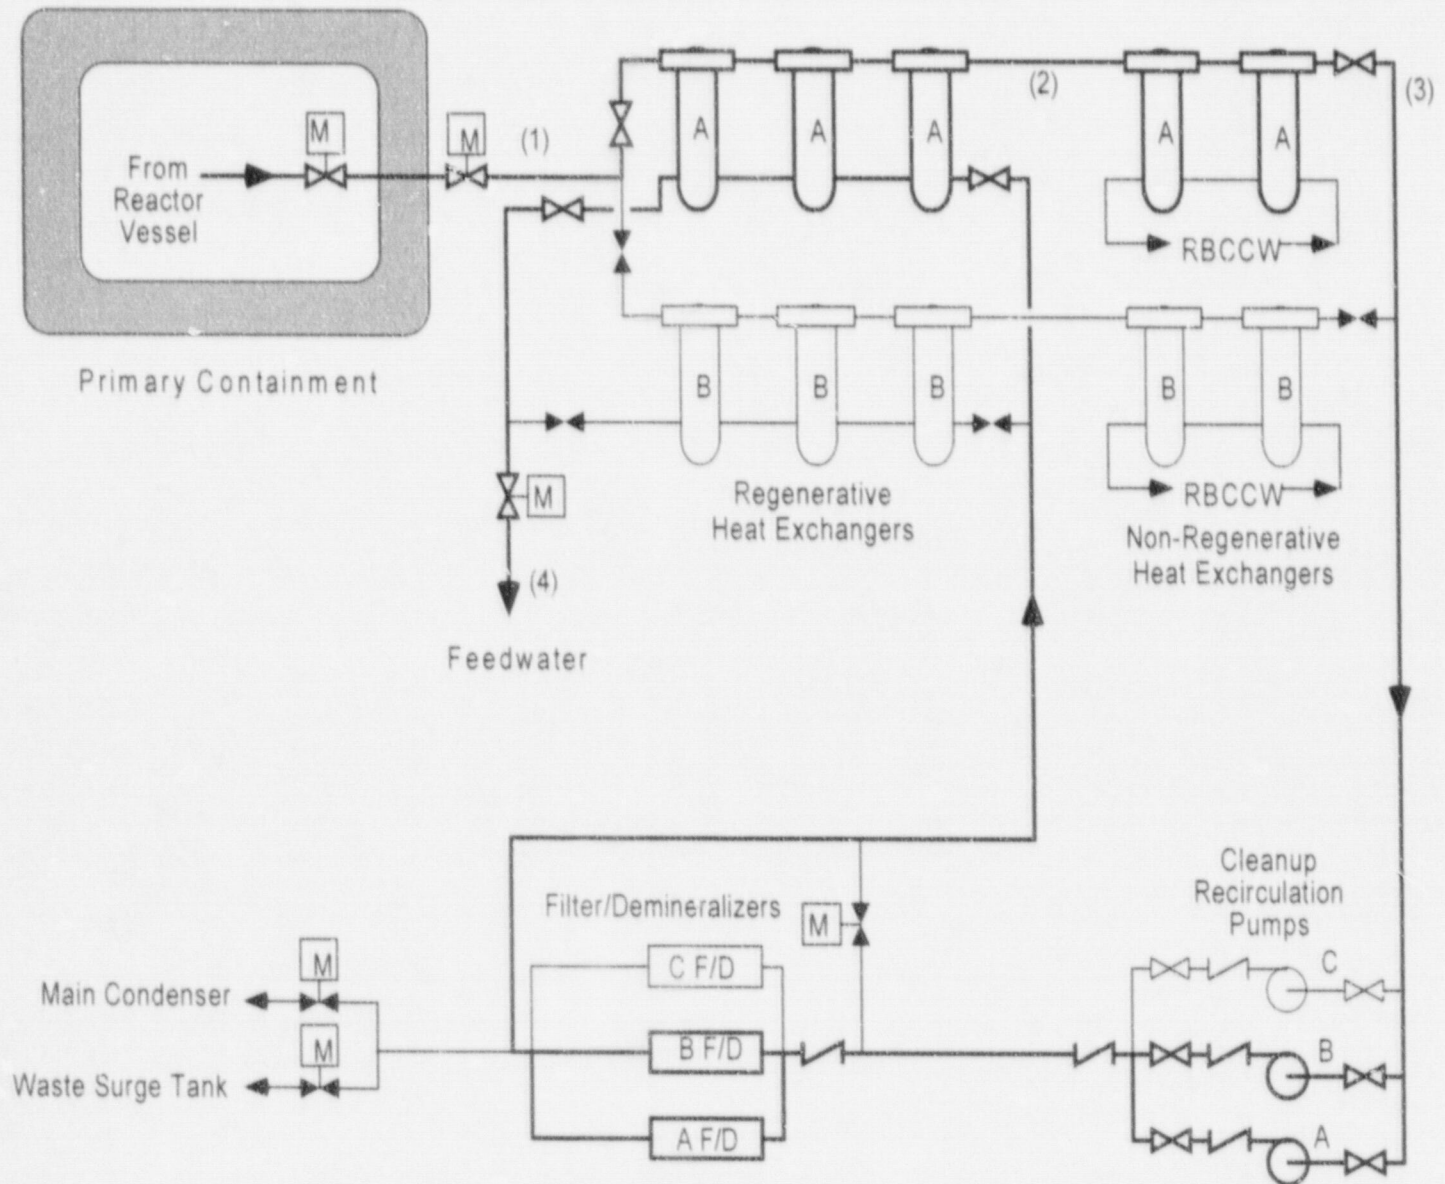
Figure 1: Reactor Water Cleanup System

Under normal conditions, four different process flow temperature conditions exist in the RWCU Heat Exchanger Room (See Attachment 1). Stream (1): The process stream entering the regenerative heat exchanger is nearly reactor coolant temperature (maximum 550 degrees Fahrenheit). Stream (2): The process stream exiting the regenerative heat exchanger to the non-regenerative heat exchanger has been cooled to approximately 230 degrees Fahrenheit by the process stream returning from the demineralizers before entering the non-regenerative heat exchanger. Stream (3): The outlet of the non-regenerative heat exchanger is cooled to approximately 120 degrees Fahrenheit which then flows to the demineralizers before returning to cool the process stream (1) flow. Stream (4): The return to the feedwater system from the regenerative heat exchanger, which has been heated to approximately 435 degrees Fahrenheit.

A General Electric Design Specification states leakage from high temperature piping of the RWCU system equipment areas shall be detected by temperature sensing elements. In the design basis calculations, this was process stream (1). Since the temperature in process stream (4) is lower than stream (1), leaks less than 49 gpm (winter conditions) would not have isolated on high temperature. A leak from process streams (2) or (3) would not be detected.

The Technical Specification allowable values are 187 degrees Fahrenheit for the high temperature isolation and 91 degrees Fahrenheit for the high differential temperature isolation. The new design basis calculation establishes the setpoint for a 25 gpm leak from process stream (4) under summer conditions. The calculation indicates that the analytical basis is approximately 160 degrees Fahrenheit for the high temperature isolation and 42 degrees Fahrenheit for the differential temperature isolation. This results in a high temperature isolation for a 36.4 gpm leak or a 17 gpm leak on differential temperature during the winter. The new Technical Specification values will need to be lower than the current setpoint, which was based on process stream (1) leak conditions.

The root cause for the errors in the RWCU calculation is not known. The General Electric Design Specification states that high temperature process leaks shall be detected. This statement was interpreted in 1981 to mean that the highest temperature process stream [RWCU process stream (1) noted above] should be the basis for the leak detection heat balance. The justification for this interpretation is not documented. The new design basis considers the lower high temperature process stream (stream 4) as the source of the leak and establishes the setpoints accordingly.

For RWCU a leakage rate higher than 25 gpm may be necessary in some instances to actuate isolation, because the original design basis calculations established the temperature analytical limits by considering the possibility of leakage from the highest process temperature (546 degrees Fahrenheit) lines in the room. Leakage from the lower temperature process return line (437 degrees Fahrenheit) would have to be on the order of 45 gpm to actuate the ambient temperature isolation, or 48 gpm to actuate the isolation on high differential temperature. The consequences of leaks of these magnitudes are bounded by the main steamline/feedwater break discussed in the UFSAR Chapter 15 "Accident Analysis". The 45 and 48 gpm leakage rates are also below the leakage expected from a crack of critical dimensions as shown in UFSAR Figure 5.2-11. Sump alarms from floor drains in the RWCU Heat Exchanger and Valve Rooms would actuate in approximately 30-45 minutes from leaks of these magnitudes. This alarm would result in operator investigation and action to isolate the leak. Additionally, there is no safety-related equipment in this area except the leak detection temperature sensors. These sensors are qualified for a steam environment; therefore, there is minimal safety significance from the possible larger leakage rates that would have been necessary to actuate isolation as a result of only utilizing the highest process temperature when determining analytical temperature limits in this area.
