U. S. NUCLEAR REGULATORY COMMISSION
REGION 1

Report No: 50-443/97-09

Licensee: North Atlantic Energy Service Corporation

Seabrook Generating Station, Unit 1
NRC Inspection Report 50-443/97-09

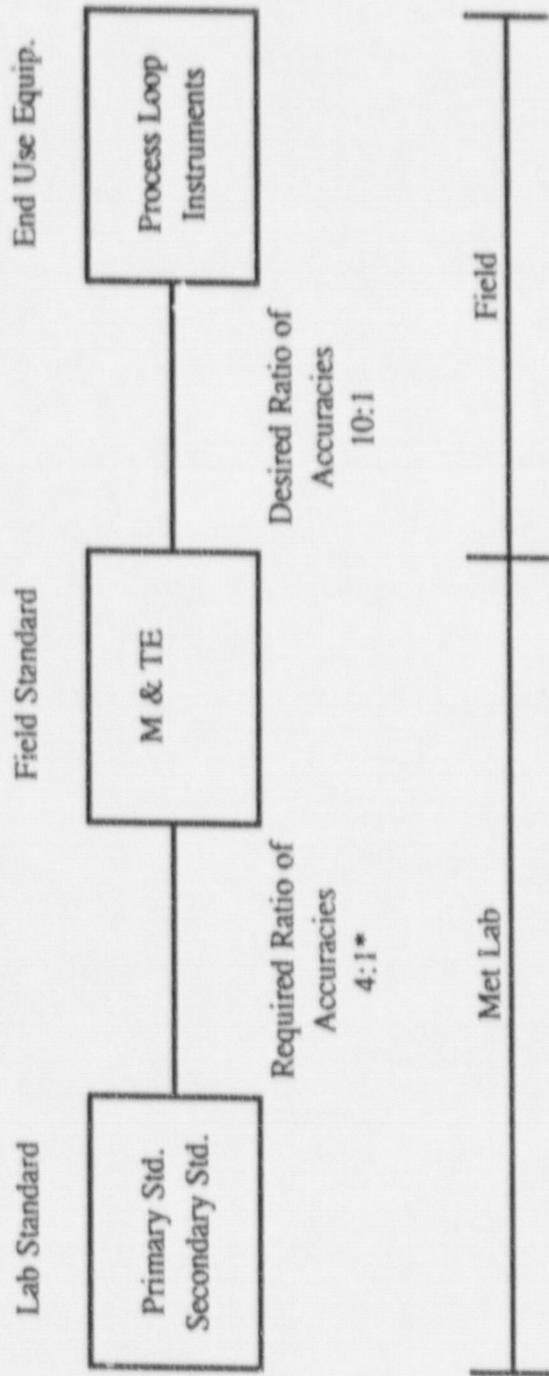
Calibration Block Diagram

* Per MA 2.3 Section 4.4.2.2 - Deviations require justification and documentation
