**OREGON STATE UNIVERSITY**

Reference: Oregon State University TRIGA Reactor (OSTR)  
Docket No. 50-243, License No. R-106

Subject: Scram Failure on February 17, 1998 - Event No. 33732

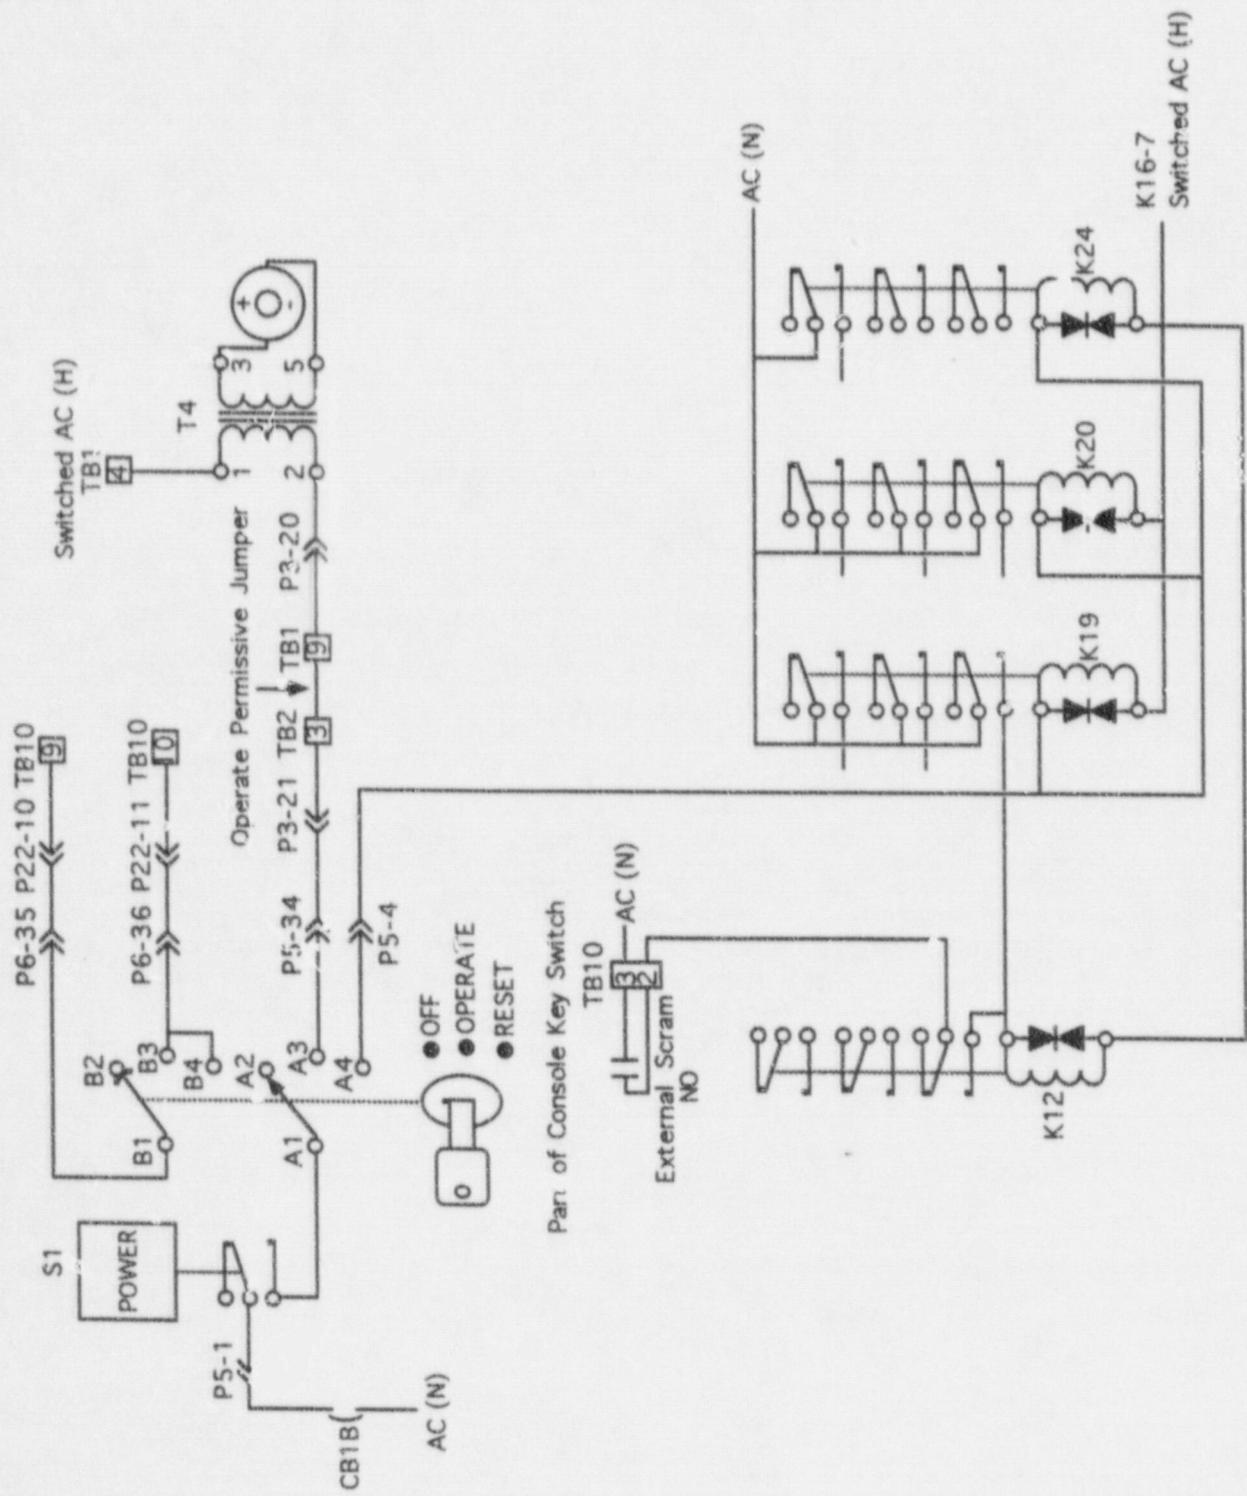
Figure 1. Reactor Operate Circuit, As-designed

The second cause is a wiring change that makes the OSTR circuit different from that in the original General Atomics (GA) Instrument Maintenance Manual. Figure 1 shows the relevant portion of circuitry as designed and shown in the GA manual. It can be seen that if the key switch is turned to the OPERATE position, magnet current is supplied from terminal block one, terminal number four (TB1-4) through TE 1-9, then TB2-3, A3, A1 and the console power switch. However, when the key

is turned to RESET, this circuit is opened and there is no magnet current, thereby causing the rods to drop in if they were up, or disabling their withdrawal if they were down.

2. The wiring has been restored to its as-designed condition (Figure 1). Specifically, the connection between TB1-9 and TB10-10 has been removed and a jumper has been installed between TB1-9 and TB2-3. This action ensures that the event cannot be repeated, since whenever the key switch is turned to the RESET position, the magnet current is interrupted. TRIGA facilities which are wired in this manner have performed physical tests demonstrating that this arrangement performs as intended.

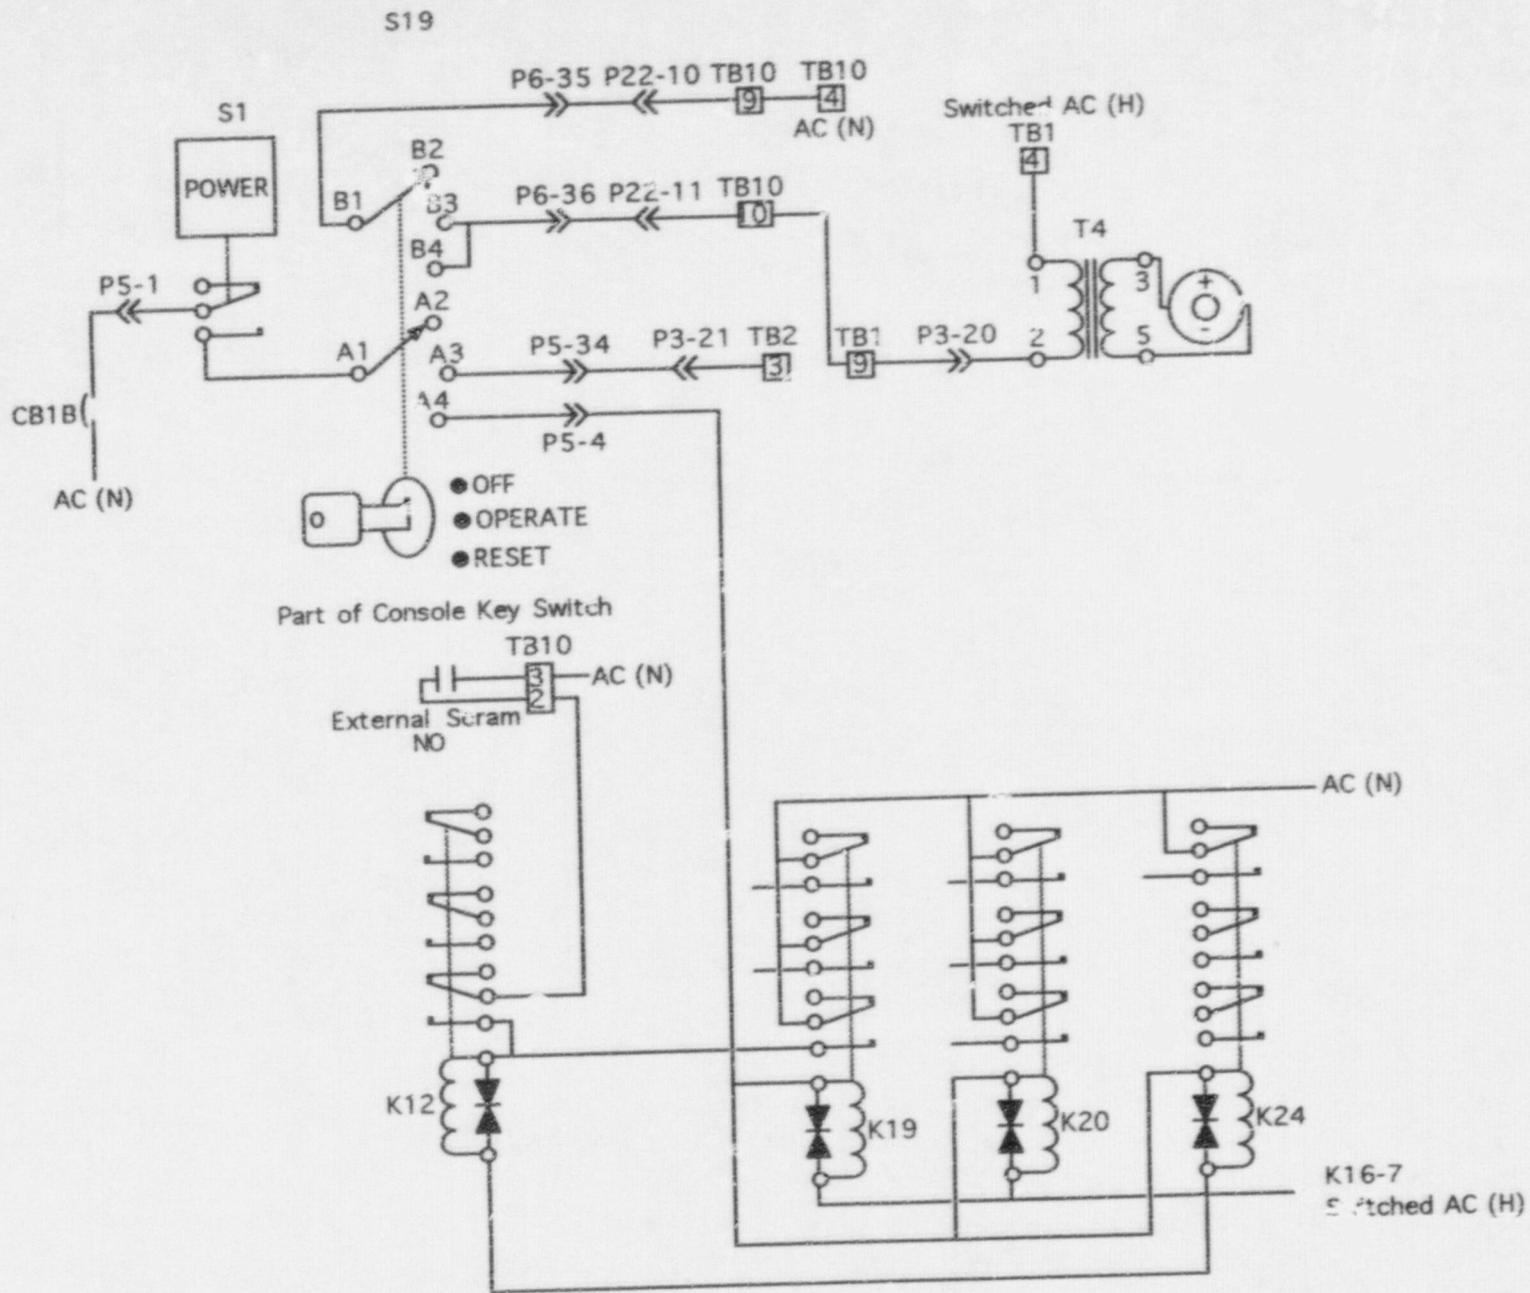
Figure 2. Reactor Operate Circuit - As Found

The occurrence has two causes. The first is the fact that the spring return key switch failed to return completely to the OPERATE position after being turned to reset the scrams. Logical analysis concludes that it must have been making electrical contact in the RESET position, i.e. touching contacts A4 and B4. (See attached figures.) The root cause for its failure to completely return to the OPERATE position appears to have been a long term build-up of dirt. Since being removed, cleaned, and relubricated the switch shows no tendency at all of being sticky or of not fully returning to the OPERATE position.

A careful examination of the *actual* OSTR console circuitry showed that it was different from that illustrated in the GA manual. The difference can be seen in Figure 2, where it is shown that the jumper between TB1-9 and TB2-3 is in fact between TB1-9 and TB10-10. The impact of this change is that control rod magnets have power whenever the key switch is in either the OPERATE or the RESET position. During the event under discussion, when the key switch did not fully return to the OPERATE position, the reset relays and the control rod magnets were both energized. Therefore, when the manual scram button was pushed, the relay did not close and the reactor did not scram.

Investigations of OSTR documentation have resulted in the conclusion that the jumper was wired in this manner sometime during the initial installation of the reactor console. The records which were reviewed in an attempt to determine when this occurred included the 10 CFR 50.59 safety evaluation file, the reactor installation log, the Reactor Supervisor's log, the Reactor Operations Committee minutes, the reactor console log, the console circuit diagrams and the circuit change log, as well as the active and inactive experiments log. In addition, personnel who were involved with the facility in the early days were interviewed to see if they had any recollection of changes associated with the key switch.

3. The OSTR Scientific Instrument Technician, with the assistance of the reactor operations staff, has performed a physical, electronic check of the wiring in the scram circuitry and demonstrated that it is as originally designed and approved. These tests were performed under the observation of an NRC inspector, Mr. Craig Bassett. Other non-scram related circuits have also been checked and shown to be as-designed. These checks provide good assurance that there are no other similar unknown conditions or deviations from the approved design.
