LICENSEE EVENT REPORT (LER)

FACILITY NAME (1) CRYSTAL RIVER UNIT 3	DOCKET NUMBER (2) 0 5 0 0 0 3 0 2	PAGE (3) 1 OF 0 4
--	---	-----------------------------

TITLE (4)
LEAKS DISCOVERED IN THE NUCLEAR SERVICES SEA WATER SYSTEM

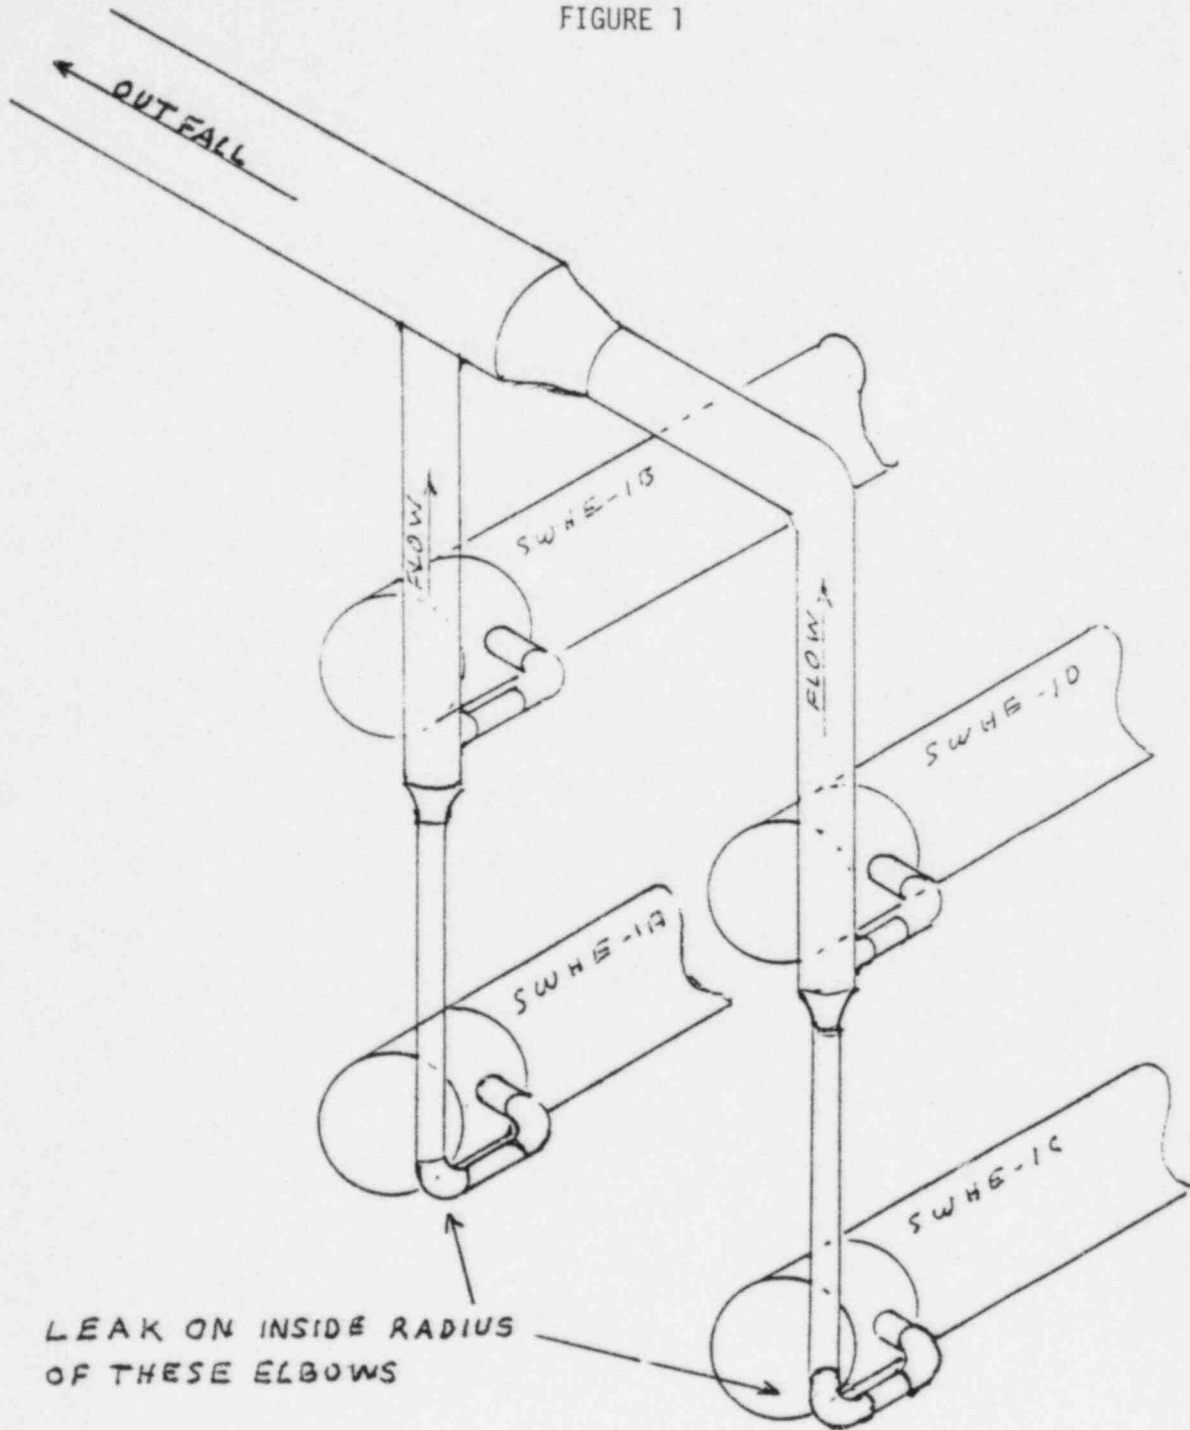
FIGURE 1

On August 12, 1986, Crystal River Unit 3 was operating at 94% reactor power and producing 870 MWe. At about 1800 the auxiliary building non-licensed operator discovered a leak in the Nuclear Services Sea Water System piping (KE, PSF) downstream from the "A" Nuclear Services Closed Cycle Cooling System heat exchanger (SWHE-1A) (CC, HX) (see Figure 1). The discovery was made during a routine inspection of operating equipment. The leak was stopped approximately two hours later when an external compression patch was applied over the leaking pipe. Subsequently, while a more permanent repair was being designed, ultrasonic testing performed on the remainder of the affected section of piping indicated the degradation was localized.

Prompted by this leak, it was decided to perform ultrasonic testing on the corresponding section of pipe from a redundant heat exchanger (SWHE-1C). On August 18, 1986, while preparing that section of pipe for ultrasonic testing, it developed a leak in approximately the same location. This leak was stopped similarly to the previous leak.

The two sections of pipe involved are fourteen inch diameter 90 degree elbows. These elbows are PVC lined carbon steel and were manufactured by the Kelley Company.

Ultrasonic testing of the two sections of pipe confirmed the degradation is confined to a small area (less than two inches in diameter) around the leaks. Calculations indicate the system still meets seismic, deadweight, and pressure requirements. These are the only two elbows with orientation changing flow from horizontal to vertical not previously relined with urethane.

The leaks in the Nuclear Services Sea Water System piping are believed to be the result of erosion caused by suspended solids in the unfiltered sea water. Both of these leaks were located in an area of high turbulence.

The leaking elbows have been encapsulated by welding another elbow over the defective sections and the void between the pipe and the encasement has been filled with Master Flow 713, a cement grout. During the next refueling outage, the Nuclear Services Sea Water System piping will be evaluated for needed repairs.
