LICENSEE EVENT REPORT (LER)

FACILITY NAME (1) Beaver Valley Power Station, Unit 1	DOCKET NUMBER (2) 0 5 0 0 0 3 3 4	PAGE (3) 1 OF 5
--	--------------------------------------	--------------------

TITLE (4)
Inoperable Fire Detection System in Diesel Generator Area

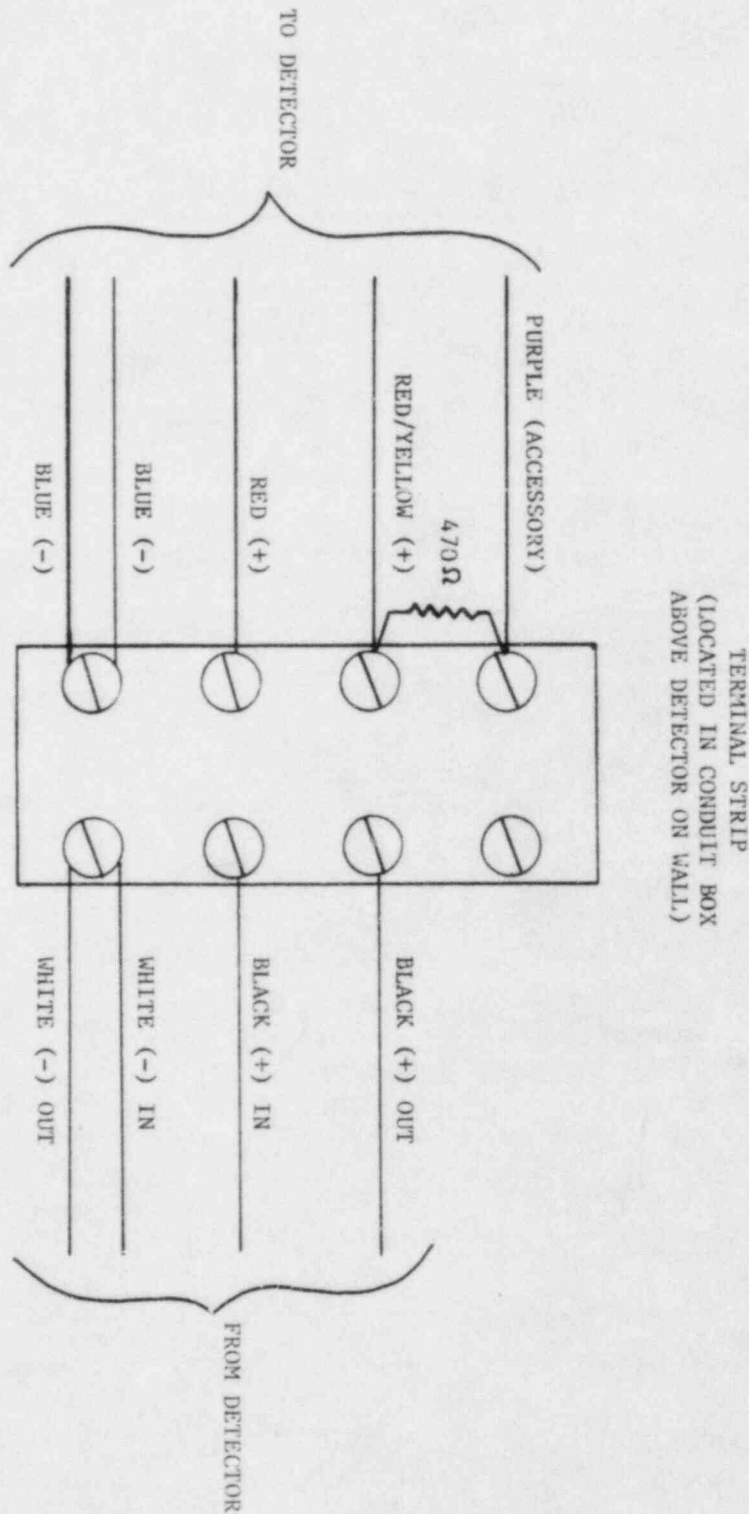
FIGURE 1

On 4/1/86, Honeywell personnel arrived on site to troubleshoot the #2 Diesel Generator Fire Protection System. They confirmed that two of the #2 Diesel Generator's smoke detectors were inoperable. Further investigation determined that the one inoperable detector (D100) had a missing 470 Ohm accessory resistor. The other inoperable detector (D101) had its accessory resistor in place but had a loose connection (due to a loose screw) where one of the resistors was attached to the detector's conduit box terminal strip (see attached Figure 1). Both the inoperable detectors were type TC100C. These detectors, when alarmed, draw 26 mA of current. This 26 mA of current is not enough to trigger an alarm in the local fire alarm panel (type W931). In order to increase the alarm current, Honeywell installed these accessory resistors in parallel with the detectors alarm LED (see attached Figure 2: Schematic of TC100C Smoke Detector). The resistor is across detector junction points J2-5 and J2-3. This is done by physically placing the resistor across the purple and the red/yellow wires at the detector terminal strip located approximately six inches from the detector (see Figure 1).

Detector D100 (the one with the missing resistor) had been replaced by Honeywell personnel in January 1985. It is believed that when the detector was replaced, the technician failed to re-install the resistor. Detector D101 had been replaced in August 1984. It is not known if the terminal strip screw was left loose at this time or if it came loose at a later date. An accessory resistor was added to detector D100's terminal strip. The loose connection on D101's terminal strip was tightened. After these corrective actions were taken, both detectors were verified to operate/alarm properly.

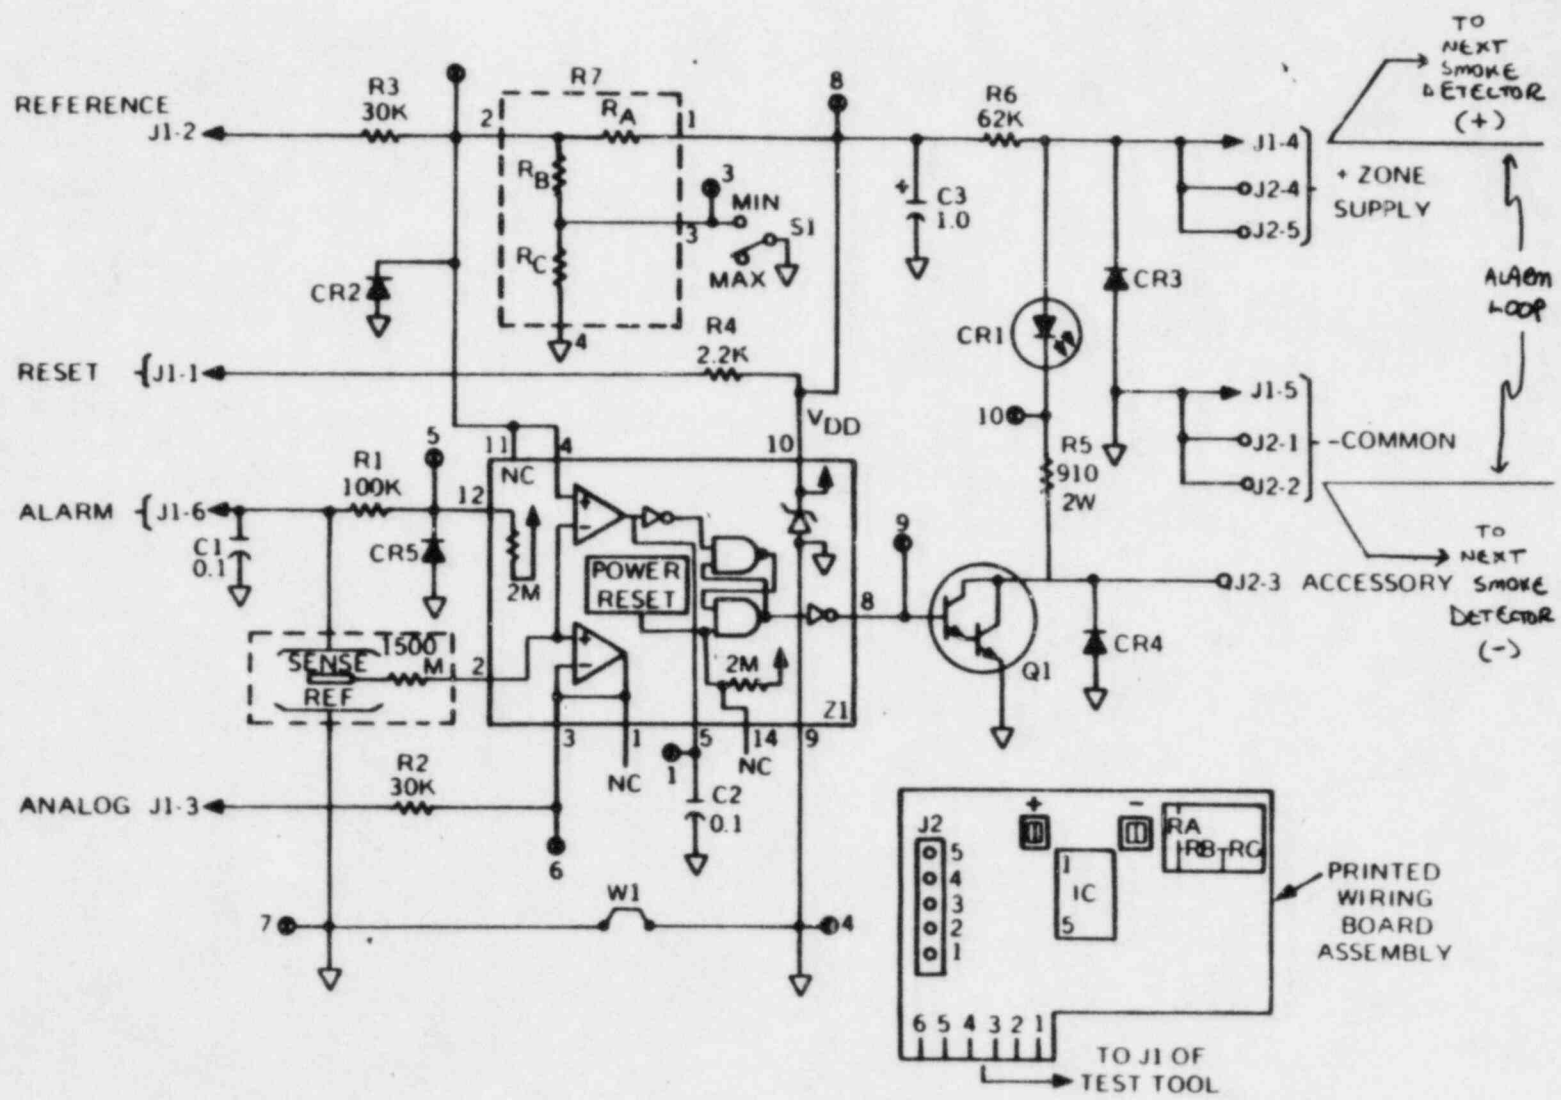
FIGURE 2

Schematic-TC100C Smoke Detector.
