AEOD TECHNICAL REVIEW REPORT^{1/}

UNIT: Davis-Besse Unit 1 TR REPORT NO.: AEOD/T603
DOCKET NO.: 50-346 DATE: April 30, 1986
LICENSEE: Toledo Edison Co. EVALUATOR/CONTACT: R. Tripathi

SUBJECT: INADVERTENT PUMP SUCTION TRANSFER AND POTENTIAL AUXILIARY
FEEDWATER PUMP CAVITATION AT DAVIS-BESSE

EVENT DATE/LER NO.: January 15, 1985; LER NO. 50-346/85-002-00

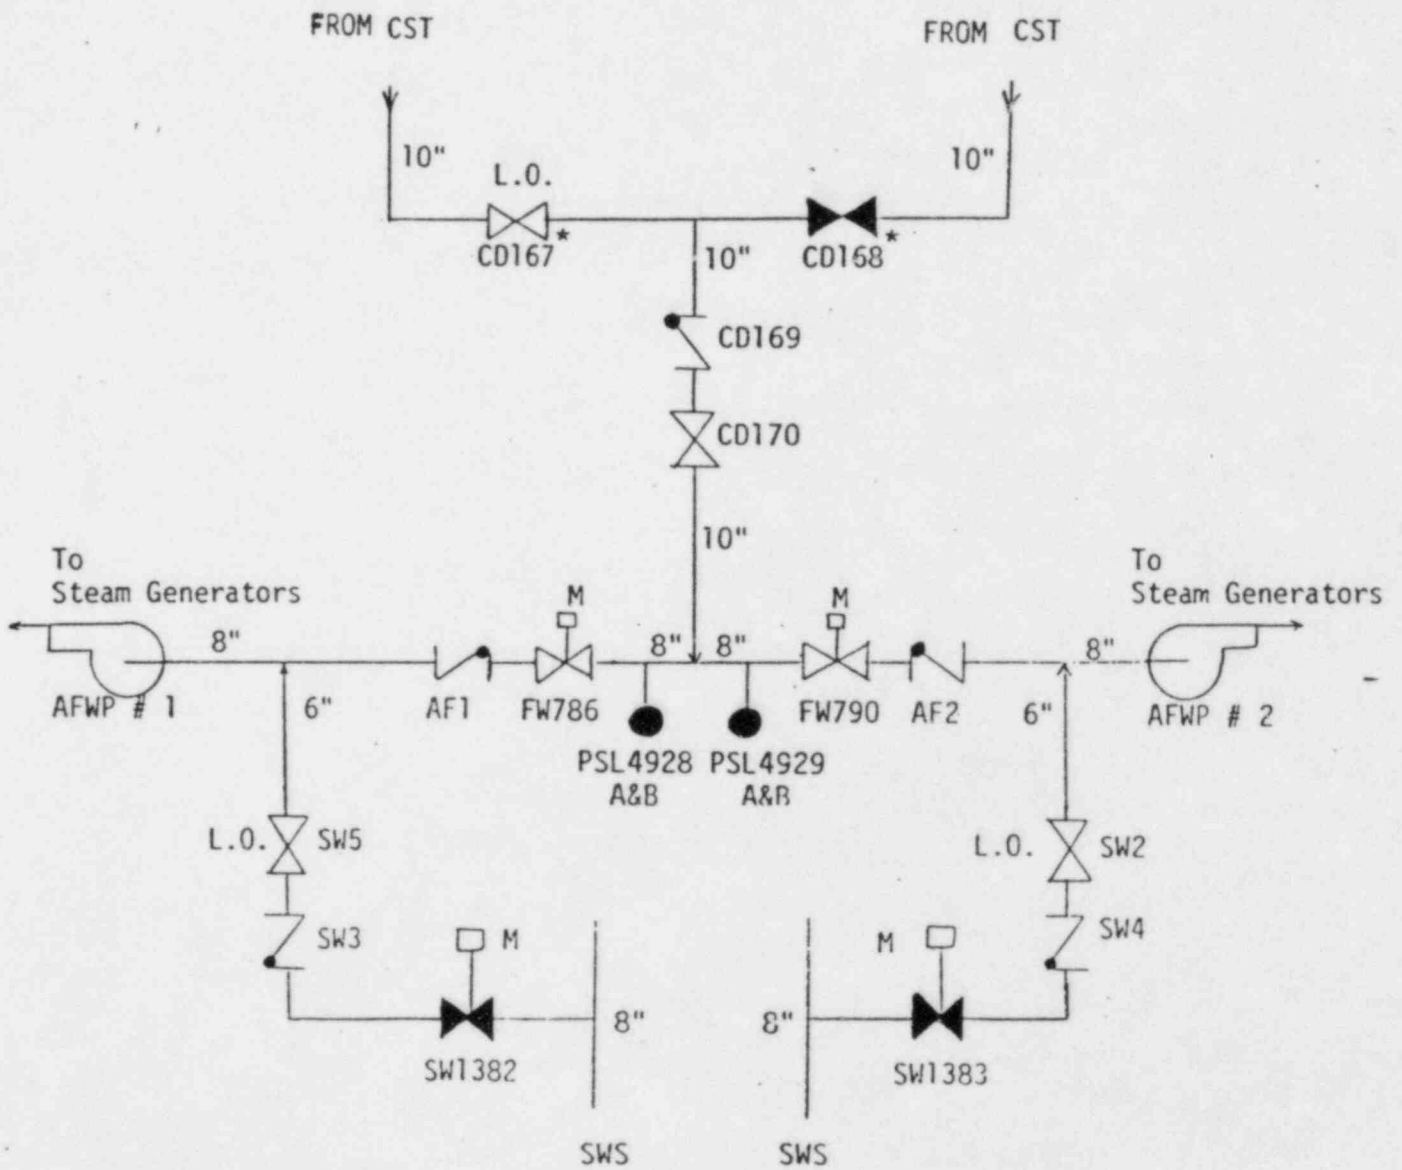
Figure-1 Davis-Besse AFW Suction Line-up

As described in Reference 1, following the June 9, 1985 event, the licensee has performed a study to investigate the cause of this and the past inadvertent transfers of the AFWP suction from the CST to the SWS. That study concluded that drop in the suction pressure due to the conical strainer S257 (downstream of the CST) may be responsible for the inadvertent AFWP suction transfer.

Figure 1 shows a schematic of the supply lines to the AFWPs. In the current design, the feedwater valves FW786 and FW790 close on sensing low suction pressure, and service water valves SW1382 and SW1383 open. If it is an inadvertent transfer to the SWS then the operator would have to manually open the feedwater valves FW786 and FW790, and close the service water valves SW1382 and SW1383. In the proposed modification, the feedwater valves FW786 and FW790 will be left open and de-energized. After receiving a low pump suction pressure signal, the time-delay mechanism in the suction transfer circuitry, after a pre-determined delay (a couple of seconds), will open the service water valves SW1382 and SW1383. In the event of an inadvertent switchover of the pump suction from the CST to the SWS and subsequent isolation of the SWS, the pump will continue to receive suction from the CST. If the CST is available, then in case of an inadvertent pump suction transfer, the operators would only need to isolate the SWS. Thus, with minimal operator intervention, an adequate supply of water to the AFWPs will be ensured.

In the event the CST inventory is depleted, the switchover to the SWS will take place as it does now. The check valves AF1 and AF2, downstream of the feedwater valves FW786 and FW790, respectively, will prevent backflow to the CST as designed. Since the SWS pressure is, typically, 90 psig, the AFWPs will take suction from the SWS rather than draw on the lower pressure segment of the supply line from the CST. The check valves will isolate this portion of the system. We note that both pairs of valves - FW786 & FW790 and SW1382 & SW1383 - receive the low pressure signal at the same time. Furthermore, we have examined the stroke times of the feedwater valves and the service water valves from the last in-service test and note that the service water valves open fully before the feedwater valves close. This proposed modification of leaving the feedwater valves open and de-energized is intended to minimize any potential AFWP cavitation problem. We note that there are two pressure sensors for each AFWP and following single failure of the associated pressure sensor, a potential pump cavitation problem due to the AFWP drawing on empty CST does not exist. In case of a seismic event, leaving the feedwater valves open and de-energized has a disadvantage of draining the service water through a potential break in the piping upstream of the feedwater valves because this portion of the auxiliary feedwater piping is not seismically qualified, thus defeating the design isolation function of the feedwater valves. However, the probability of a seismic event occurring at the Davis-Besse site is small. Therefore, the combined probability of an event similar to the one being discussed occurring concurrent with a seismic event is even smaller.

- o To ensure an adequate water supply to the AFWP when the SWS is inadvertently isolated, subsequent to a spurious transfer from the CST, the licensee is considering a design modification which involves leaving open the breaker for the CST supply valve. This proposed modification is redundant to the time-delay mechanism discussed earlier.
