SUBJECT: TRANSFER OF LEAD RESPONSIBILITY FOR EVALUATING THE ADEQUACY OF  
THE TRANSFER CANAL SEAL BETWEEN HATCH UNIT 1 AND UNIT 2  
REACTOR BUILDINGS

GPC/NRC MEETING  
FUEL TRANSFER CANAL  
JANUARY 22, 1987

PRELIMINARY NOTIFICATION OF EVENT OR UNUSUAL OCCURRENCE PNO-II-86-90

SUBJECT: AIT DISPATCHED TO INVESTIGATE LEAK FROM SPENT FUEL POOLS

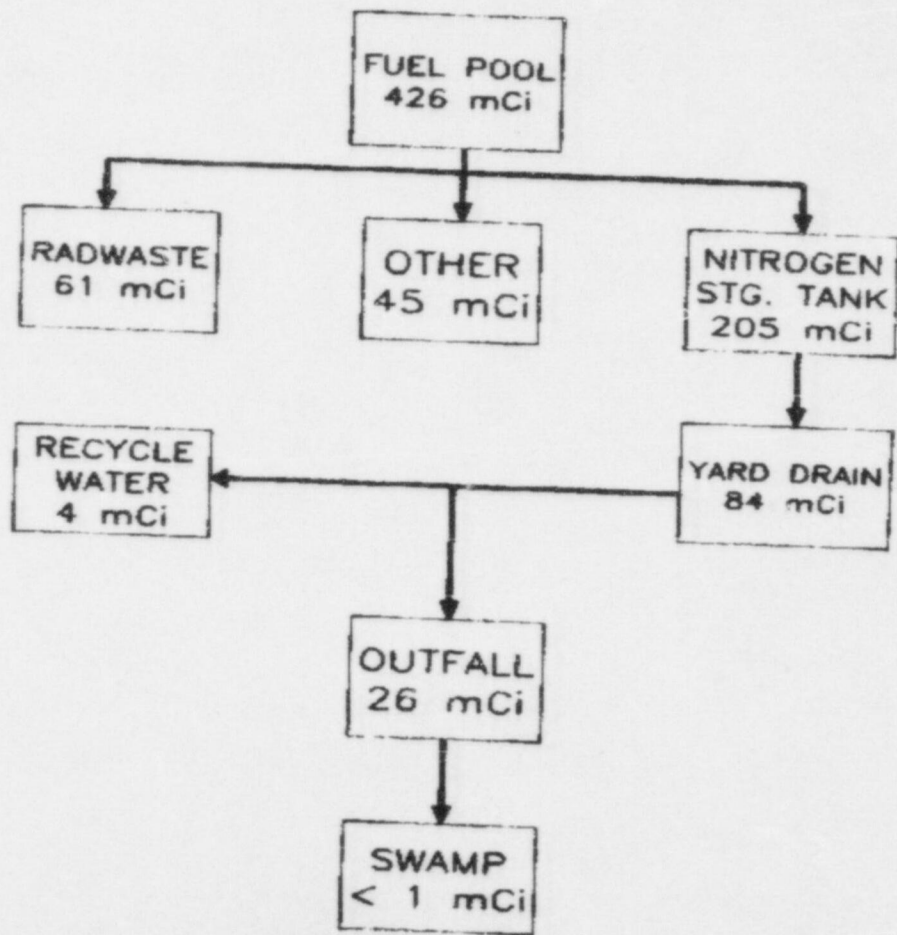
# FUEL TRANSFER CANAL FLOWPATH

If three seals on one side of the transfer canal or all six seals fail simultaneously, the water inventory in the transfer canal will drain out through the three inch seismic gap between the HNP-1 and HNP-2 reactor buildings to the yard drainage system. If the transfer canal gates are closed then only water in the canal will escape. If the gates are open, then water will also be lost from the spent fuel pools. The consequences of this loss are three fold.

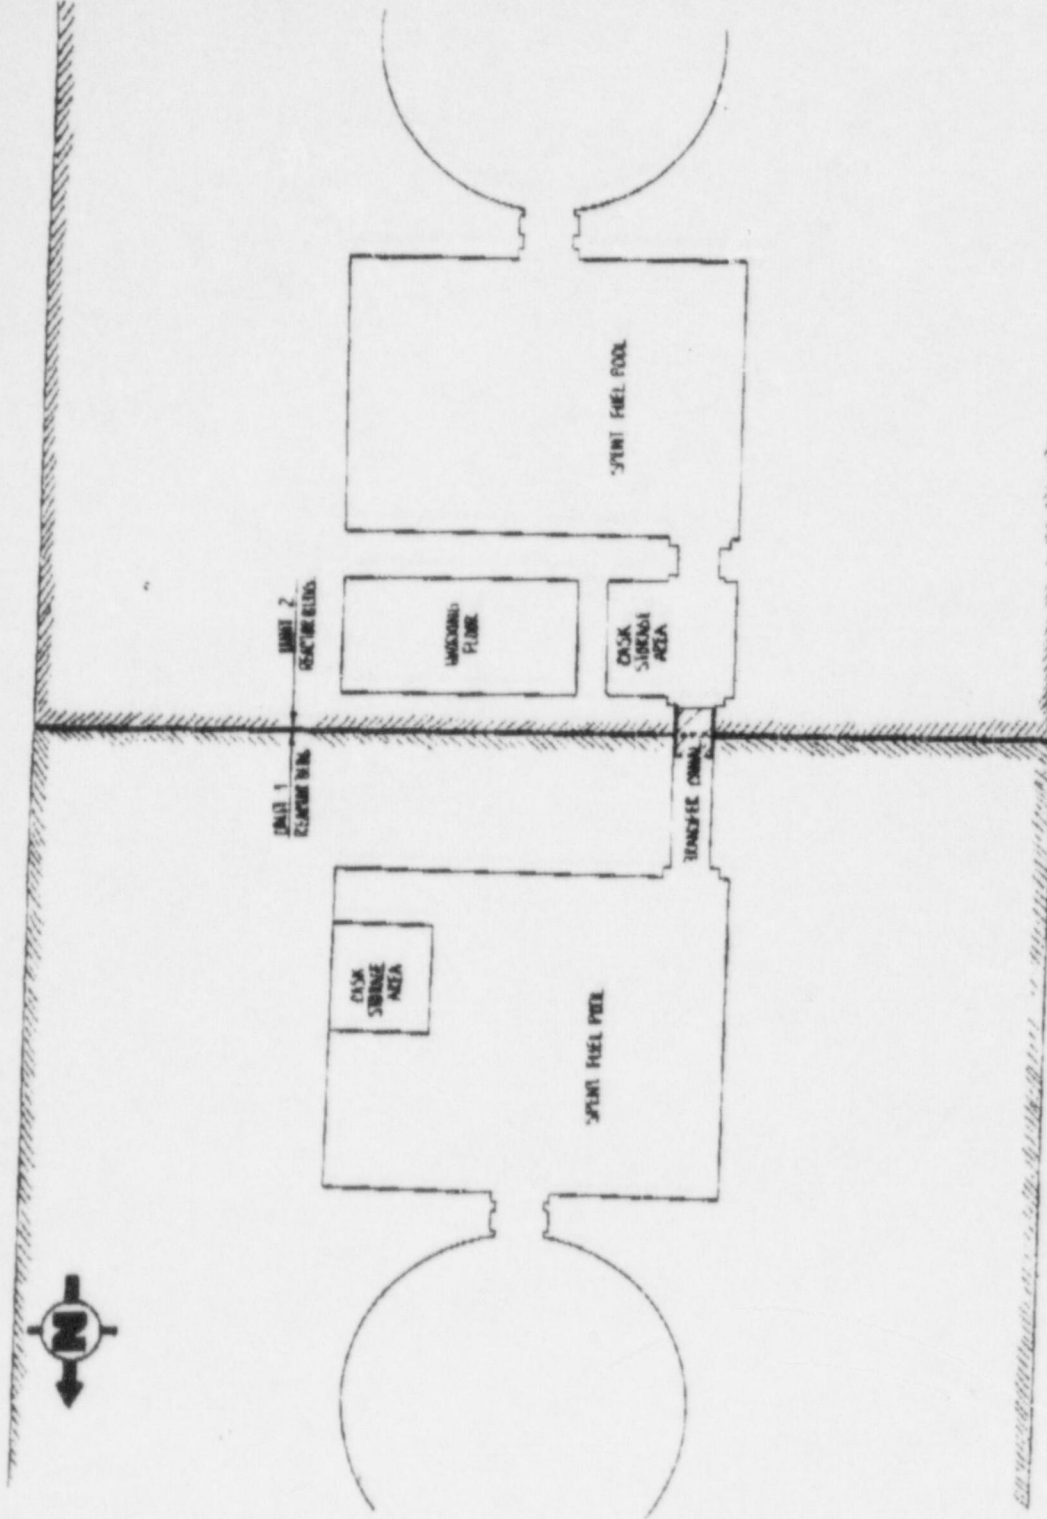
PARTIAL PLAN VIEW OF REFUELING FLOOR

The U-shaped transfer canal, located on the refueling floor between the HNP-1 and HNP-2 spent fuel pools, is removable and as such requires inflatable bellows type seals for watertightness. The seals are located at either end of the canal (horizontal seals), and in the 9-inch space adjacent to the 3-inch seismic gap between the HNP-1 and HNP-2 reactor buildings (vertical seals).

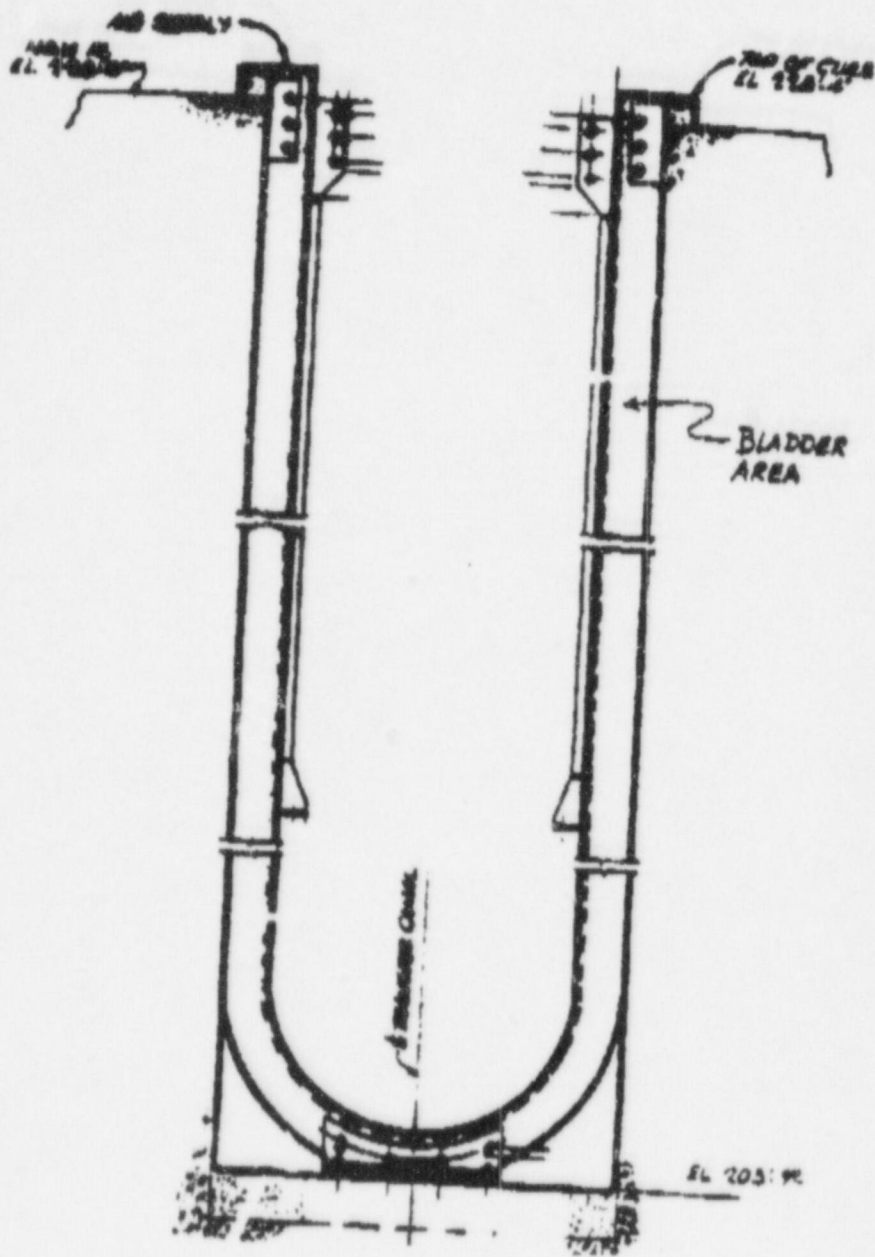
END VIEW

1. In the original design, the transfer canal seals were pressurized by a single feed line from a unit 2 service air system service box which branched into six separate feeds to the individual seals. These lines were equipped with local pressure indicators and check valves. A manual cross tie to the unit 1 air supply is available.

2. Subsequent to the fuel pool leak down, several changes were made to improve reliability of the air supply. A second supply from HNP-1 service air was incorporated such that in each horizontal seal pair, one is fed from HNP-1 service air, and one is fed from HNP-2 service air. In this arrangement, loss of, say, the whole unit 2 air system will not affect but one of the seals in the pair and system integrity is maintained (transfer canal seal system). A common line was incorporated to supply the vertical seals with both HNP-1 and HNP-2 service air. Check valves placed in the feed piping to this common header prevent back flow upon loss of air from one unit or the other. Other changes included the addition of pressure switches that would alarm in both control rooms upon a drop in pressure in either supply. ] answer system

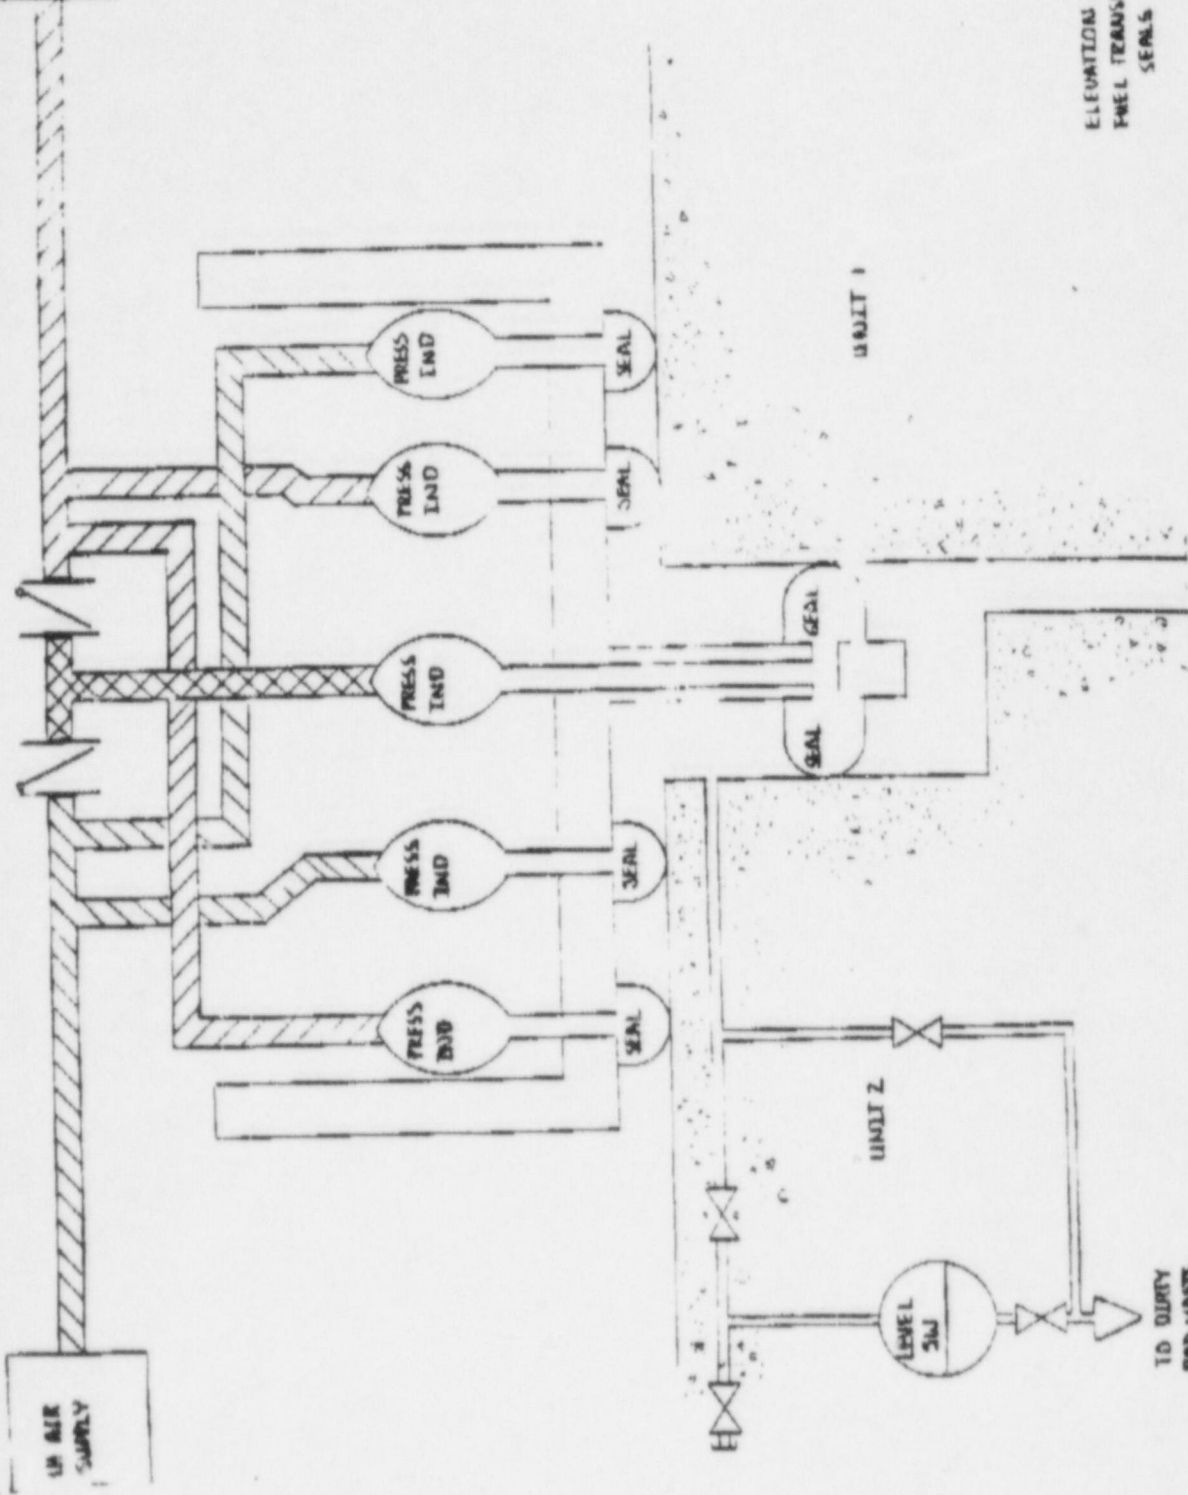
ELEVATION VIEW (NFS)  
FUEL TRANSFER SEAL  
SEALS

The transfer canal seals are located in pairs to provide an additional safety margin, i.e. if one of the seals fails, the other seal in the pair maintains integrity and water does not leak out. If both horizontal seals in a pair fails, water is prevented from leaking out by the vertical seal on that side.
