LICENSEE EVENT REPORT (LER)

FACILITY NAME (1) Fort St. Vrain, Unit No. 1

REACTOR SCRAM ON UNDERVOLTAGE WHILE PERFORMING CN-2191

SUBJECT: Licensee Event Report
87-003, Supplemental
Report

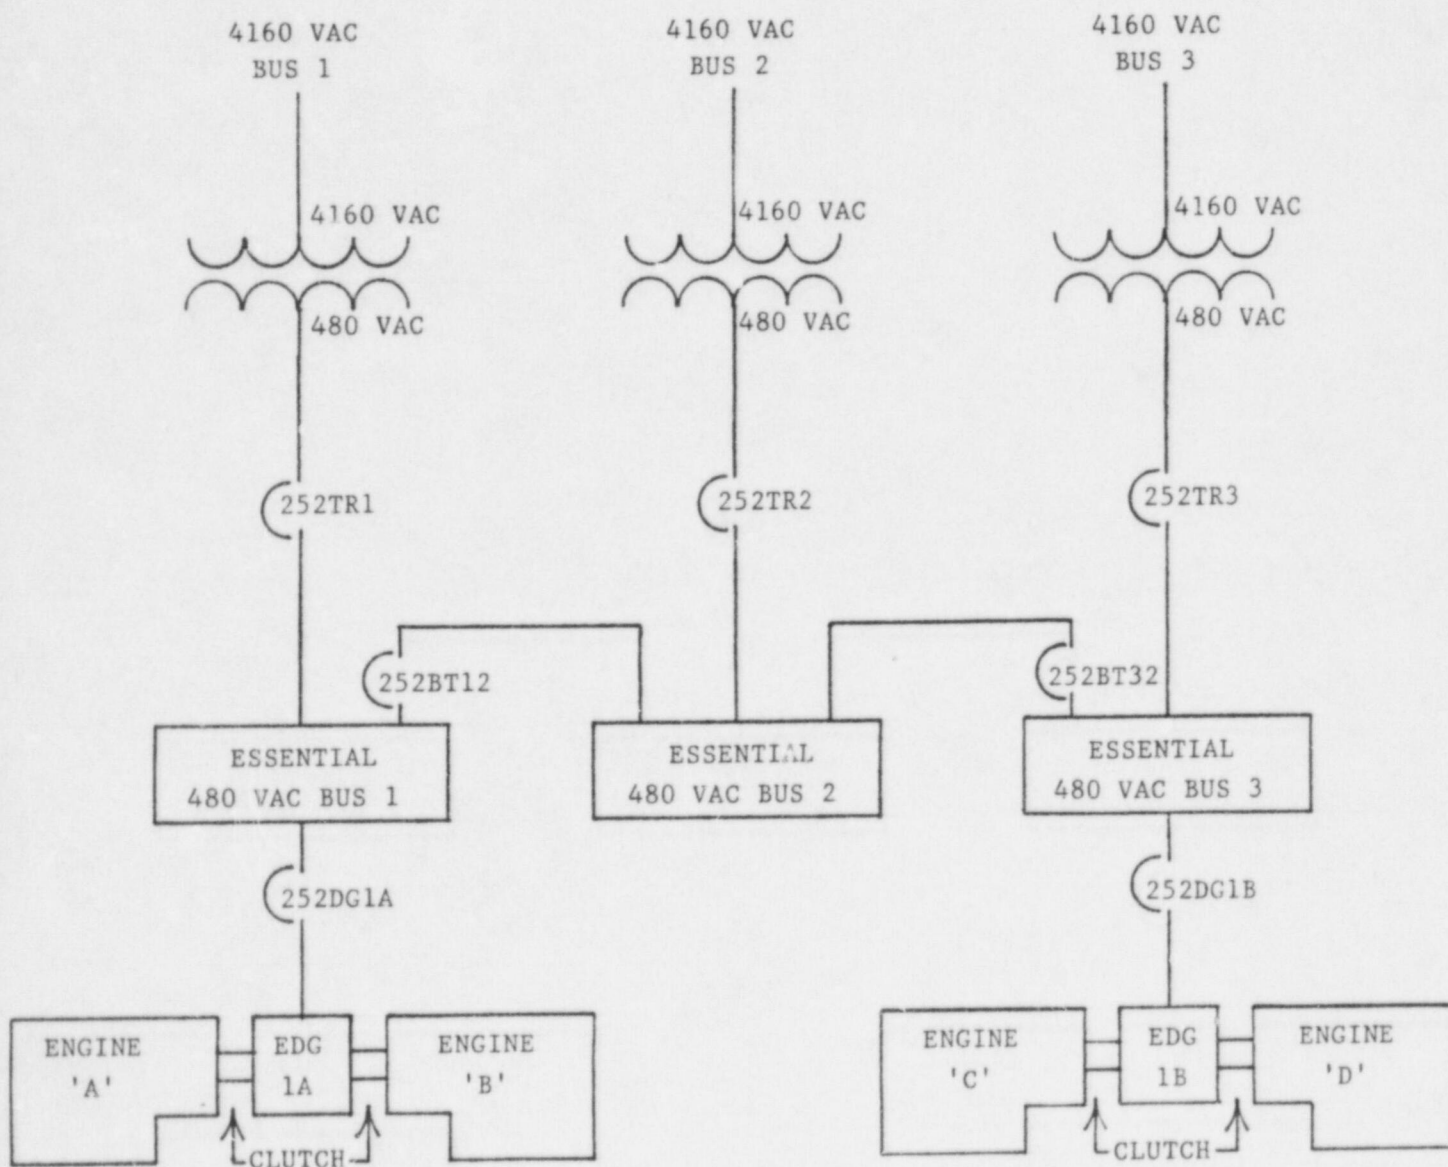
FIGURE 1

Essential electric loads required to ensure an orderly shutdown and continued maintenance of the plant in a safe condition are powered from three 480 VAC essential buses. Under normal conditions, load center transformers, rated at 4160 VAC to 480 VAC 3 phase, 60 Hertz, are utilized to supply each of the 480 VAC essential buses (Refer to Figure 1). Protection under degraded voltage conditions is provided for the essential power system by the use of undervoltage relays to produce appropriate action corresponding to the degree of voltage degradation.

On a complete loss of 480 VAC essential bus voltage caused by the loss of all outside power, a set of inverse time delay undervoltage relays set at 328 volts (68.3% of 480 volts nominal) and arranged in two-out-of-three logic per bus will be tripped. Loss of voltage on two-out-of-three 480 VAC essential buses will:

1. Trip all three main power circuit breakers (252TR1, 252TR2, and 252TR3)
2. Start the emergency diesel generators
3. Load shed all three essential buses
4. Close both diesel generator breakers (252DG1A and 252DG1B) and sequence loads onto Bus 1 and Bus 3.

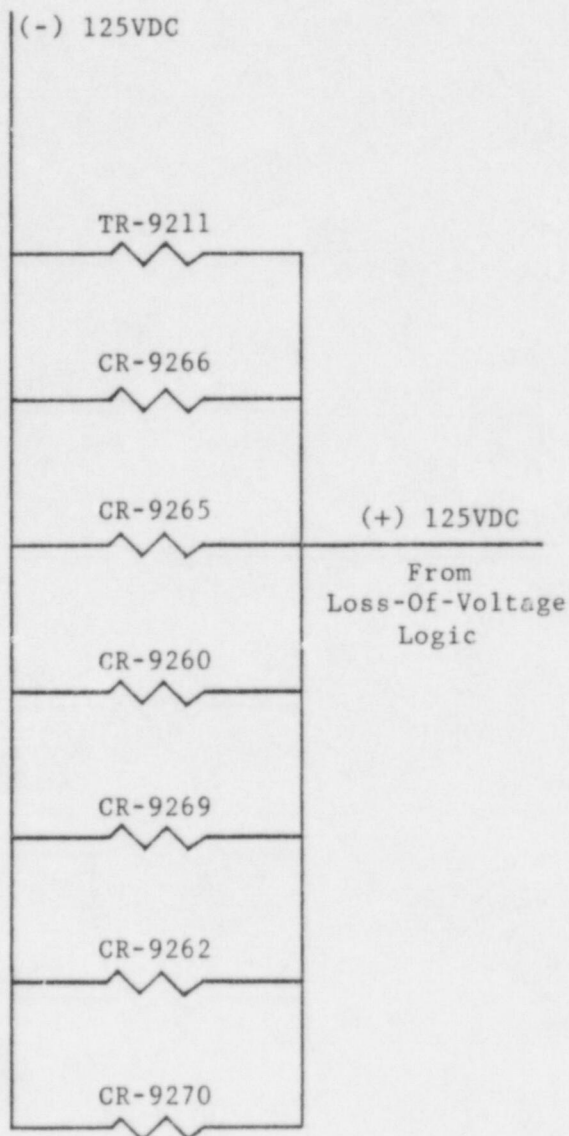
FIGURE 2

On February 3, 1987, Results engineers were performing Functional Test FT-2191-5 on redundant load shedding relays CR-9260 and CR-9261 following their replacement per Change Notice CN-2191. These relays will independently trip the feeder breaker for 480 VAC essential Bus 2 and various circuit breakers on all three 480 VAC essential buses as part of the overall load shedding process. The tie breaker between Bus 2 and Bus 3 (252BT32) was closed prior to the start of the Functional Test to ensure that Bus 2 would remain energized from Bus 3 when the feeder breaker to Bus 2 (252TR2) was tripped. FT-2191-5 was to be performed by removing the 125 VDC feed wires from each relay to be tested, applying an external 125 VDC source directly to the relay coil and verifying that the proper load shedding actions take place when the relay coil is energized (Refer to Figure 2).

At approximately 1735 hours, when the Results Engineer applied the external 125 VDC source to the relay coil of CR-9260, Bus 2 and Bus 3 feeder breakers (252TR2 and 252TR3) tripped, simultaneously deenergizing both Bus 2 and Bus 3, thus completing the undervoltage relay logic for a loss of all outside power. 1A diesel generator had previously been cleared out for maintenance, and could not start. 1B diesel generator successfully started on 'D' engine. 'C' engine failed to start, thus prohibiting 1B diesel generator output breaker (252DG1B) from automatically closing and re-energizing essential Bus 2 and Bus 3. Both engines on a diesel generator must be running for the generator output breaker to automatically close. The failure of Bus 2 and Bus 3 to be re-energized within 30 seconds completed the undervoltage relay logic for an automatic reactor scram actuation from the Plant Protective System (PPS) to the scram contactors. The scram contactors at the time of the undervoltage scram actuation were already in a tripped condition with all control rods fully inserted. The Reactor Mode Switch (RMS) was in the "OFF" position, therefore the scram contactors could not be reset or returned to a non-tripped condition. The automatic scram actuation from the PPS affected only the associated logic and alarm circuitry.

The Results Engineer performing the Functional Test inadvertently allowed the 125 VDC feed wire previously disconnected from CR-9260 to momentarily contact the external 125 VDC power source while CR-9260 was energized. CR-9262 was the only relay that picked up as a result of this momentary contact.

Results personnel have been instructed to properly insulate wires removed from circuits during testing to prevent inadvertent circuit actuations in the future.
