BOSTON EDISON COMPANY  
800 BOYLSTON STREET  
BOSTON, MASSACHUSETTS 02199

June 16, 1986  
BECO Ltr #86-079

Subject: Second Response to NRC Confirmatory Action  
Letter #86-10, Regarding the Events Which  
Occurred on April 4, 11-12, 1986 at Pilgrim  
Nuclear Power Station

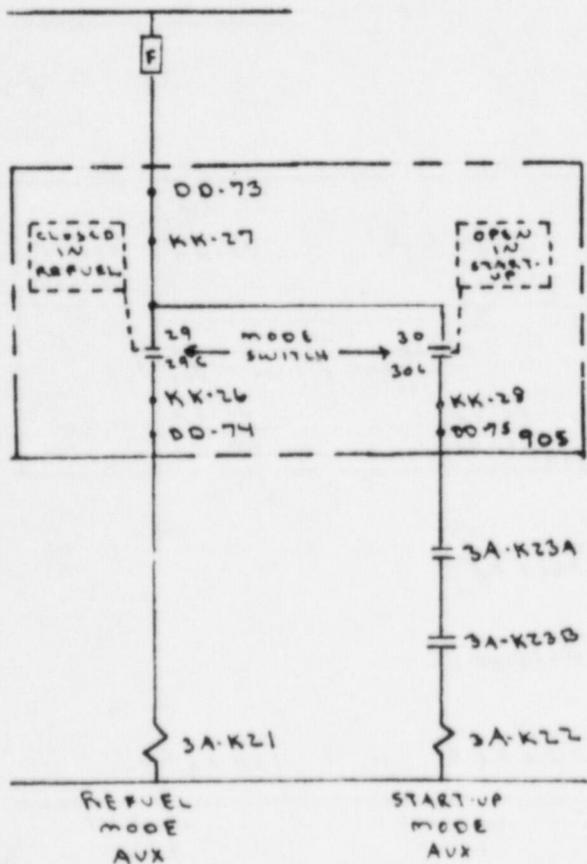
MIV16-6 (Should Be)

As a result of the performance of step 8 on page 11 of PNPS Procedure TP 86-64, Remove Existing SB-1 Type RMS, Replace with SB-9 Type RMS, a discrepancy was found between the Elementary Diagram MIV16-6 wiring and the "as found" wiring. The difference is shown below:

From these drawings it can be seen that in the "should be" MIV16-6 configuration, relay 3A-K21 can be energized independent of the position of RMS contact 30-30C and is solely dependent on the position of RMS contact 29-29C, i.e., the contacts are in parallel, while in the "as found" configuration, relay 3A-K21 is dependent on the position of both RMS contacts 29-29C and 30-30C, i.e., the contacts are in series. As a result, 3A-K21 could never be energized with contact 30-30C open, which is in conflict with the design diagram. This concept is outlined in the following table where blank=open, X=closed, 0=de-energized, 1=energized:

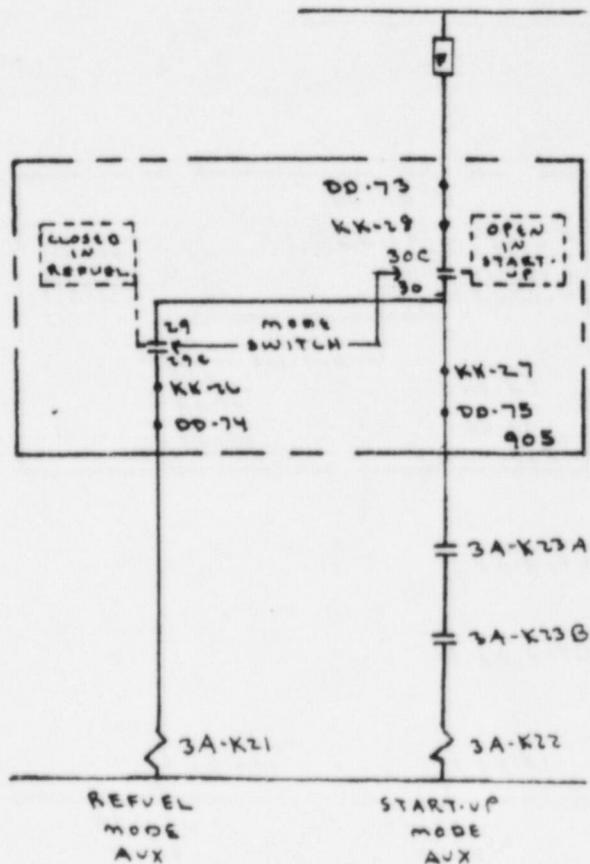
As found

If contact 30-30C were to fail open in the refuel position while contact 29-29C were to close, relay 3A-K21 would again remain de-energized in the "as found" circuit while it would have energized in the "should be" circuit. As a result, single rod withdrawal in the refuel mode would not have been able to be performed as desired.

In response to Task 2, since the miswiring could only result in the inability to withdraw a rod when desired, the resultant condition was more conservative than the design prints.

Wiring discrepancies were electrical equivalents, damaged wire and loose connections. All electrical equivalents were returned to their designed condition. All loose wires were tightened and the damaged wire was replaced. These repairs were made through the replacement project with standard work practices employed and witnessed by the Quality Control Group.
