March 14, 1999  
1920-99-20126

Subject: Three Mile Island Nuclear Station, Unit 1 (TMI-1)  
Operating License No. DPR-50  
Docket No. 50-289  
LER 99-002-00, "Potential Failure of Multiple Containment Monitoring  
System (CM) Containment Isolation Valves (CM-V-1, 2, 3, and 4) due to  
Inappropriate Use of Vendor Information"

## Potential Failure of Multiple Containment Monitoring System (CM) Containment Isolation Valves (CM-V-1, 2, 3, and 4) due to Inappropriate Use of Vendor Information

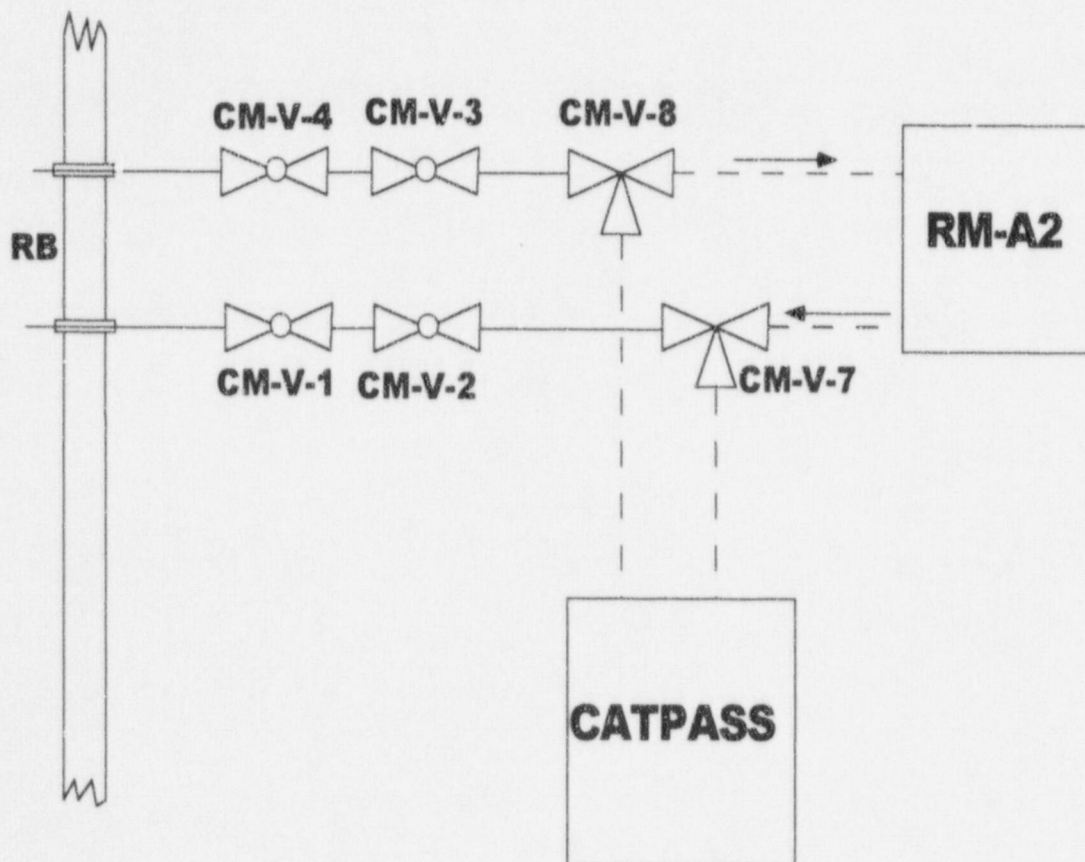
Containment isolation valves (CIVs) CM-V-1, 2, 3, and 4 are 1 inch pneumatic ball valves manufactured by Crane-Flomatics (now owned by the Hi-Gear Valve Company). As shown in Figure 1 below, the Reactor Building (RB) Radiation Monitor (RM-A-2) is also located in the IB and taps into the same process piping that is isolated from the RB by these CIVs. The direction of RB air flow is normally out of the RB through CM-V-4 and 3 respectively to RM-A-2, returning through CM-V-2 and 1 respectively; samples can either be drawn out of the RB through CM-V-1 and 2, or through CM-V-4 and 3, respectively.
