Subject: Crystal River Unit #3
Docket No. 50-302
Operating License No. DPR-72

1/22/86 - MEDIA STATEMENT RE: JANUARY 10, 1986 DIVING ACCIDENT

SUBJECT: REPORT NO. 50-302/85-44

Facility Name: Crystal River 3

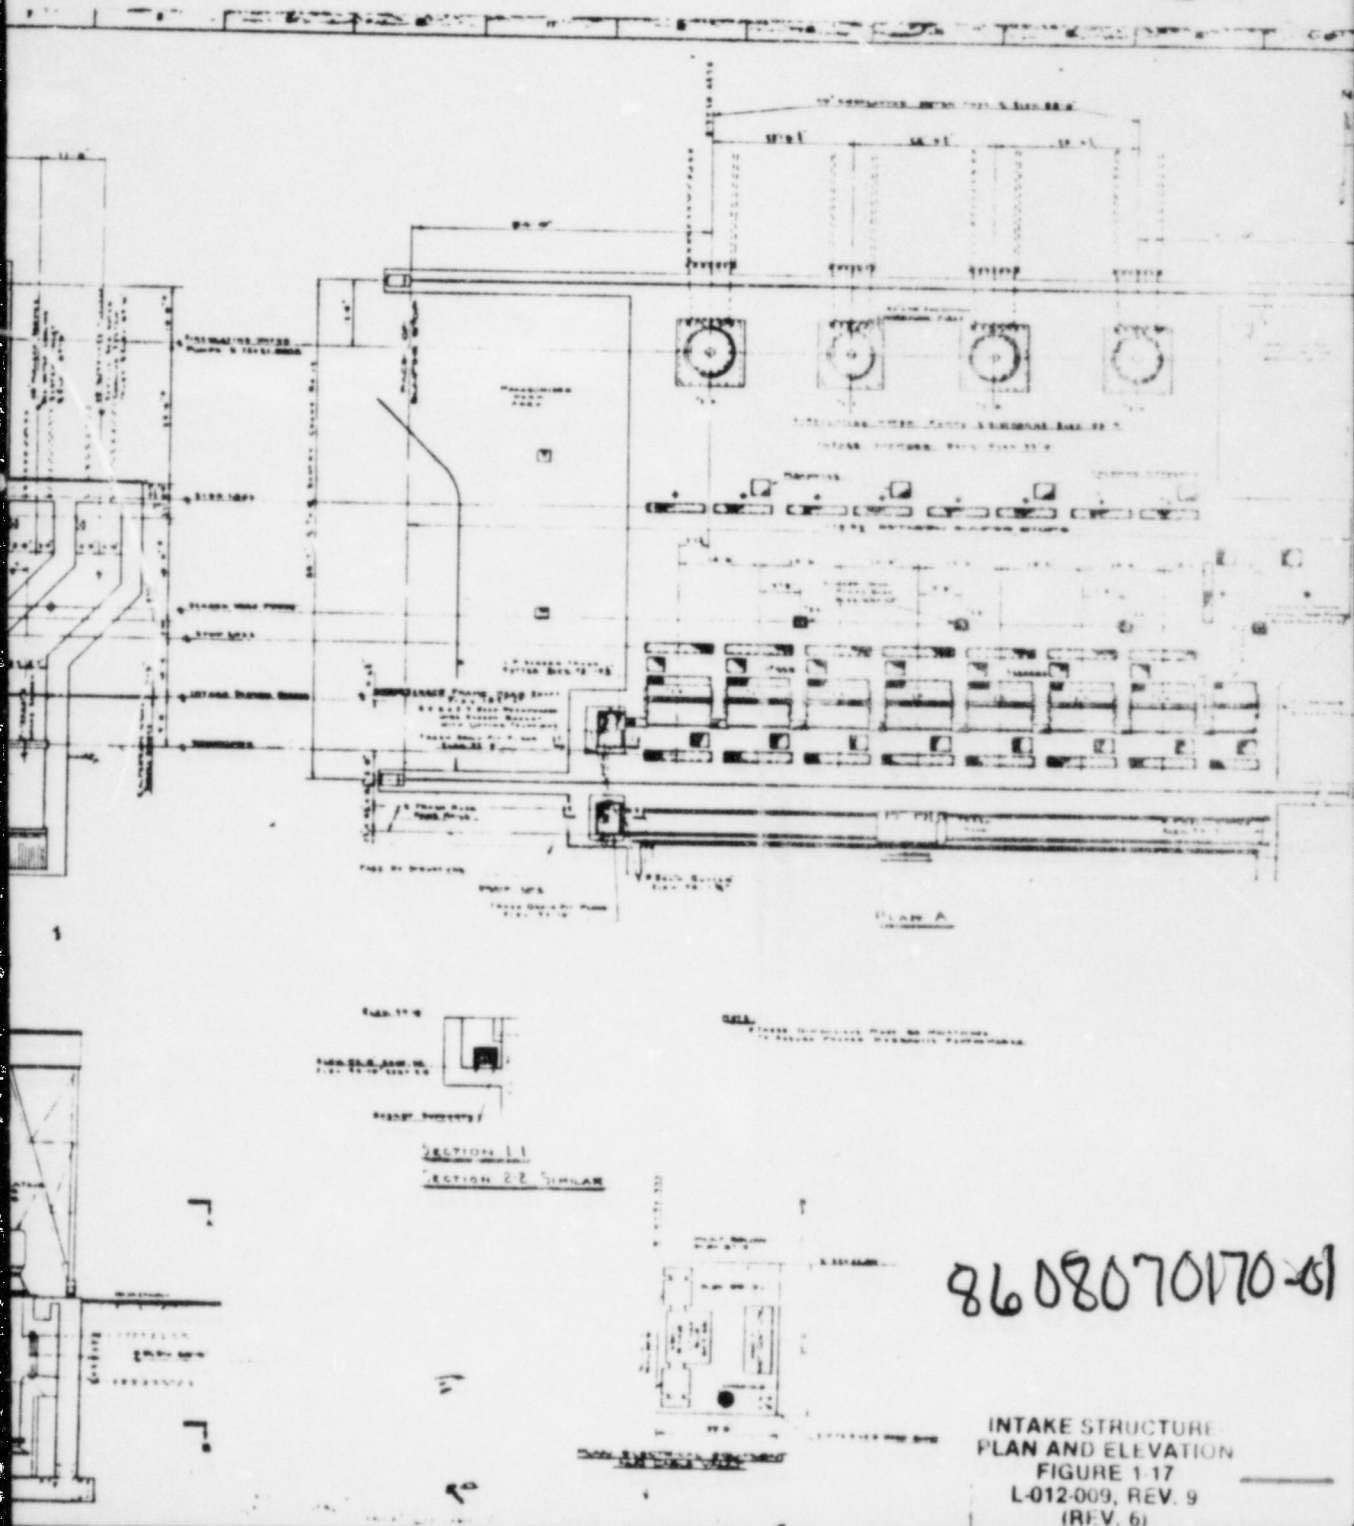
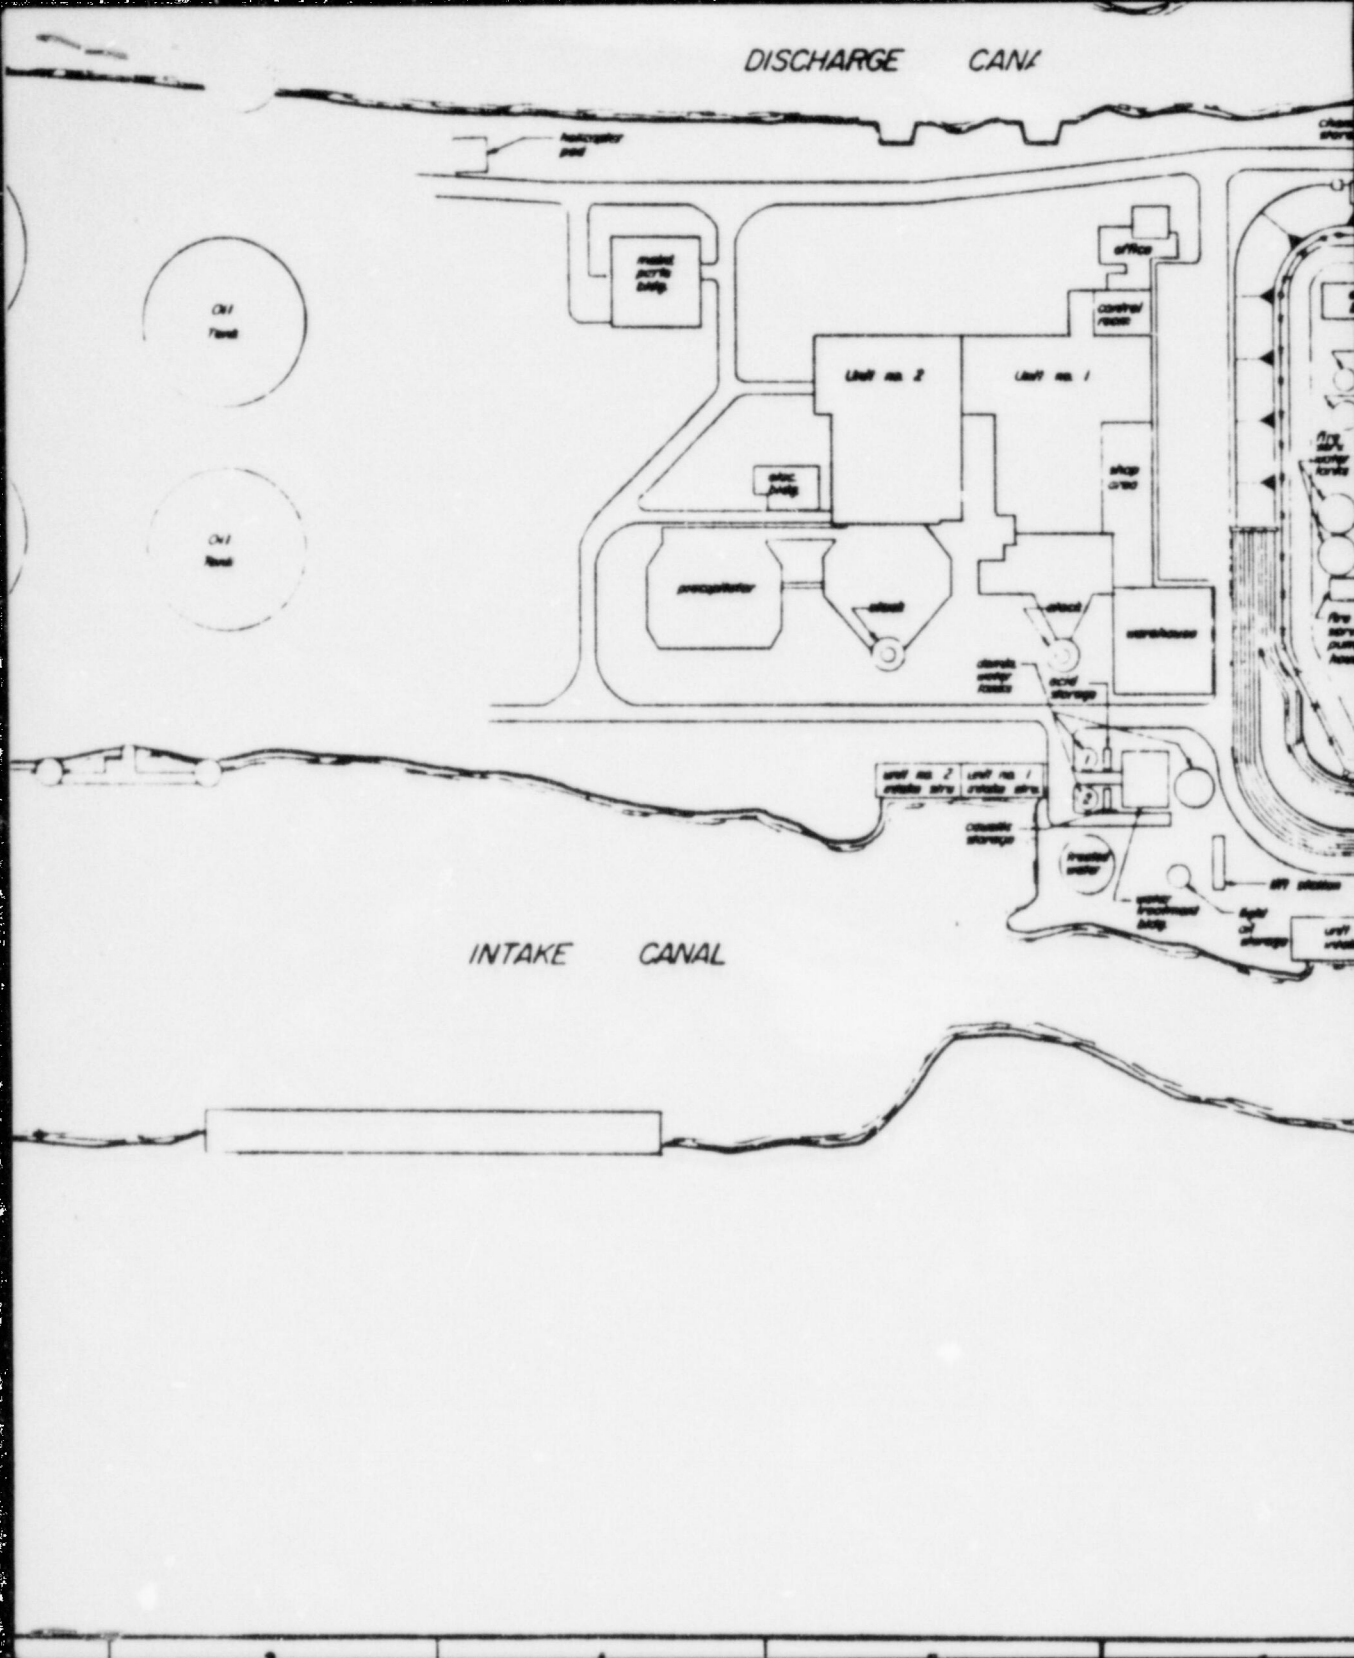
INTAKE STRUCTURE
PLAN AND ELEVATION
FIGURE 1-17
L-012-009, REV. 9
(REV. 6)

At 1700 on January 10, 1986, the body of a diver who had been working at the intake structure was recovered. This diver had entered the water to locate another diver who had previously entered the water and was overdue to return to the surface.

- c. On January 10, 1986, the licensee contracted divers to clean and remove trash from the plant's intake structure, which provides cooling water to the plant from the Gulf of Mexico. During this period, the plant was in a cold shutdown (Mode 5) condition with reactor cooling being provided by the decay heat removal (DHR) system. The DHR system utilizes pumps (RWPs) that take water from the Gulf via the intake structure to provide a cooling heat sink.

At about 4:30 p.m., it was reported that one of the divers was missing. Shortly thereafter, it was reported that a second diver, who had gone into the water to look for the first diver, had died. During this time period, the running RWPs were secured thus leaving the plant without cooling water.
